GEOTECHNICAL REPORT

Project: Erf 155 Keurboomstrand, Plettenberg Bay

Date: 11.12.2020

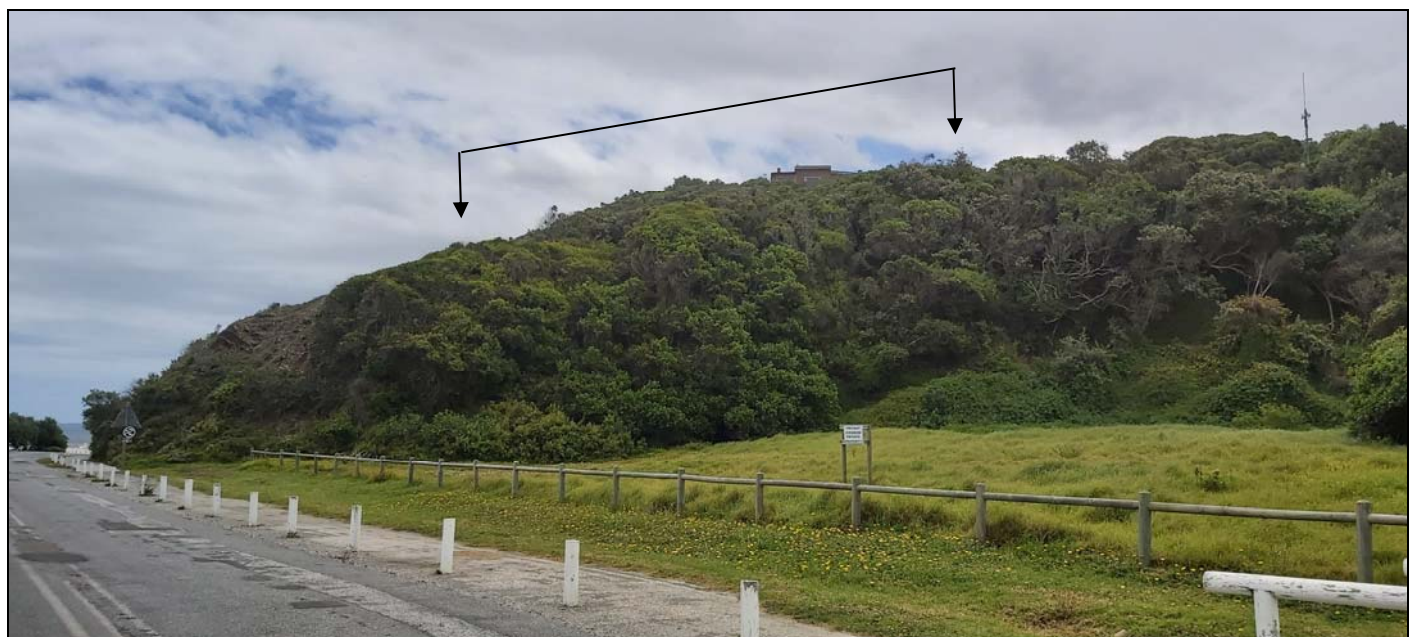
The site is a potentially developable portion of Remainder of Erf 155 Keurboomstrand, which is a vacant stand, 5.6Ha in extent, located on a south-facing slope, which overlooks the ocean. The proposed development area is a relatively small portion of the stand on the eastern side with a gentle to moderate gradient, which becomes steep to very steep towards the east, west and south

Figure 2: View looking west towards the proposed development area on the hill

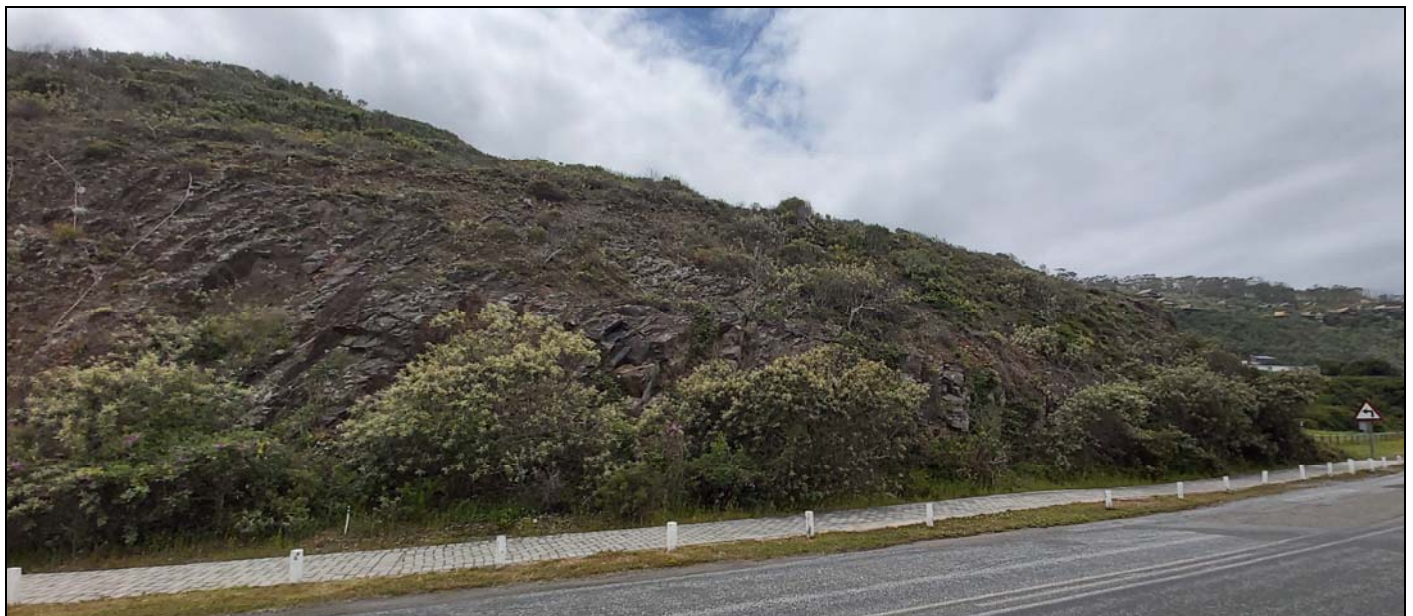
The site is underlain by feldspathic sandstone and shale of the Silurian Baviaanskloof Formation of the Table Mountain Group, which is clearly visible on the steep slopes near the southern boundary (see Figure 4&5). The bedrock is locally overlain by alluvial and/or colluvial silty sand, gravel and cobbles.

Figure 5: Feldspathic sandstone and shale of the Baviaanskloof Formation exposed on steep slopes below the site

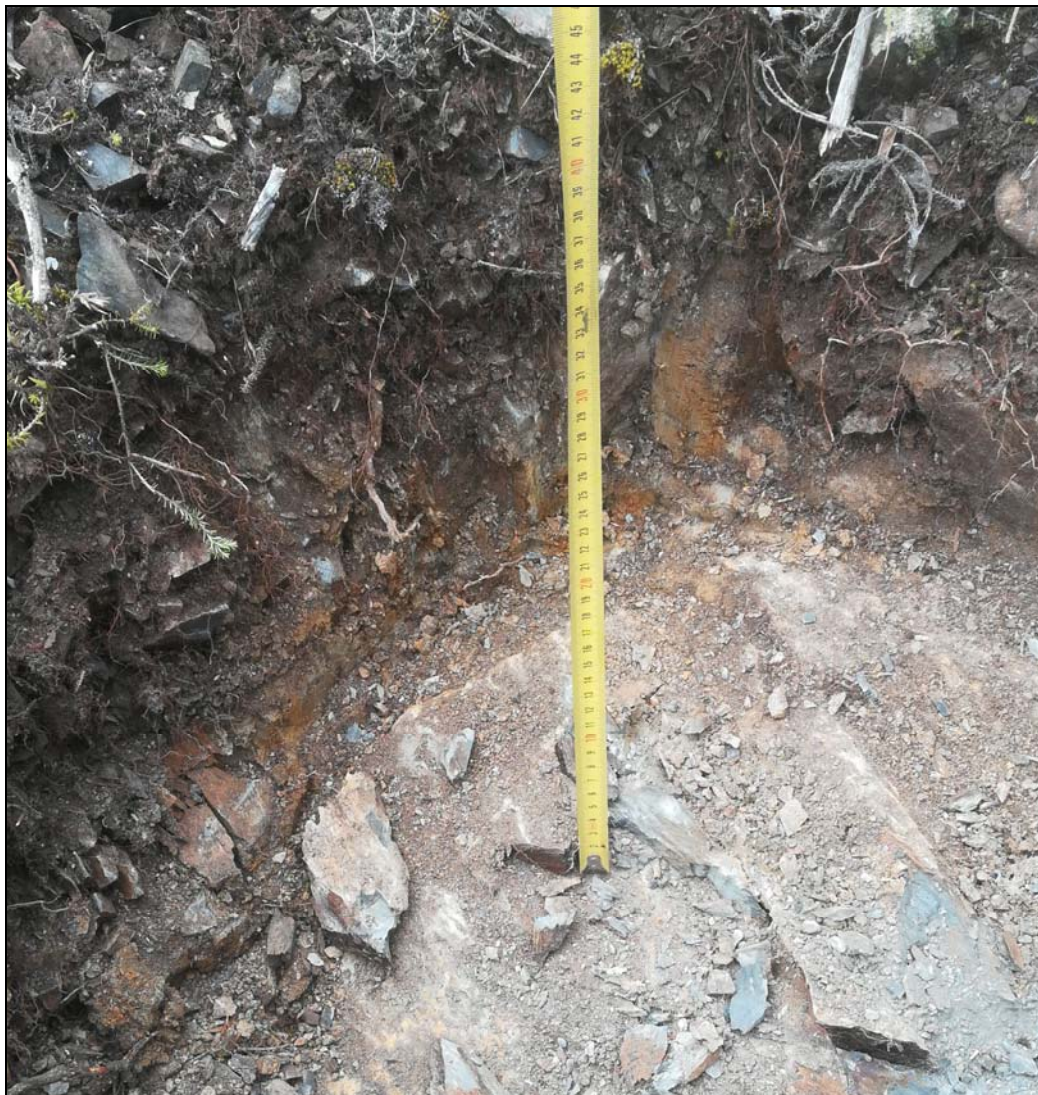
Test pits conducted on the site (see Figure 6&7) recorded a general soil profile consisting of silty sandy gravel and cobbles of colluvial origin, overlying bedrock shale and feldspathic sandstone of

the Baviaanskloof Formation. Two test pits refused on this rock at a depth of 0.5m below NGL, and one test pits refused on very dense colluvial cobbles at a depth of 0.8m BNGL. Insitu penetration tests (DCP) refused on this rock or very dense cobbles at a maximum depth of 0.45m BNGL. No clay or any other highly problematic soils were encountered in the test pits and the general subsurface conditions were found to be highly favourable for structural loading. No lab tests were necessary due to the presence of shallow hard rock which provides a highly suitable founding medium.

Figure 7: Bedrock exposed in test pits

Earthworks: The presence of shallow rock may hamper earthworks and deep excavations but will generally provide a highly stable and suitable founding medium. Excavations deeper than 0.5m can be provisionally classified as “hard”, requiring mechanical wedging and splitting (e.g. jackhammer/hydraulic pecker). No blasting is likely to be permitted in this residential area. It proposed that the proposed dwellings are designed and positioned in a manner which will take into account the terrain and underlying geotechnical conditions, such that minimal earthworks or terracing will be necessary (i.e. split levels or suspended structures).

Foundations & floors: Single and/or double storey masonry or timber structures can be founded on conventional strip/pad foundations on clean, tight bedrock at a minimum depth of 0.5m below GL. Light reinforcement of strip footings is recommended to span across irregular rock/ soil ground conditions that may occur in linear trenches. A safe design bearing pressure on very soft, highly weathered bedrock is 250kPa. But since foundations may span across rock and soil, bearing pressures should be kept to max 150kPa. The engineer should inspect foundations before casting to ensure suitable founding conditions and no undetected problems or areas where no rock was encountered in trenches. Specialist geotechnical advice should be sought in cases where the conditions encountered in foundation trenches differ vastly from that reported in the investigations. Fill material supporting ground floor concrete surface beds must be minimum G7 quality, compacted to 95% MDD and tested for approval by the engineer. Suspended floor slabs should be considered where fill heights are excessive to minimise importation of fill.

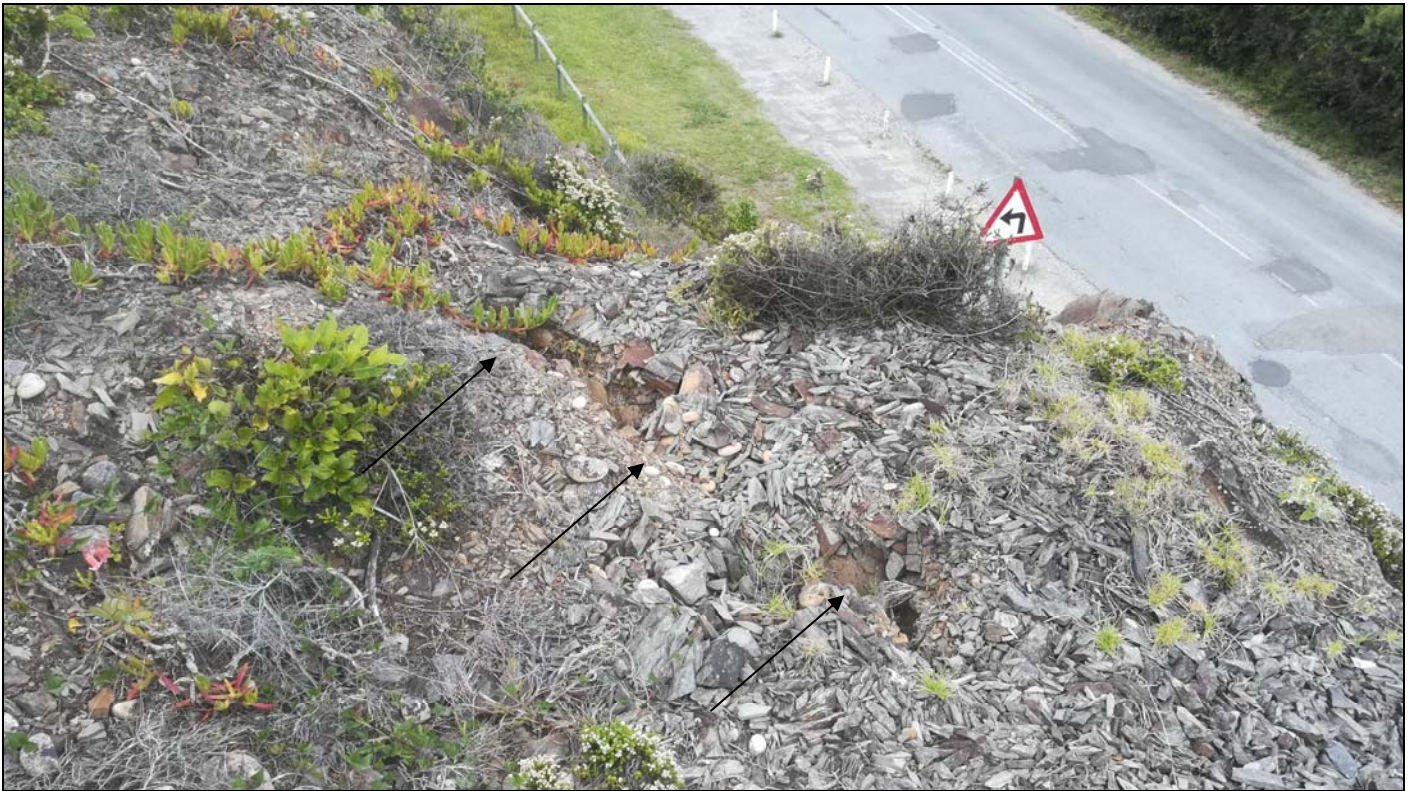
Some localised stability issues were noted along the edge of the very steep slope along the southern boundary with the Keurboomstrand Road (MR394), where a tension crack has developed along the edge of the cliff (See Figure 8). This is a localized phenomenon and the cracks do not extend further back than 1m from the top of the slope.

Figure 8: Tension crack along the edge of very steep slope on southern boundary

No earthworks or development is recommended on slopes steeper than 1:4, unless special engineering solutions are developed, and no development is recommended within a buffer zone of 5m from the top of slopes which exceed a gradient of 1:2 (most notably along the southern boundary).

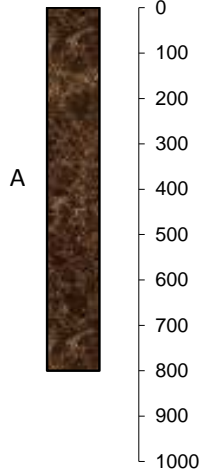
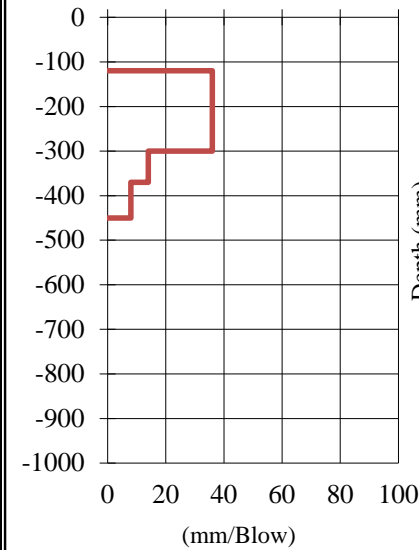
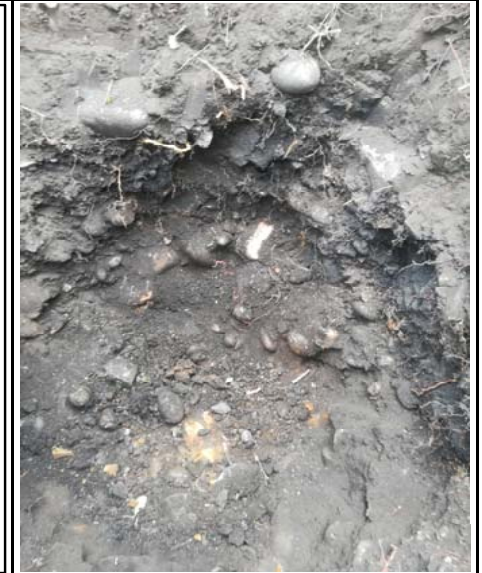
TP 3

(0 to 800) Moist, light-dark brown, medium dense to very dense, matrix supported, **GRAVEL & COBBLES & BOULDERS IN SILTY SANDY MATRIX**, colluvial.

Refusal @ 800mm on very dense cobbles
No Water
