# **Aquatic Rehabilitation Plan for George Rex Wetland, Knysna.**

**Prepared by: Dr. Jackie Dabrowski of Confluent Environmental (Pty) Ltd**

**Prepared for: Jazz Spirit I30 (Pty) Ltd**

**July 2019**

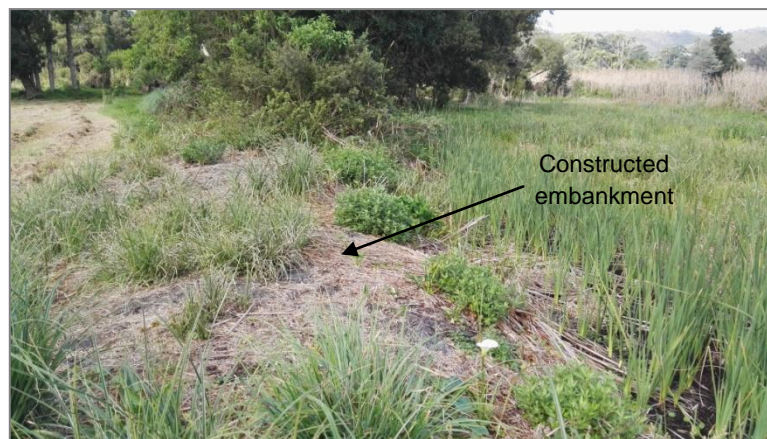
A drainage channel has been excavated along the eastern and southern boundary of the wetland in order to concentrate stormwater flows and reduce flooding over the site (Figure 3). Infill dumped along the edge of the channel has had the effect of reducing soil saturation for wetland plants and reducing dispersive flows across the wetland (also discussed in the following section on dumping). Seepage from the WWTW also enters the drainage channel impacting on water quality.

Figure 3. Drainage channel embankment separating wetland vegetation (right) from mown wetland vegetation (left).

Therefore, a precautionary approach is recommended. Approximately 5 'slots' measuring 5 m across could be removed from the embankment to allow floodwaters to disperse into the wetland (orange arrows on Figure 6), while a large volume of water would still be conveyed through the channel and discharged through the new culvert proposed under Howard Street. Openings in the embankment must be made level with the surrounding wetland.

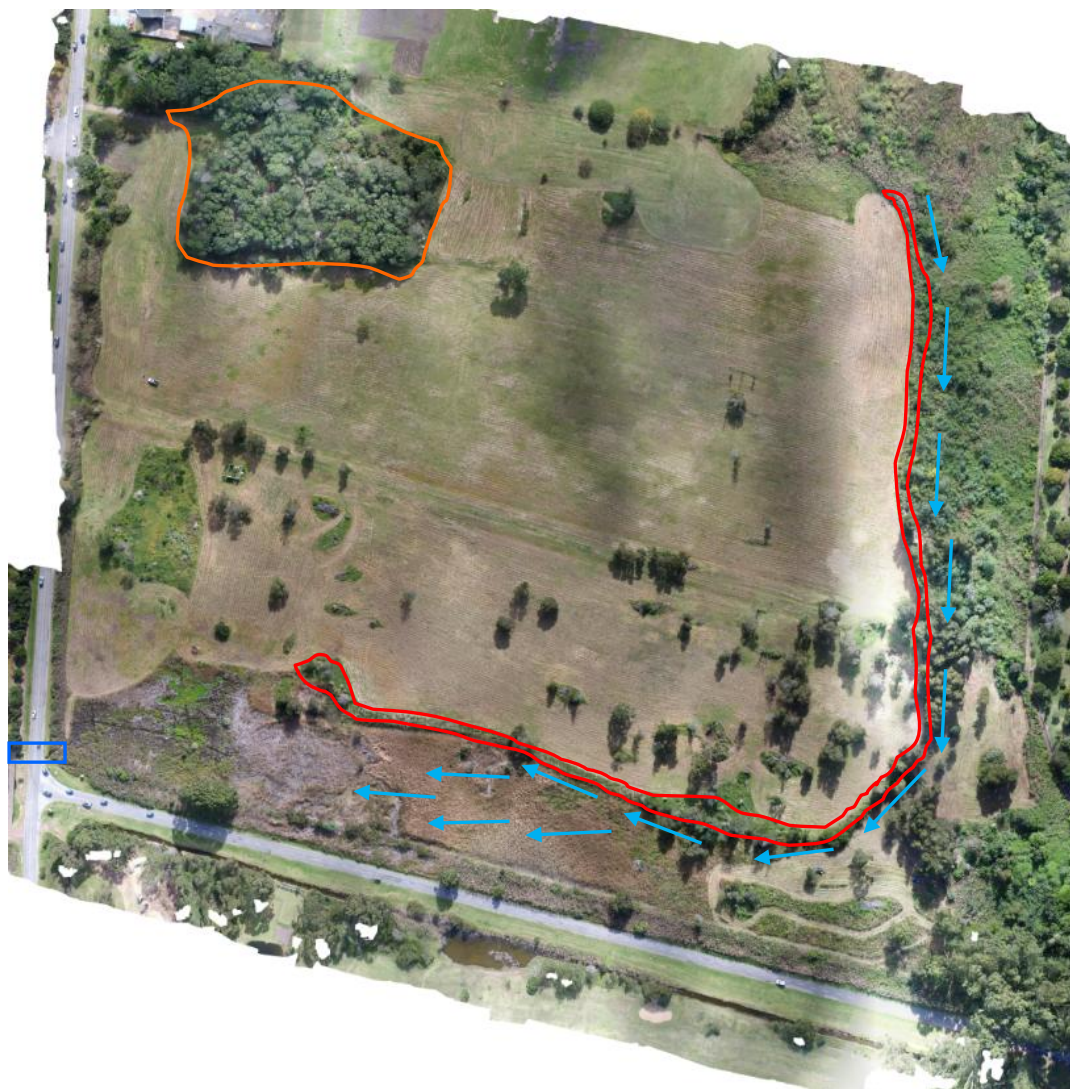
A culvert located on the corner of George Rex Drive and Howard Street was constructed to help drain stormwater out of the wetland under the road and into the estuary. Presently the land is higher on the estuary side of the road meaning that freshwater does not drain out of the wetland well, and saltwater cannot drain into the wetland except under high water levels. This is one of the factors leading to increased dominance of freshwater (and associated plant communities) in the wetland. Inflows of stormwater from neighbouring land (ie. Hunters Estate) and the WWTW have increased the amount of freshwater entering the wetland, which is mostly retained on site due to the blocked culvert (Figure 4).

Large areas of the site are mowed on a regular basis by the land-owner as the vegetation growth was viewed as a fire hazard. This has reduced the extent of obligate wetland plants such as *Phragmites australis* and *Typha capensis*. The extent of mowing can be seen in Figure 4.

Alien plant species have invaded all of the disturbed areas of the wetland, including the soil stockpile (orange outline in Figure 4), drainage channel banks, along roads and around the old farm house. Extensive alien vegetation corresponds with the red outline of the drainage channel shown in Figure 4. More isolated alien trees (as well as indigenous trees) are located in the extensively mown area.

Figure 4. Aerial drone image (2018) of the George Rex Wetland showing degraded features. Blue arrows show the stormwater channel, the red area is the stormwater channel embankment, the orange area is the historical soil stockpile which has been colonised by alien trees (in the footprint of the sports complex), and all open areas are mown. The blocked culvert in the south-western corner is indicated by the blue rectangle.

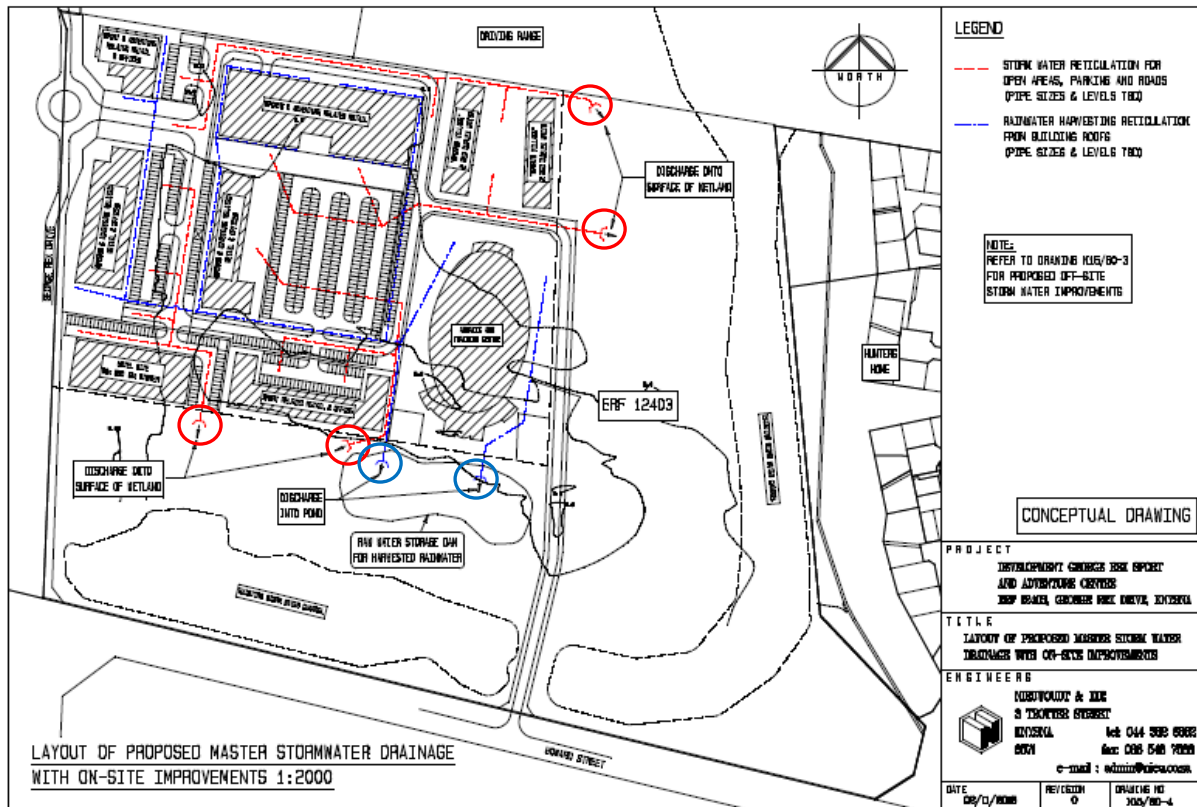
Figure 5. Stormwater drainage plan for Erf 12403 (Niewoudt & Kie, 2018)

The stormwater plan proposes to discharge stormwater from roads, car parks and other open areas into the wetland at 4 points (Figure 5). There are two points on the eastern side and two on the southern side of the development. This will support the recharge of groundwater, and provide surface flow into the wetland during periods of rainfall. This is considered a positive approach but must ensure that channelled flow doesn't occur at the discharge points. Sheet flow must be maintained as far as possible so as not to further degrade the wetland.

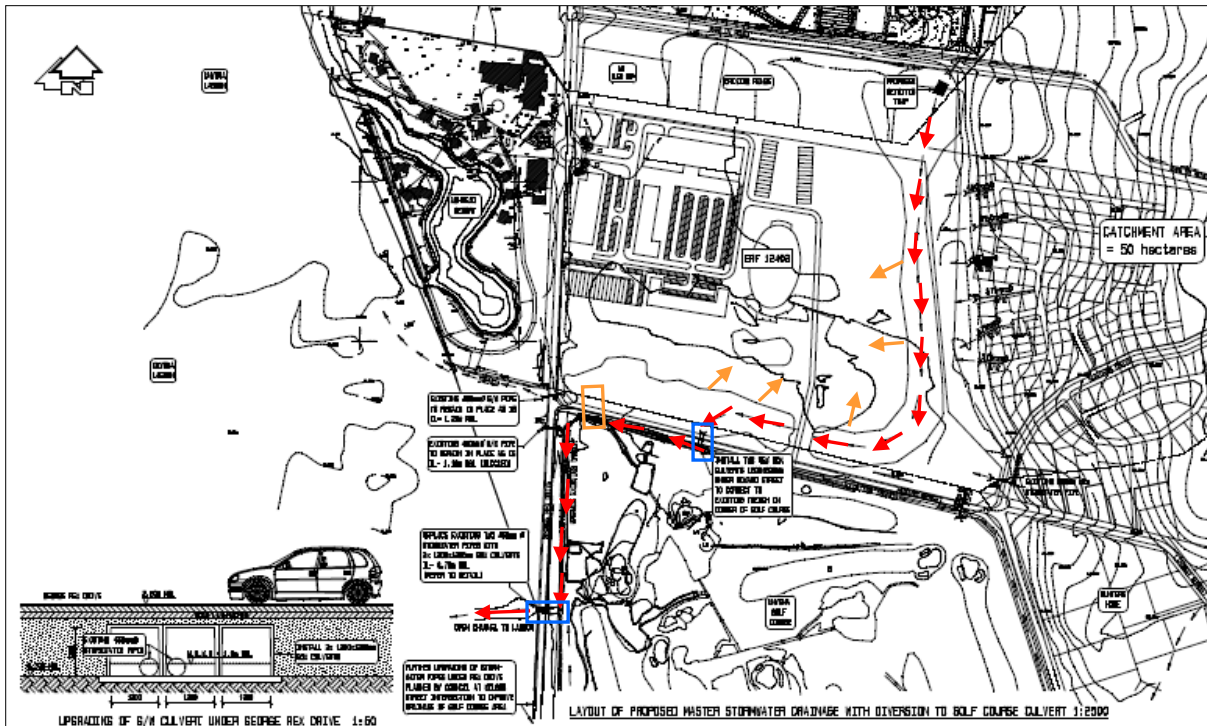
The proposed stormwater management plan for draining stormwater from Erf 12403 into the Knysna Estuary is shown in Figure 6. Stormwater flow has been shown using red arrows for clarity. The plan shows water drained from the catchment as flowing through the existing drainage channel, through box culverts under Howard Street (new culvert) to a drainage channel along the northern and western boundary of the golf course, discharging into the estuary through enlarged box culverts as shown in the inset with the car in Figure 6. It has been proposed by the engineers involved that the drainage channel will provide opportunity for enhanced connectivity with the estuary as seawater can flow up the channel into the wetland.

Figure 6. Stormwater drainage plan from Erf 12403 to Knysna Estuary (Niewoudt & Kie, 2018). Red arrows indicate proposed movement of stormwater through existing drainage channel; blue rectangles indicate proposed new culvert or culvert upgrades; and the orange rectangle is an additional culvert recommended in this rehabilitation plan. Orange arrows are locations of ‘slots’ in the drainage channel embankment proposed in this rehabilitation plan.

An alternative plan was proposed which is to divert stormwater out of Erf 12403 via a new culvert beneath Howard Street into an existing drainage channel that runs along the north and western boundary of the golf course (blue rectangle in Figure 6). Stormwater would then flow into the estuary via an upgraded box culvert on George Rex Drive. During high tides, seawater pushes up this channel and would enter the estuary via the Howard Street culvert, to an extent.

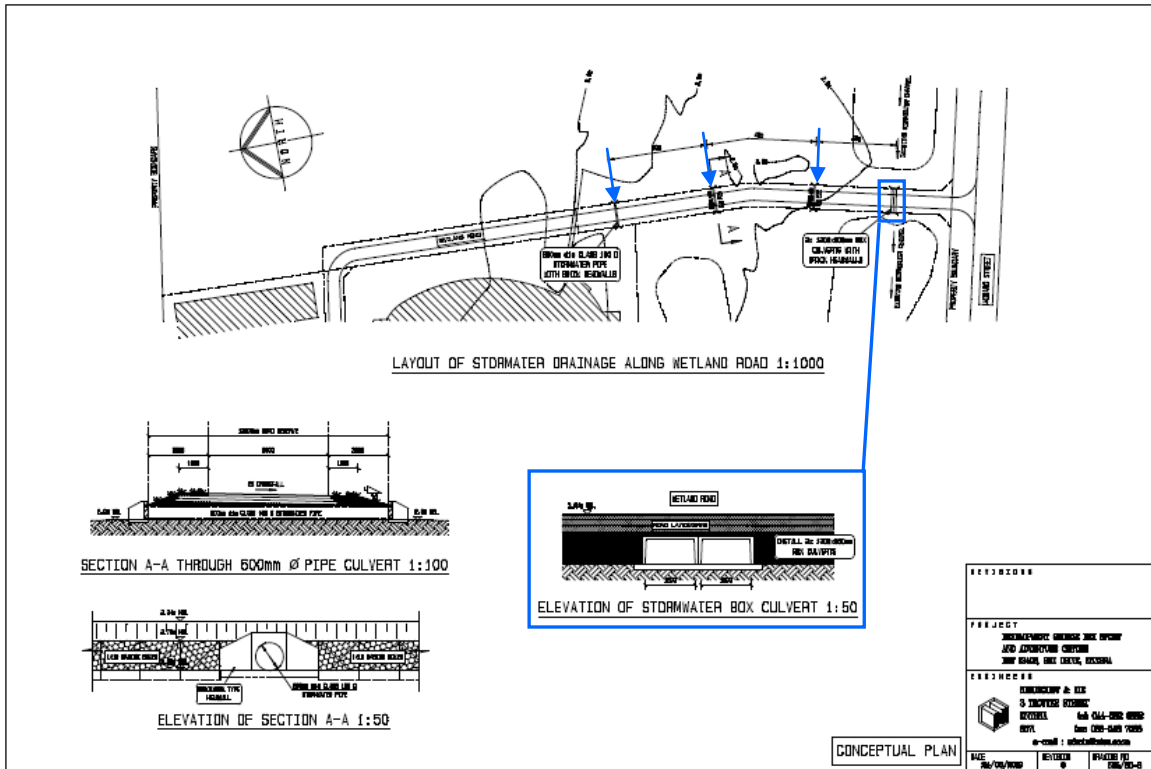
Efforts have been made to minimise disruption to hydrological connectivity by proposing the road be constructed with 600 mm diameter stormwater pipes crossing the road in the open section of the wetland (indicated by blue arrows on Figure 8). Where the road crosses the drainage channel, water flow will be maintained through two box culverts with brick headwalls (blue rectangle in Figure 8).

Given the distance covered by the road through open wetland space, the three proposed stormwater pipe crossings are considered insufficient from a number of perspectives:

- Under-road crossings provide opportunities for the safe dispersal and movement of wildlife across the site. But the pipelines are limited in size (600 mm diameter) and number (three) resulting in increased likelihood that wildlife would cross over the road;
- The aim of rehabilitating the wetland is to increase dispersive sheet flow across the surface of the wetland. If dispersed water is channelled through three relatively narrow pipes it will result in erosion at the exit points.

Figure 8. Proposed layout and cross-sections showing stormwater management of the access road from Howard Street to the sports complex.

It is therefore recommended that the stormwater pipes be upgraded to one larger box culvert at each of the three crossings. A stilling basin (or similar) needs to be installed at either end of the culvert in order to reduce the effects of channelling and erosion on the wetland.
