Aquatic Specialist Assessment for a Section 24G and Water Use License Application at 17 / 232 Redford Farm, Knysna.

Prepared by Dr. Jackie Dabrowski of Confluent Environmental (Pty) Ltd

September 2021

Updated June 2022

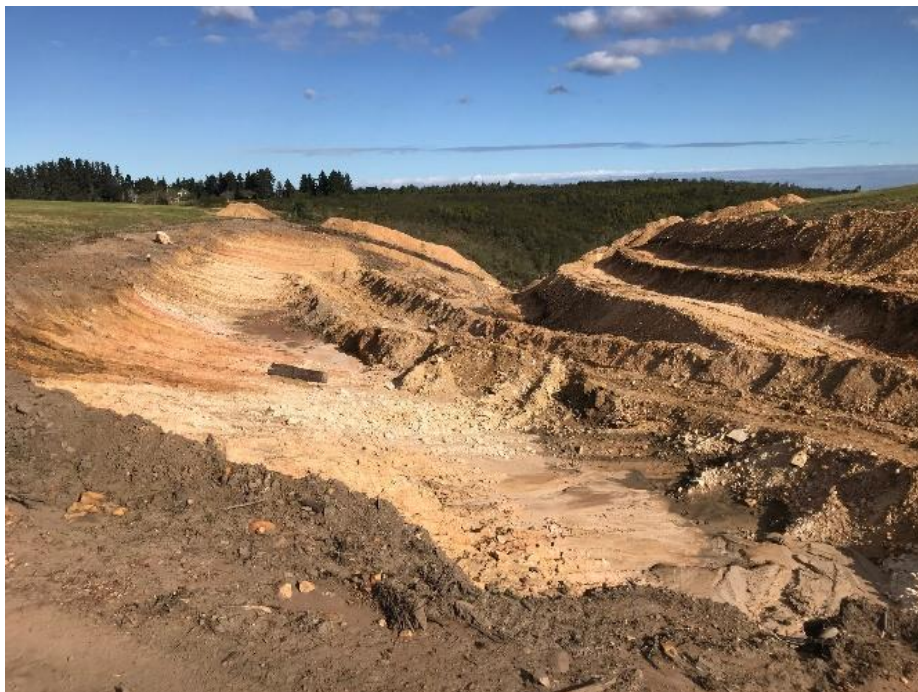
Figure 2. Photo taken of the excavated dam basin showing disturbance of topsoil, subsoil and rock, and the removal of vegetation (17 June 2021).

The site visit was conducted on 17 June 2021 which is mid-winter. During the site visit it was noted that extensive excavation for the dam had been conducted on steep slopes and valley bottom which included topsoil, subsoil, and underlying rock (Figure 2). The watercourse downstream of the excavation had no flowing water toward the upper extent, very minor flow was present further downstream indicating that it is a gaining stream (gaining water from the ground and slopes through interflow).

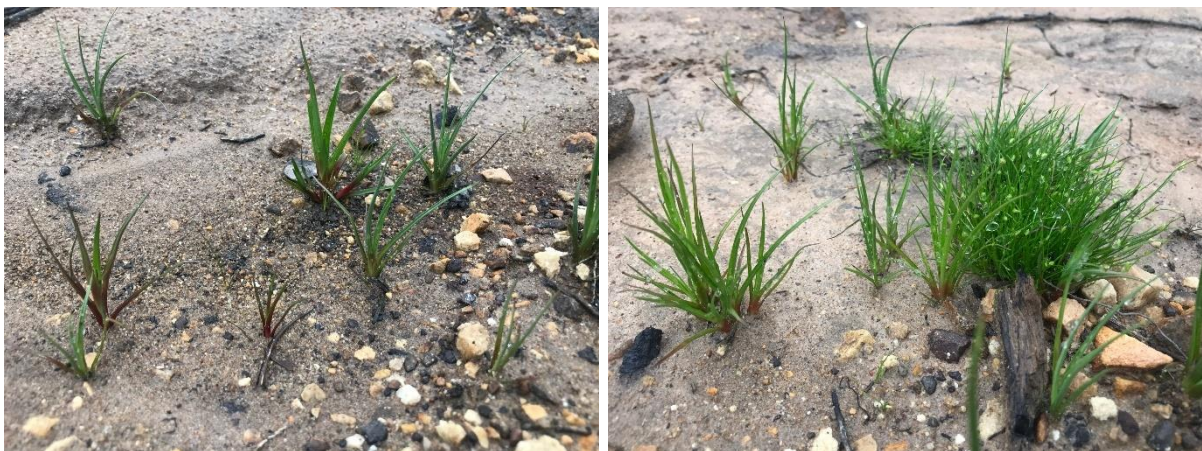
Some isolated specimens of indigenous wetland vegetation were observed to be regenerating in the disturbed channel (Figure 7) indicating that at least remnant indigenous vegetation occurred along the channel.

Figure 7. Isolated specimens of *Juncus lomatophyllus* and *Isolepis* sp. in the disturbed watercourse bed.

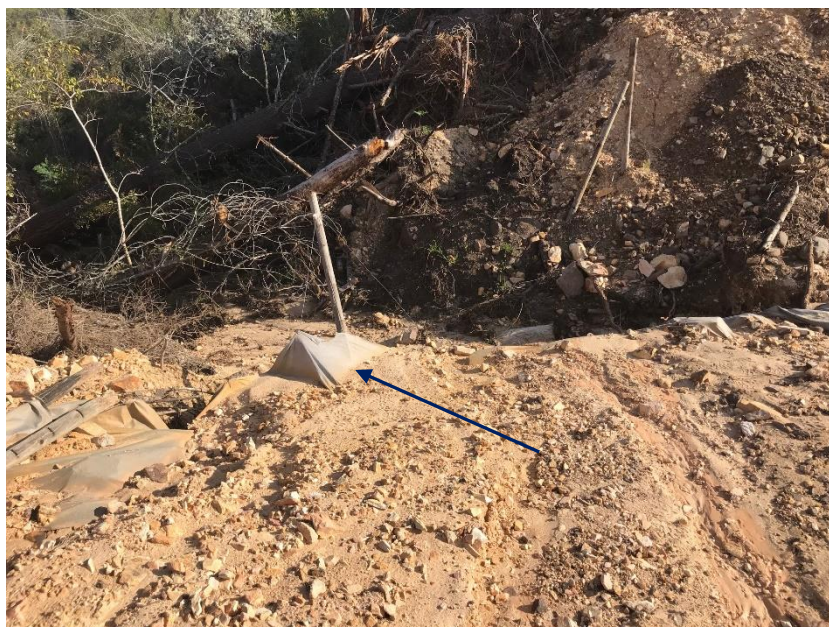
A silt fence had been installed at the lower end of the excavated area which was completely filled with silt (Figure 11), and minor sedimentation had already occurred in the stream bed downstream. An Erosion Control Plan (Confluent Environmental) was prepared and submitted to both DEA&DP and the BGCMA for their approval on 26 August 2021. The focus of the plan was the installation of multiple hay bale check dams to reduce eroded soil from reaching downstream. At the time of the first site visit (17 June 2021) the extent of sedimentation was recorded by GPS and had reached 26 m into the watercourse below the excavated area (-33.950721, 23.445723).

Figure 11. Overwhelmed silt curtain at the outflow of the dam excavation.

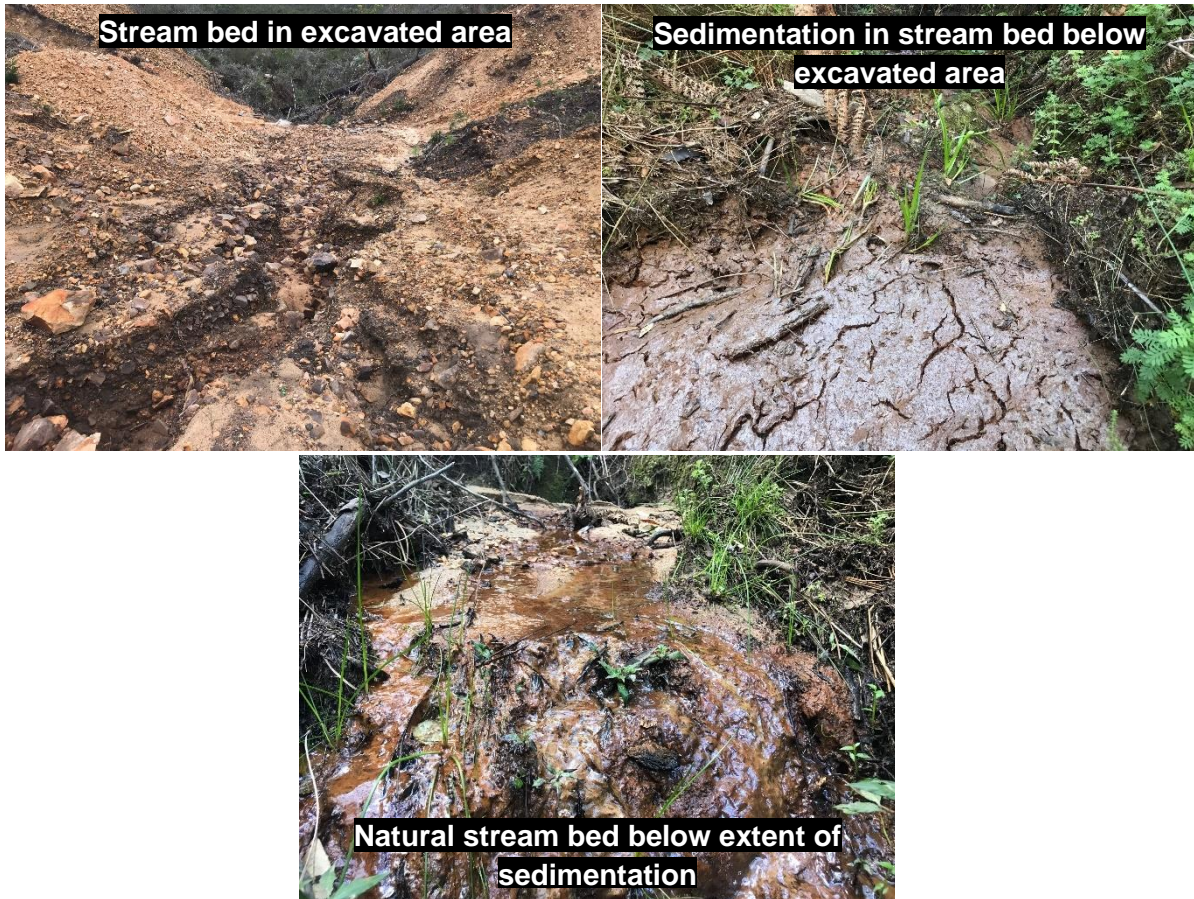
The PES was determined as far as possible without the present excavations for the proposed dam (Pre-excavation) as well as in its present state (Post-excavation). The assessment is applicable for the river reach within the excavated area only and is intended to indicate the degree to which the aquatic ecosystem has been affected by the excavation. The conventional approach to the PES assessment is to assess a longer river reach. However, the excavated area is located at the very upper extent of the watercourse. The pre-excavation PES relied on examination of photographic and video evidence provided by the landowner (D. Bernard), historical aerial and satellite imagery, and the condition of habitat downstream of the excavated area. The stream bed below the excavated site and beyond the extent of sedimentation was narrow (approximately 50 cm wide) with a mixed sand and rock substrate covered by a dense film of diatoms indicating continuous trickle flows (Figure 12). By comparison the stream bed was at least 2 metres wide in the excavated area indicating that sediment had filled in the narrow channel smothering the instream habitat.

Figure 12. Stream bed in the excavated area, and downstream with / without sedimentation as labelled.

The results of the IHI indicate that the PES of the watercourse **declined from a Class A/B (Largely Natural) to a Class E (Seriously Modified)**. Both instream and riparian habitat were seriously impacted, but riparian habitat was most severely modified by the excavation (Table 4).

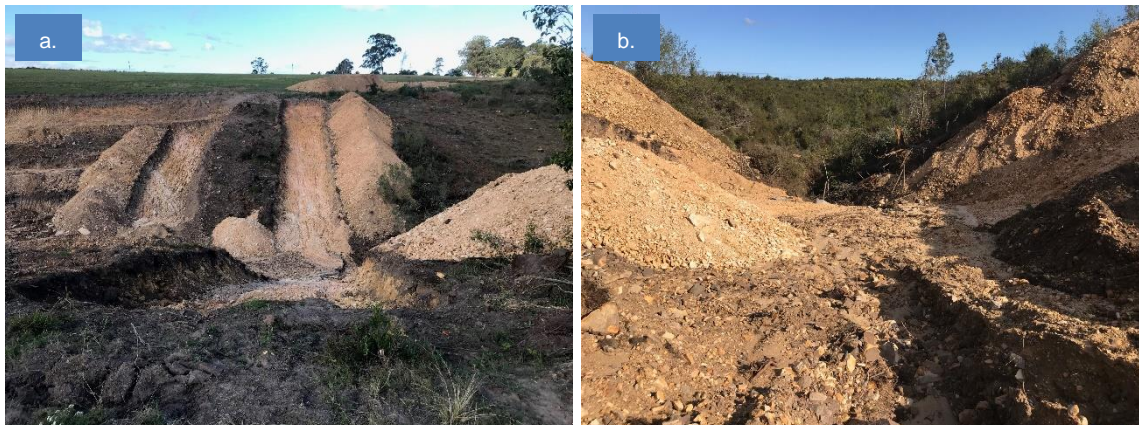
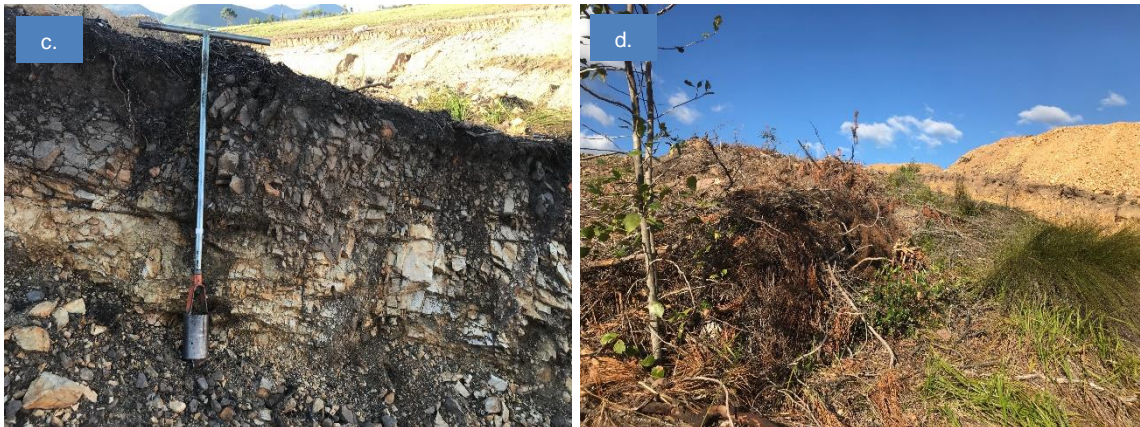
Excavation for the dam effectively removed all vegetation from the bed, channel and riparian areas. While it is impossible to know what bed and channel characteristics were present prior to the excavation, any features that may have been present were eliminated by the earthworks. Strip excavations were very deep in sections, measuring up to 130 cm in depth (Figure 13). See detailed survey of the present site in Appendix 7.2.

Figure 13. Photos of the site indicating a: the extent of earthworks across the valley effectively eliminating the watercourse channel and bed; b: the lower portion of the excavated area showing the natural vegetation beyond; c: the depth of strip excavations in relation to a soil auger (130 cm), and d: a small area of remnant vegetation on topsoil with some dead pine trees interspersed with indigenous trees and grasses.

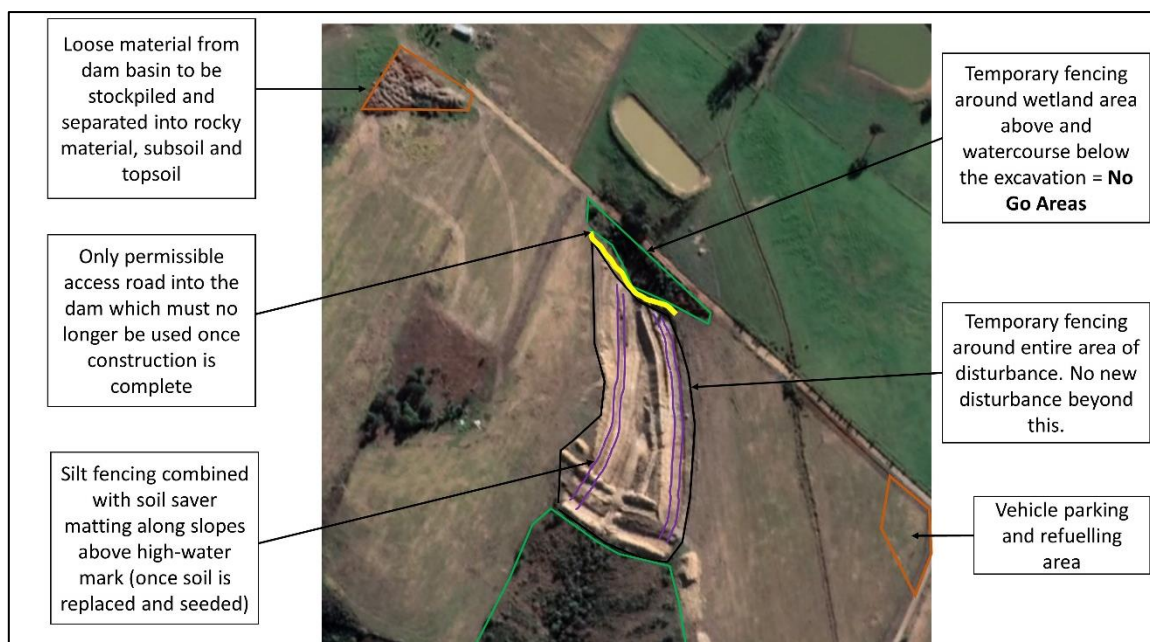
Figure 14. Annotated photo of the impacted area indicating mitigation measures should construction with the dam continue as described in Table 9 and Table 10.

Project phase	Construction			
Impact	Soil erosion above the high water mark			
Description of impact	Loosely piled soils and rock will erode over time and areas will be colonised by alien vegetation.			
Mitigatability	Medium	Mitigation exists and will notably reduce significance of impacts		
Potential mitigation	<ul style="list-style-type: none"> • Once the dam basin and wall have been prepared, any disturbed areas above the high water mark needs to be rehabilitated. • In excavated areas replace and compact first the rocky layer then subsoils in all areas above the high water mark, sloping the material to a 1:3 slope that ties in with the dam basin. <ul style="list-style-type: none"> • Cover the above compacted layer with loose topsoil from the site to a depth of at least 50 cm. • Seed the slopes with a grass mixture (Teff, Cynodon dactylon (kweek), Digitaria eriantha (Smuts finger grass), cover with a light mulch, and then nail in overlapping soil saver matting to protect the soil (Methods in Appendix 2). • On both sides of the dam two silt fences must be installed along the full length of the 'edge' approximately 8 - 10 m apart (Methods in Appendix 3).

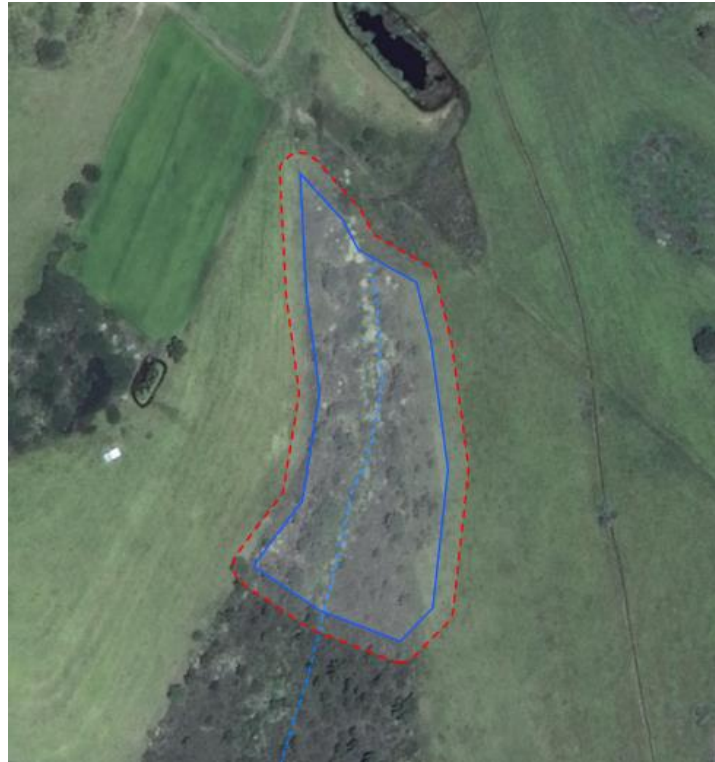
Figure 15. Photo showing the area of disturbance (blue line) and the 10 m buffer of indigenous vegetation that must be actively replanted (red dotted line).

The plant species that must be actively planted in the buffer zone (not previously disturbed slopes) can be sourced from most indigenous nurseries and are listed in Table 11. The aim is to create a complex and diverse vegetated buffer that provides (a) habitat, (b) improves connectivity and (c) protects the banks from surface runoff that will cause erosion.
