SITE PHOTOGRAPHS

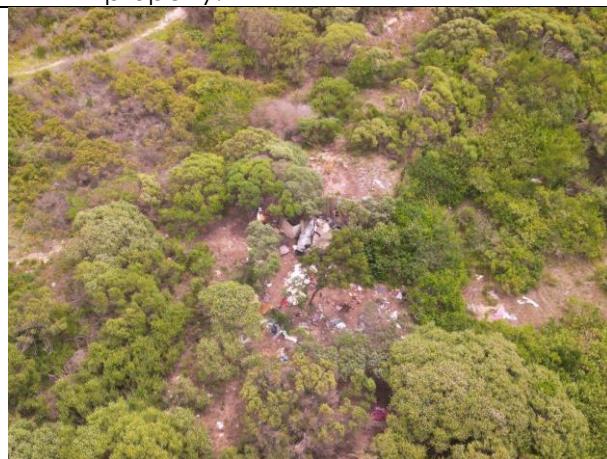
10. Aerial view of illegal dumping on site.

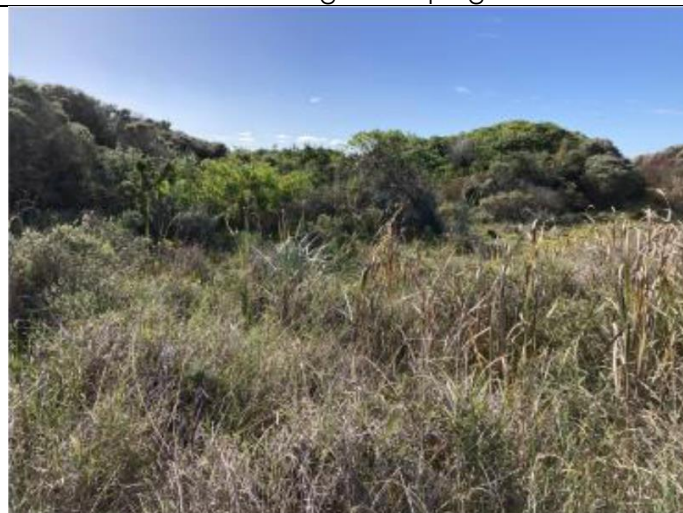
12. Wetland vegetation observed between the shrubs (DSA).

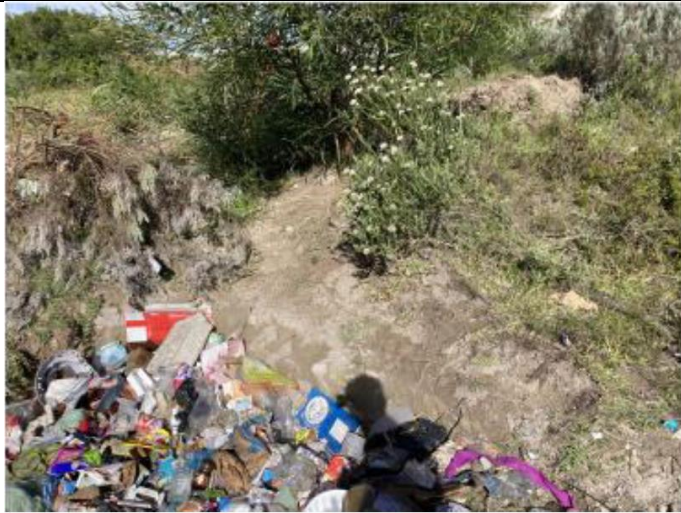
13. Illegal sand mining and waste dumping on site (DSA).

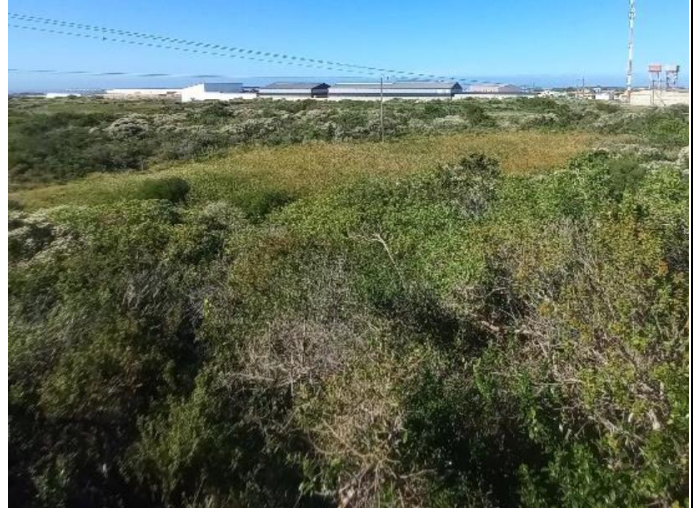
16. Artificial Wetland A dominated by *Typha capensis* (SRK Consulting).

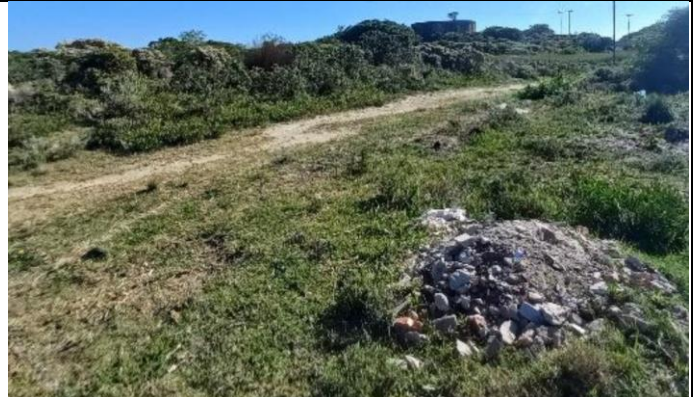
Transformed areas dominated by the grasses such as *Cynodon dactylon*, a few alien species and rubble (SRK Consulting).

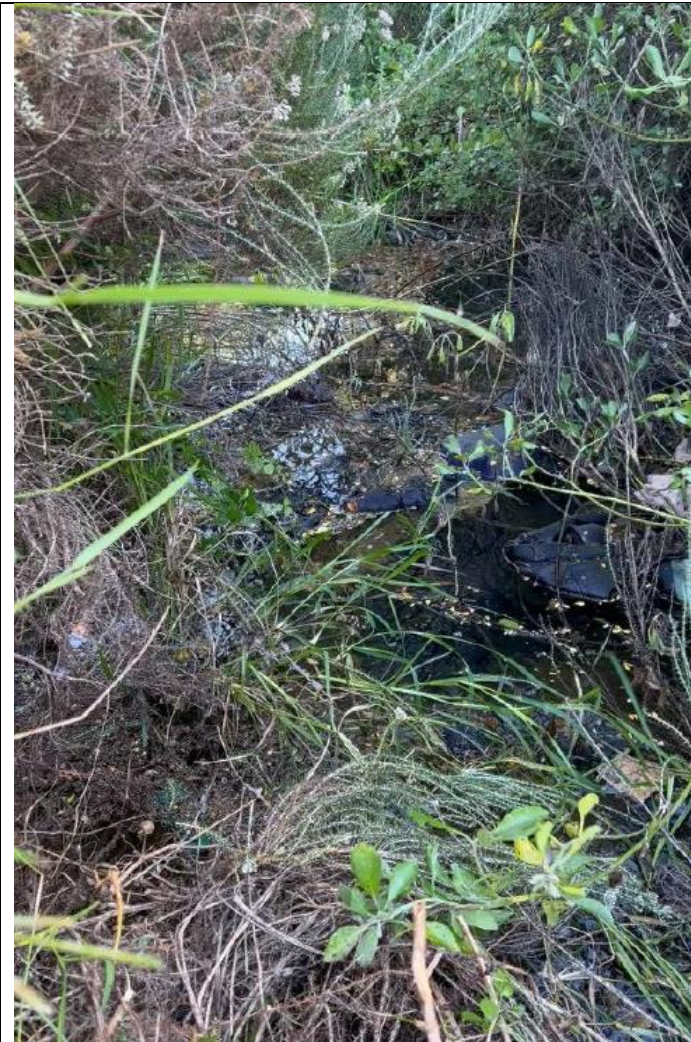
1. Leak to the west of Wetland A.

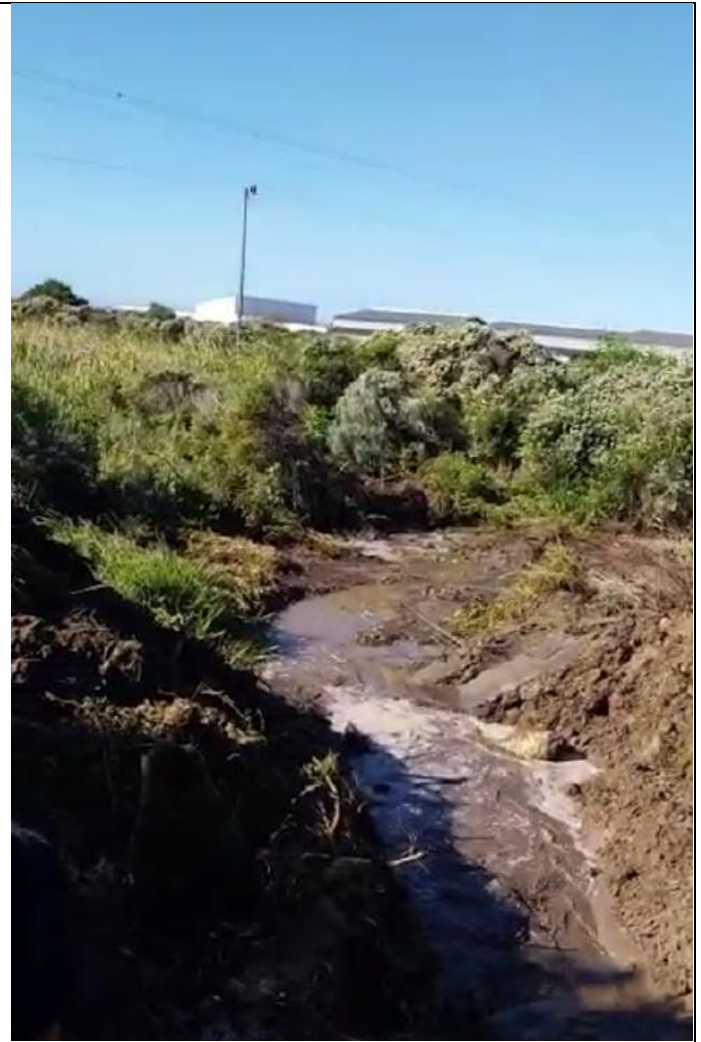
2. Leak to the west of Wetland A.

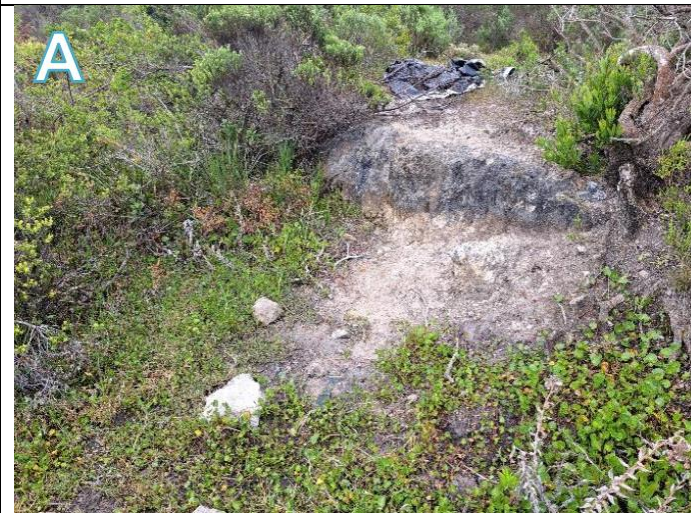
3. Excavations into calcrete (Confluent Environmental).

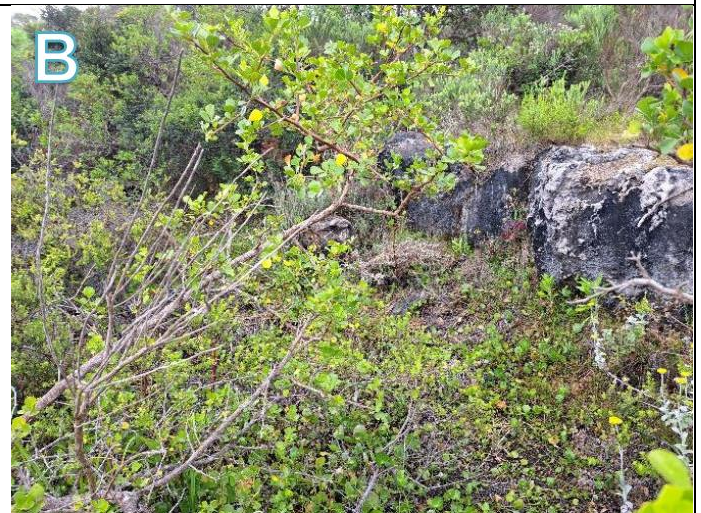
4. Excavations into calcrete (Confluent Environmental).

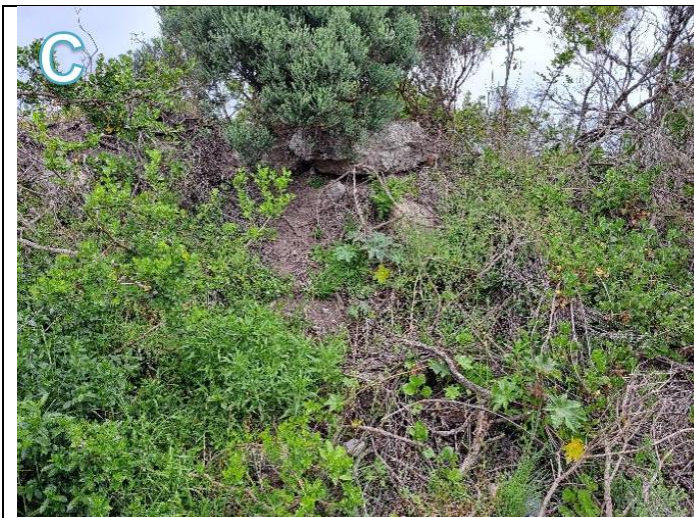
5. Vegetated stockpiles of excavated material around the perimeter of Wetland B (Confluent Environmental).

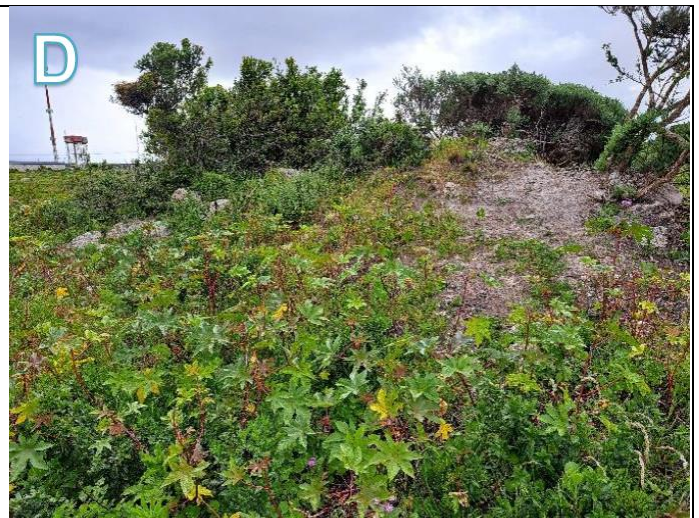
6. Vegetated stockpiles of excavated material around the perimeter of Wetland B (Confluent Environmental).

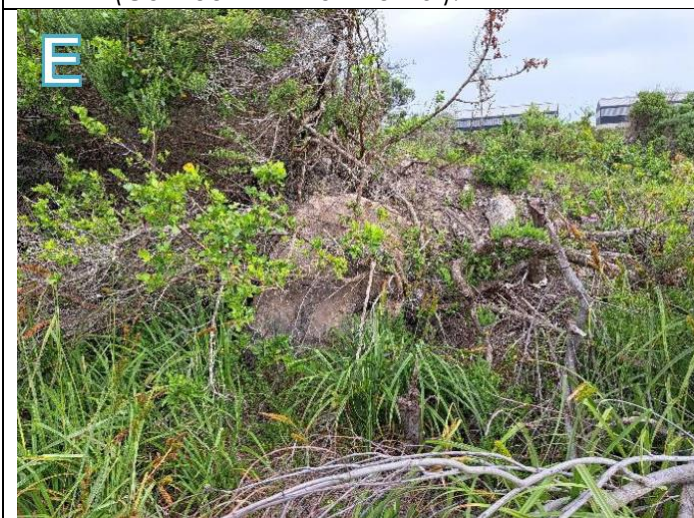
7. Vegetated stockpiles of excavated material around the perimeter of Wetland B (Confluent Environmental).

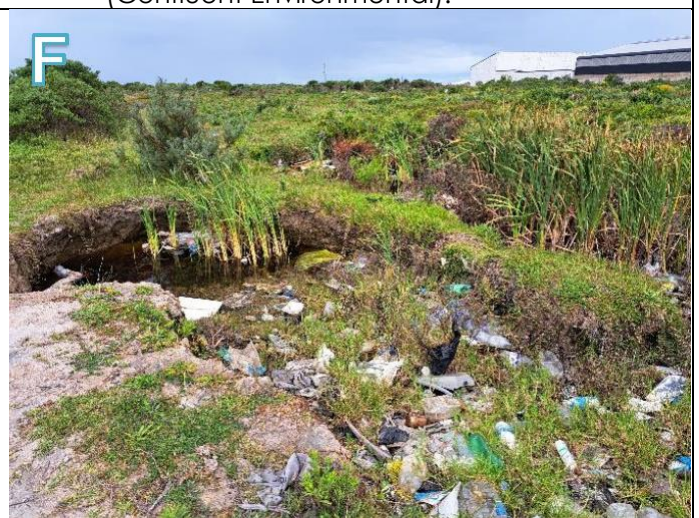
8. One of several small excavations vegetated with *T. capensis* and filled with solid waste and litter (Confluent Environmental).

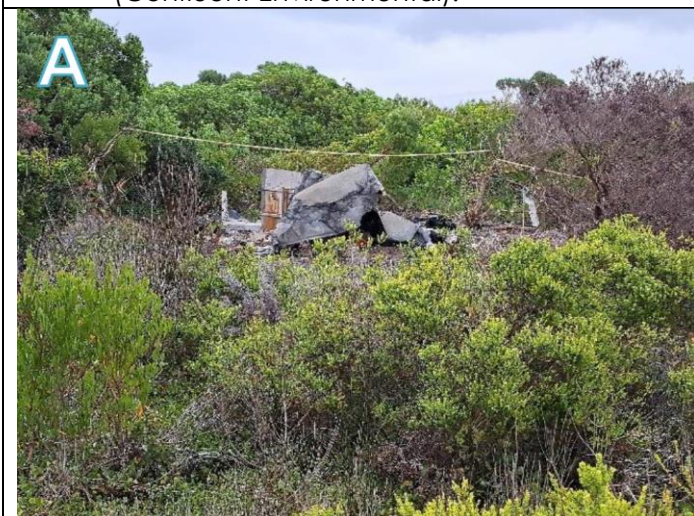
9. Temporary shelters (Confluent Environmental).

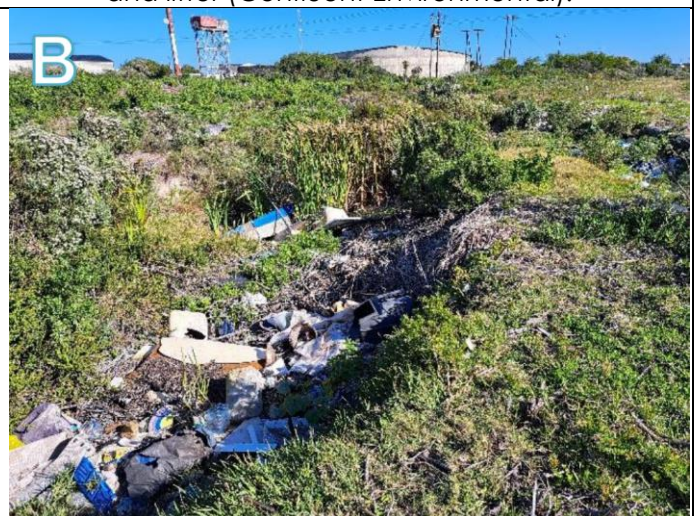
10. Illegal dumping and littering (Confluent Environmental).
