MYOLI BEACH ACCESS; MAINTENANCE MANAGEMENT PLAN

Myoli Beach, Sedgefield

Prepared by: Knysna Municipality Environmental Management Department

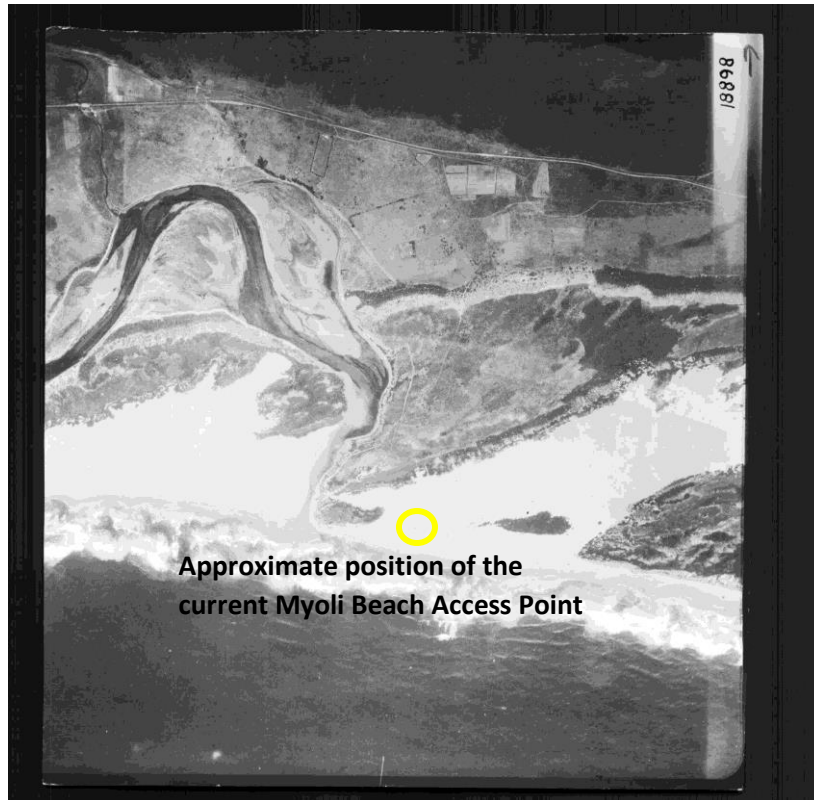
Figure 5 Aerial photo circa 1930's indicating prevalence of dunes and windblown sand at the site. Source: South African National Parks, Wilderness Lakes Section of the Garden Route National Park.

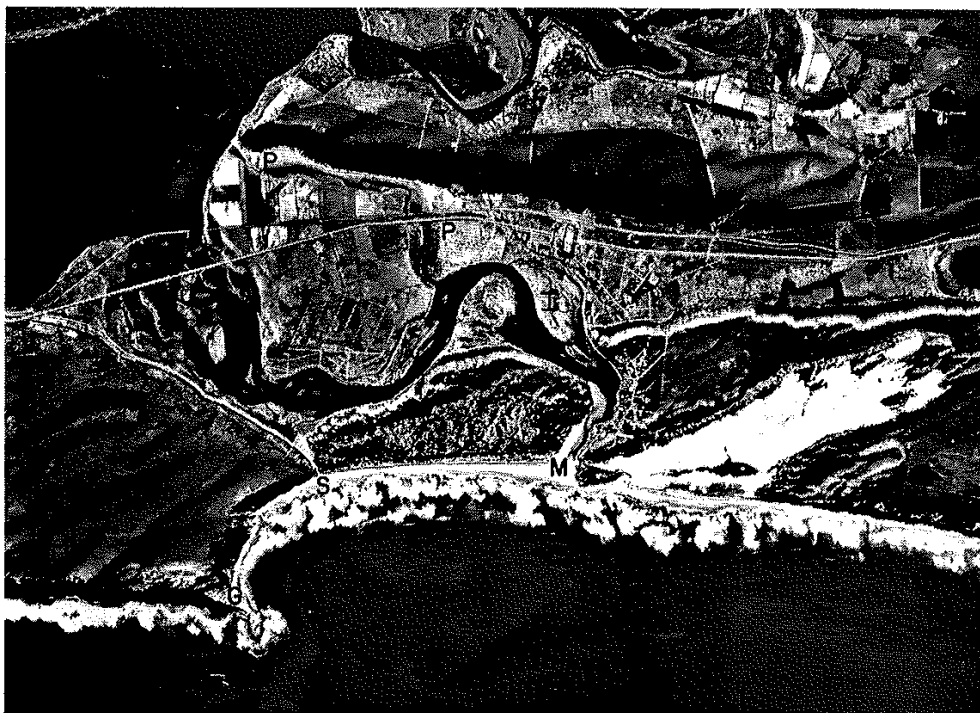
Figure 6 Aerial photograph from 1958, with prevalence of windblown sand as a result of the south-westerly evident. Source Figure 6c of Whitfield, 1983

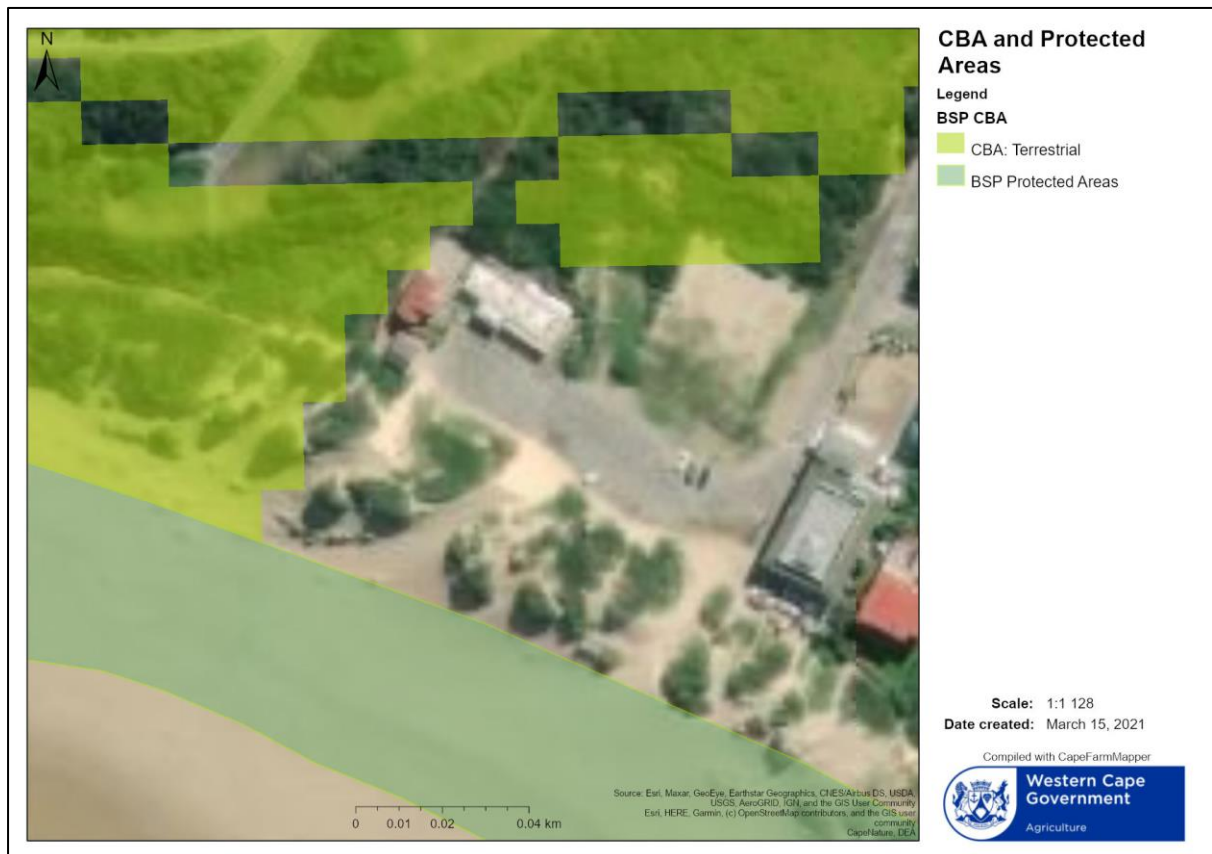
Figure 8 Proximity of the site to Protected Areas and Critical Biodiversity Areas

The site does not fall within a protected area or critical biodiversity area. No species of concern or with any threat status or level of protection are found within the site. A species list of plants found on site is provided below:

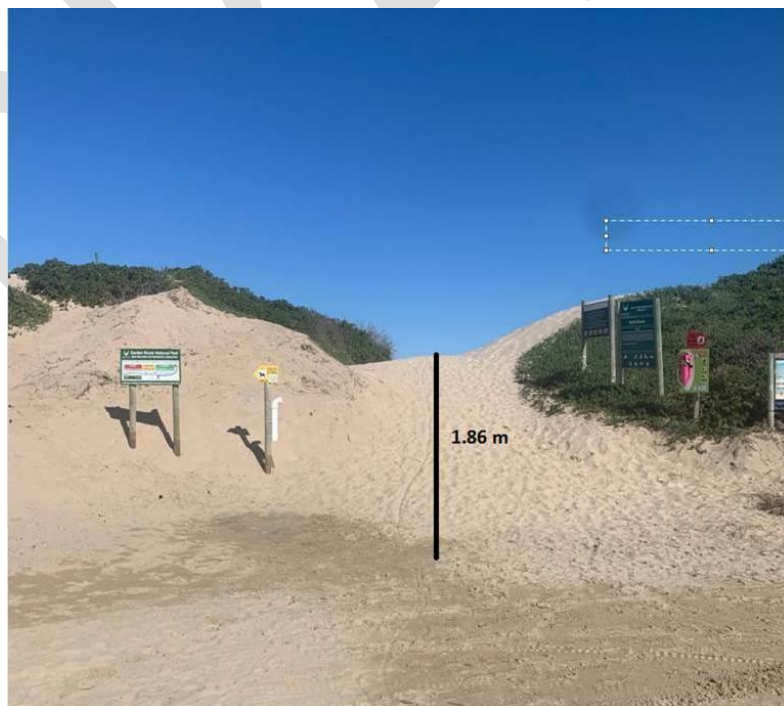
Figure 10 The proposed maintenance height, as viewed from the parking area.

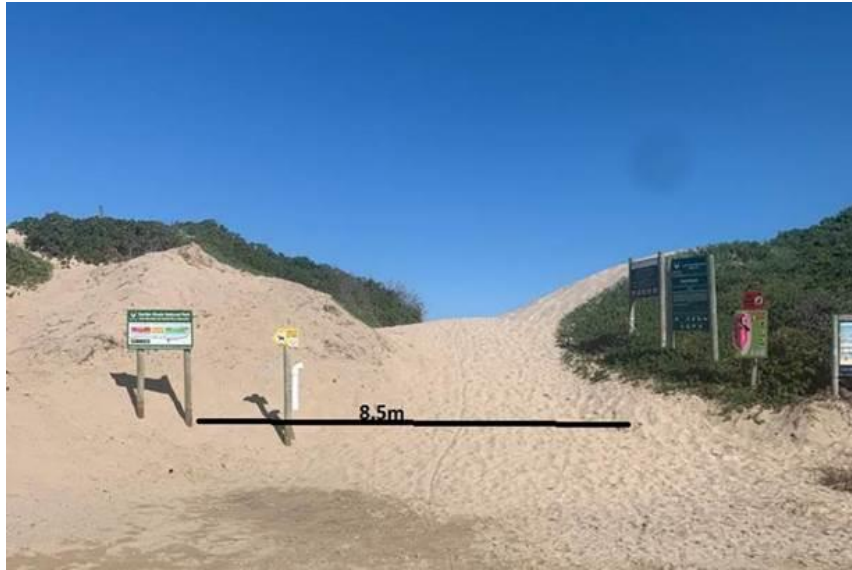
Figure 11 Width at the base of the vehicular entrance

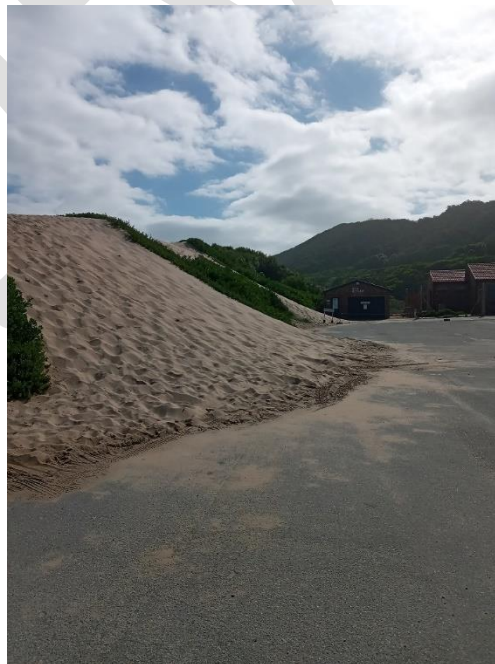
Figure 12 Current sand inundation in the parking area. Photograph taken 6 April 2021.

The maintenance of the parking area concerns three sites where sand frequently accumulates: the entrance to the NSRI building; the length of the dune adjacent to the parking lot and the main entrance to the beach (Figure 4 and 12). All these sites will require the removal of sand to open up the parking bays and to clear the entrance to the beach. The accumulated sand will be placed in the same position as the sand that will be removed from the vehicular access.
