**Project: George Rex Wetland Reserve,  
Knysna**

**March 2017**

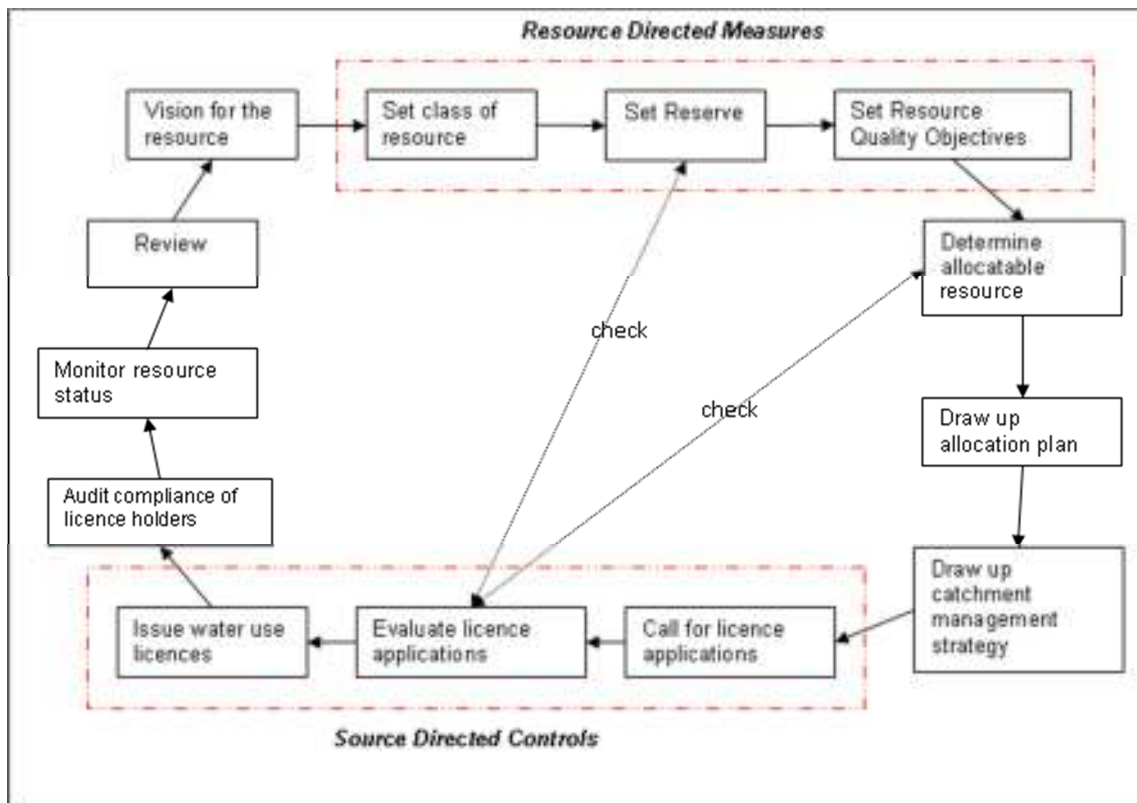
Figure 2.1: The DWS's Water Resource Management cycle.

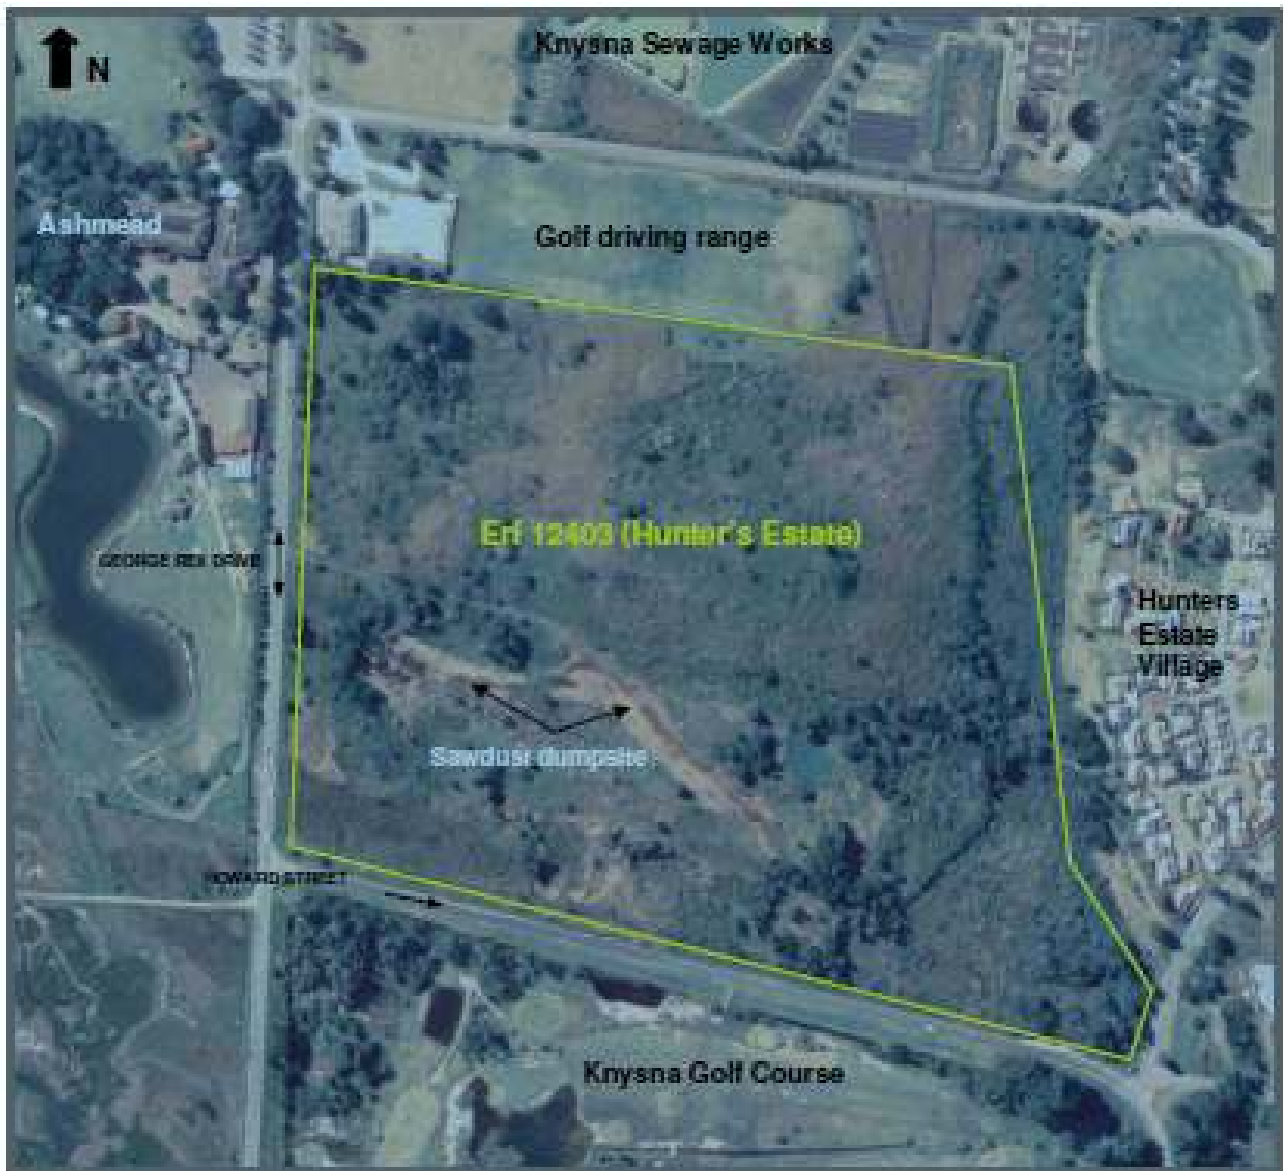
George Rex wetland (Erf 12403) is located adjacent to the Knysna Estuary in the K50B quaternary catchment (**Figure 3.1**). The entire property is elevated 2 to 3m above mean sea level and was historically within the associated floodplain of the estuary. The site is 19.406 Ha in extent (Vreken, email communication, 22 April 2016) and is characterised by fairly flat terrain (<1:100) which drains very slowly in a south and westerly direction into the Knysna estuary. The soil has a medium to low permeability and persistent rainfall will tend to pond on the surface (Outeniqua Geotechnical Services, 2015).

**Figure 3.1:** The position of Erf 12403 or the George Rex wetland (study site).

Activities upslope of the site have the potential to impact the quality of the groundwater. Approximately 100m to the north of the site is the WWTW, which consists of a number of lined sludge ponds (see **Figure 3.1, Figure 4.3**). To the north east is a cemetery and to the east the Hunters Estate residential development. Polluted stormwater from the surrounding area therefore has the potential to impact the groundwater quality on the site (WSP Environmental, 2006).

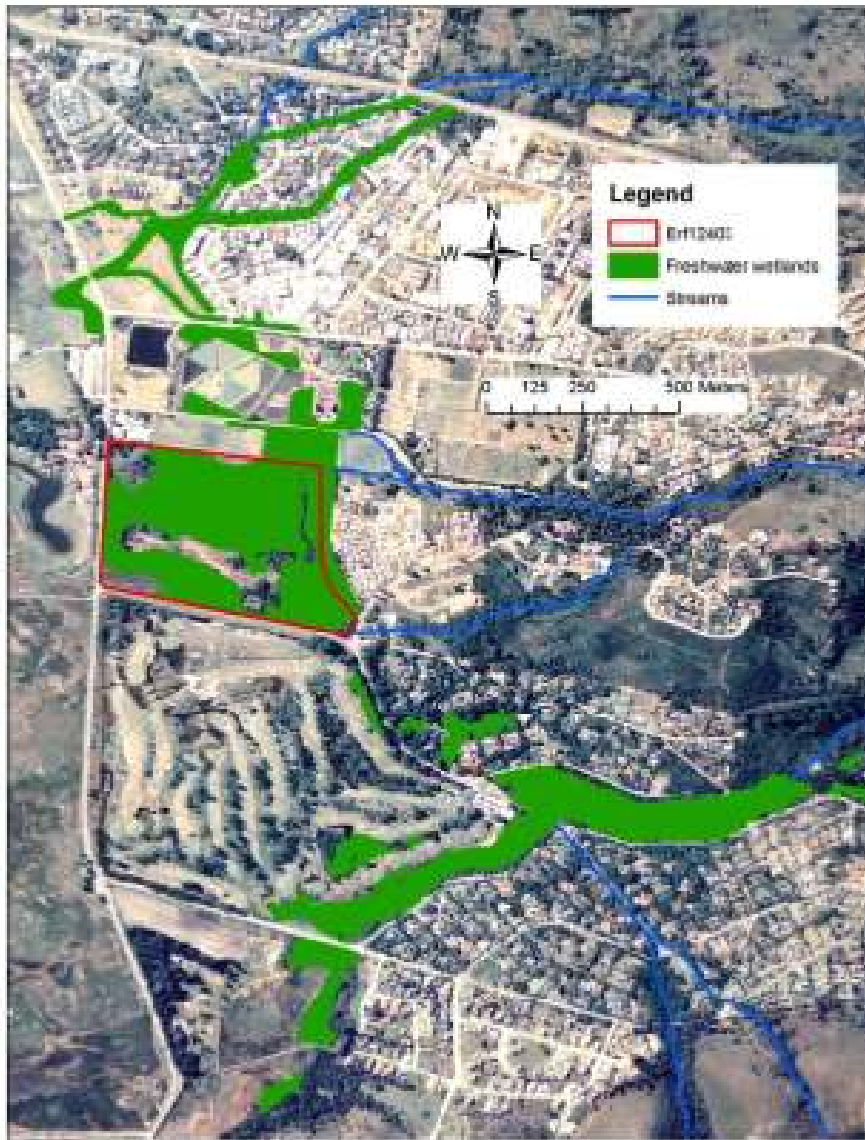
**Figure 4.2:** Distribution of freshwater wetlands in the area. The boundary of Erf 12403 is shown in red (Bornman, 2006). Most of the erf is composed of freshwater wetlands.

By 2003, the proportions of wetland types had changed such that only 0.7 ha of estuarine wetlands remained, with the previously small freshwater wetland area having increased to 13.5 ha (7.3 ha of which were regarded as intact; the rest comprising former estuarine wetlands that became fresh due to salinity decreases). The remainder of the site (5.8 ha) was comprised predominantly of highly degraded areas, with much of the degradation attributable to historic dumping of wood wastes as well as more recent dumping of infill material, and impacts from the adjacent catchment and nearby WWTW. Despite the degraded portions of the site however, the vast majority of the site was still regarded as wetland (**Figure 4.2**).

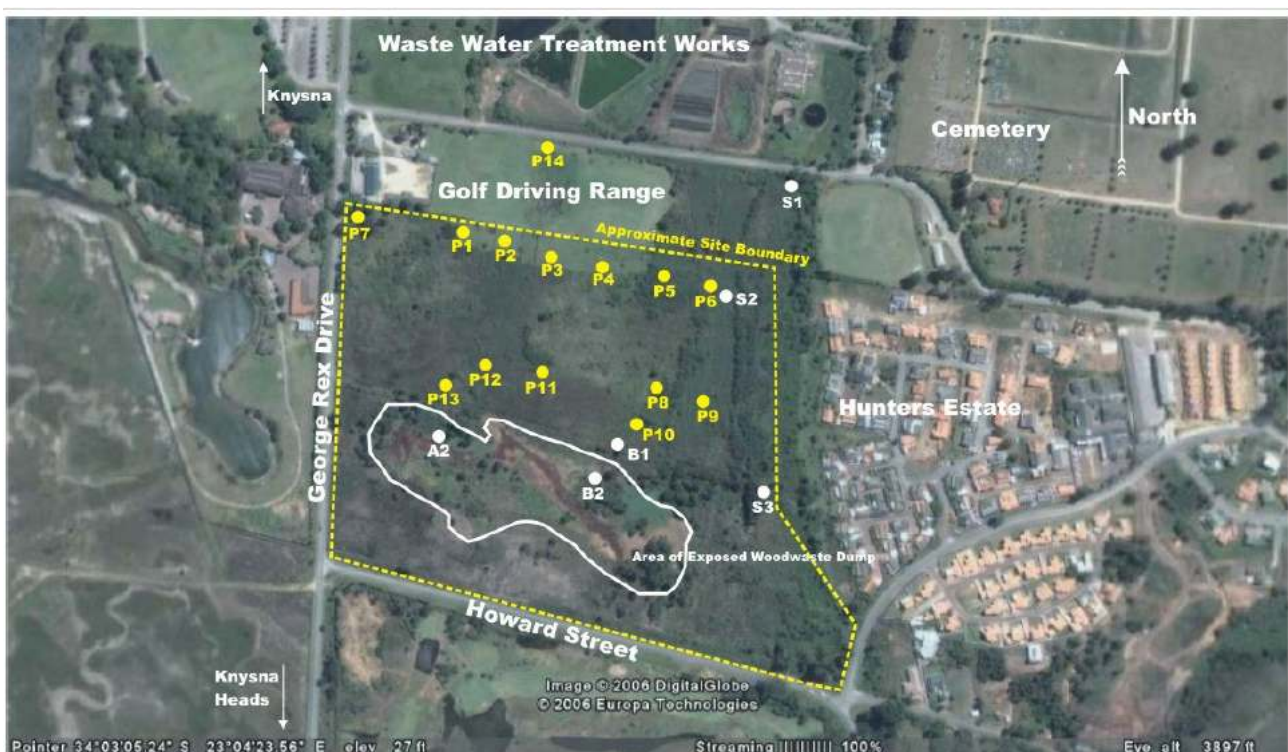
**Figure 4.3: Location of water level sampling points and piezometers (WSP Environmental, 2006).**

Piezometer	Ground Height (a.m.s.l)	Water level (b.m.g.l)	Water level (a.m.s.l)
P1	1.92	0.00	1.92
P2	1.84	0.00	1.84
P3	2.10	0.00	2.10
P4	2.34	0.03	2.31
P5	2.46	0.00	2.46
P6	2.29	0.00	2.29
P7	2.09	0.39	1.70
P8	2.44	0.20	2.24
P9	2.09	0.00	2.09
P10	2.44	0.04	2.40
P11	1.88	0.00	1.88
P12	1.81	0.00	1.81
P13	1.79	0.14	1.65
P14	2.44	0.00	2.44
A2	2.12	0.51	1.61
B1	2.00	0.20	1.80
B2	1.85	0.00	1.85

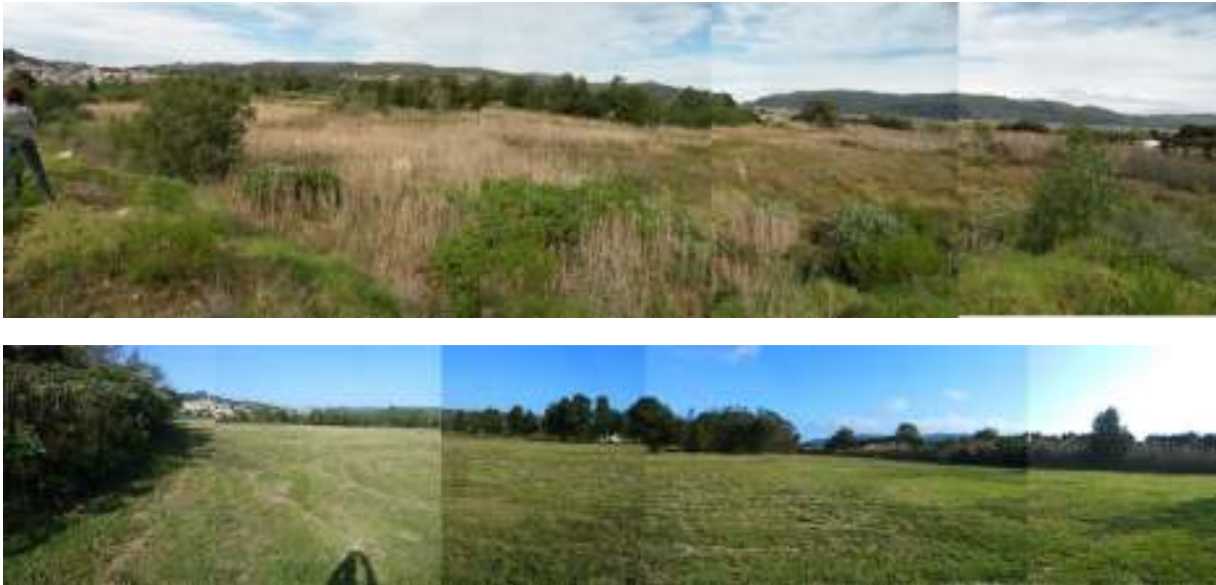
**Figure 4.4:** Panoramic view of the site in June 2008 (top), prior to the clearing and mowing of the vegetation at the site, and (bottom) April 2016 after mowing of the site was instituted at the request of the municipality (due to perceived fire risk).

The authors therefore still endorse the findings of Bornman (2006) who recognised that, whilst historically almost the entire site would have been covered by wetland vegetation, under the present day conditions some of these areas have been lost as functional wetlands due to infilling at the site. Based on the findings of Bornman (2006), in 2008 the DWS accepted that 71% of the site was regarded as wetland and the remaining 29% of the site could be regarded as “non-wetland” due to the degraded nature of some portions of the site. Under present conditions, because the hydrological drivers are still operating, if the mowing of the vegetation was stopped, alien vegetation removed and the draining of flows around and across the site reduced through rehabilitation of the excavated canal and drain, then wetland vegetation is likely to re-establish across the majority of the site, as was documented in 2003 (**Figure 4.5**) and observed by this author in 2008 (**Figure 4.4**).

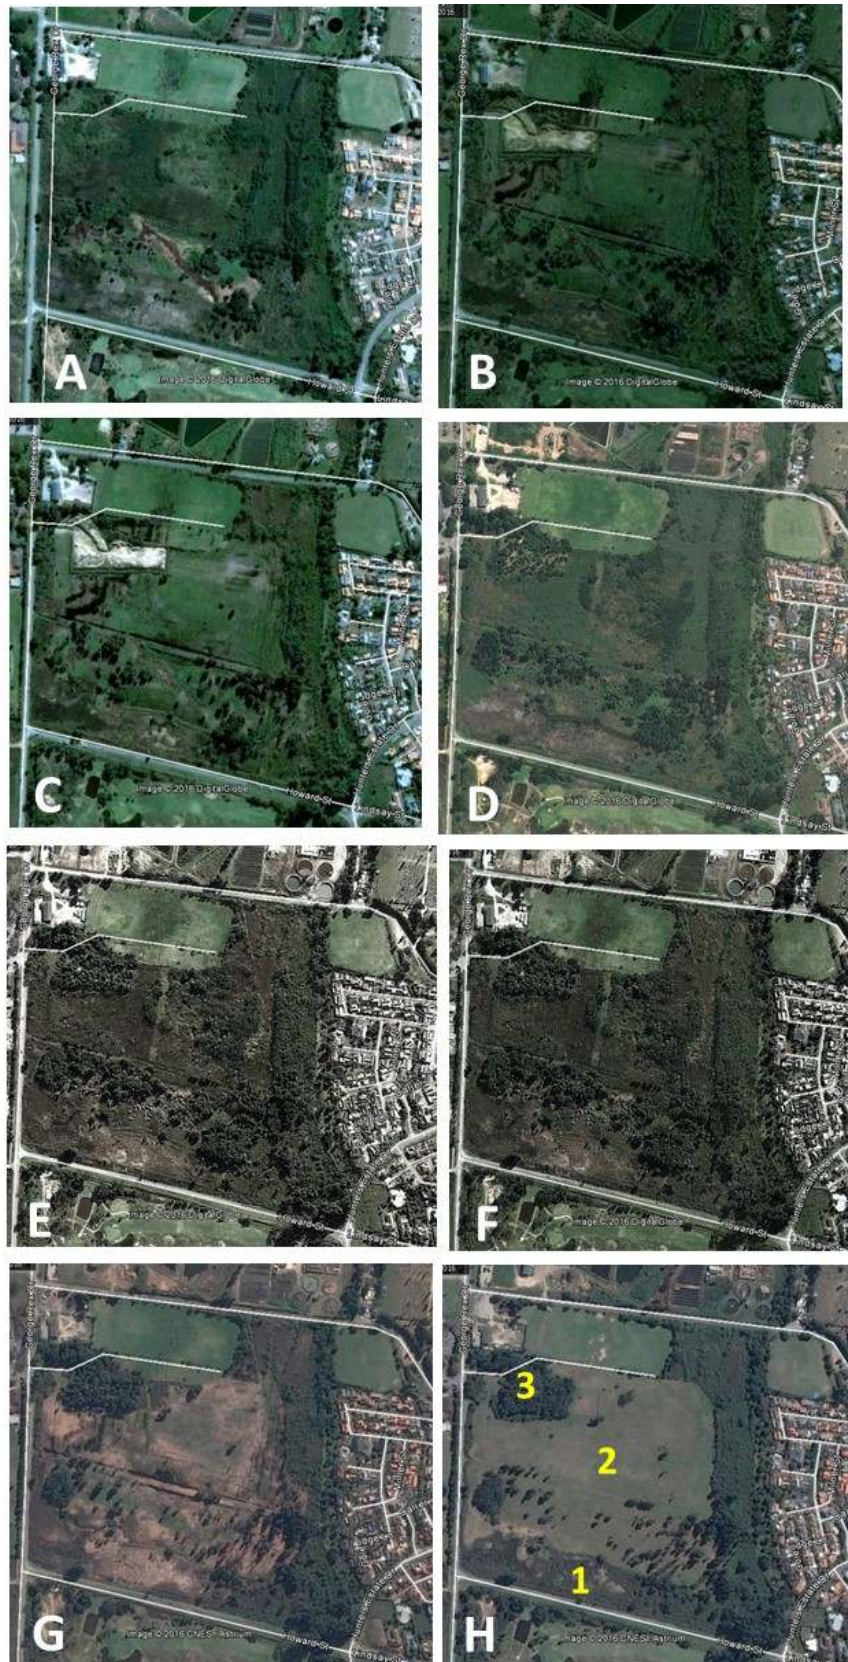
**Figure 5.2:** Google Earth images from 2003 (A), 2005 (B), 2006 (C), 2010 (D), 2011 (E and F), 2013 (G) and 2016 (H) that show the changing vegetation of the site through this period. In the 2016 image (H), the main vegetation types - reeds (1), mowed grass (2) and invasive alien trees (3) - are indicated.

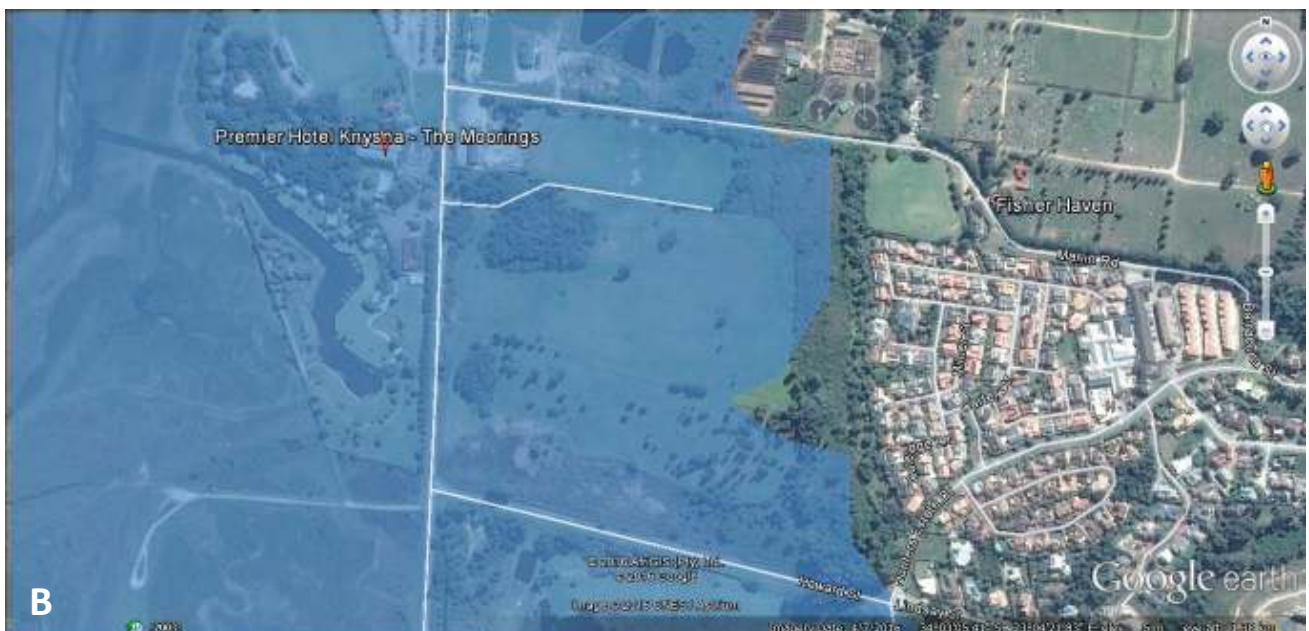
**Figure 6.1: Google Earth images of the Knysna Estuary EFZ (A) and the George Rex wetland opposite “The Moorings” (B) and within the EFZ.**

Delineation of the Estuary Functional Zone (EFZ) (**Figure 6.1A**) shows that Erf 12403 (study area) falls almost completely within the EFZ (**Figure 6.1B**). Allanson & Associates (1995) reported that the area was elevated 1 to 5 m above the mean water level in the adjacent estuary, and according to the contours on the base plan of the area, the entire property is elevated 2 – 3m amsl. The level of George Rex Drive is at +2.35m amsl. Under extreme water level conditions and with the expected sea level rise, it is not impossible that this level will be exceeded in the future (Huizinga, CSIR, pers. comm.; cited in Bornman, 2005).

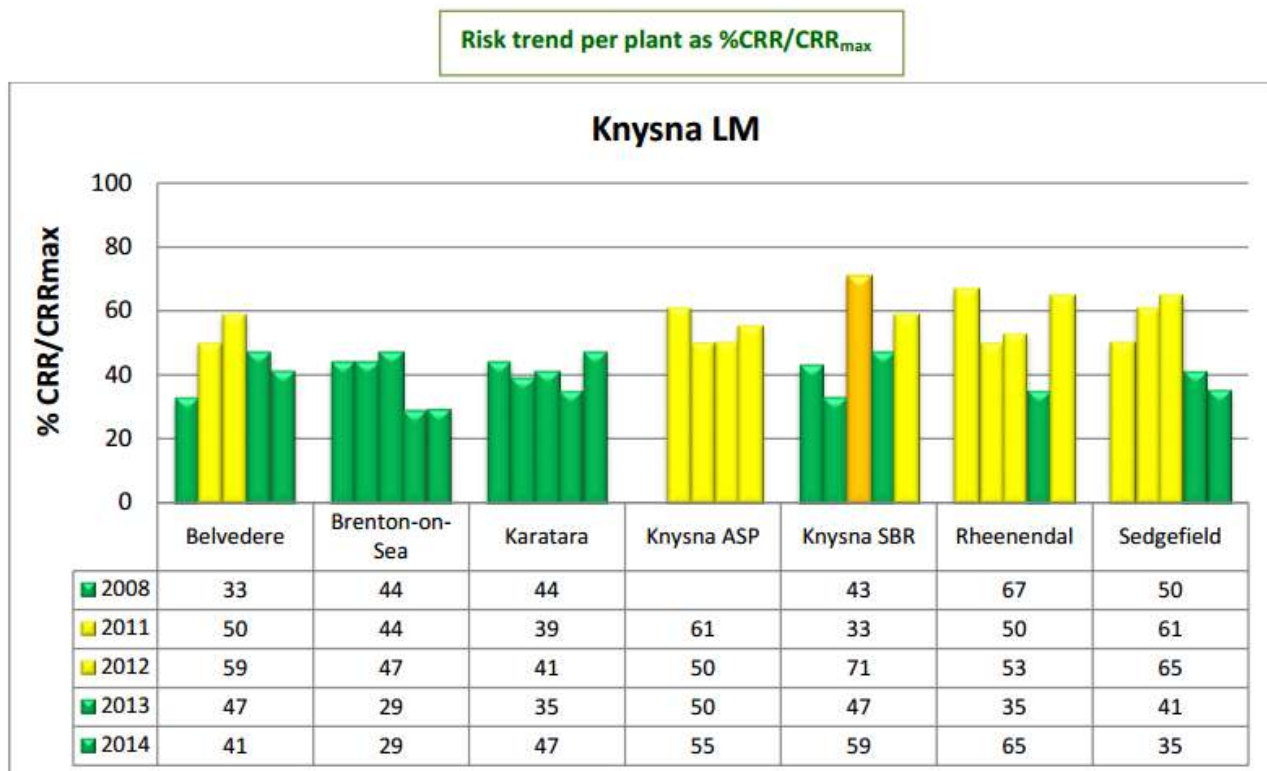
**Figure 6.5: Risk trend for Knysna Local Municipality WWTPs (DWS, 2014b).**

The risk trend shown for the Knysna 2 SBR system (75% effluent compliance, but 0% microbial compliance) for the 2012-2013 monitoring period, showed a lack of flow measuring and the resulting report of a large overloading of the works. The plant achieved a 58.8% Medium Risk rating (DWS, 2014b).

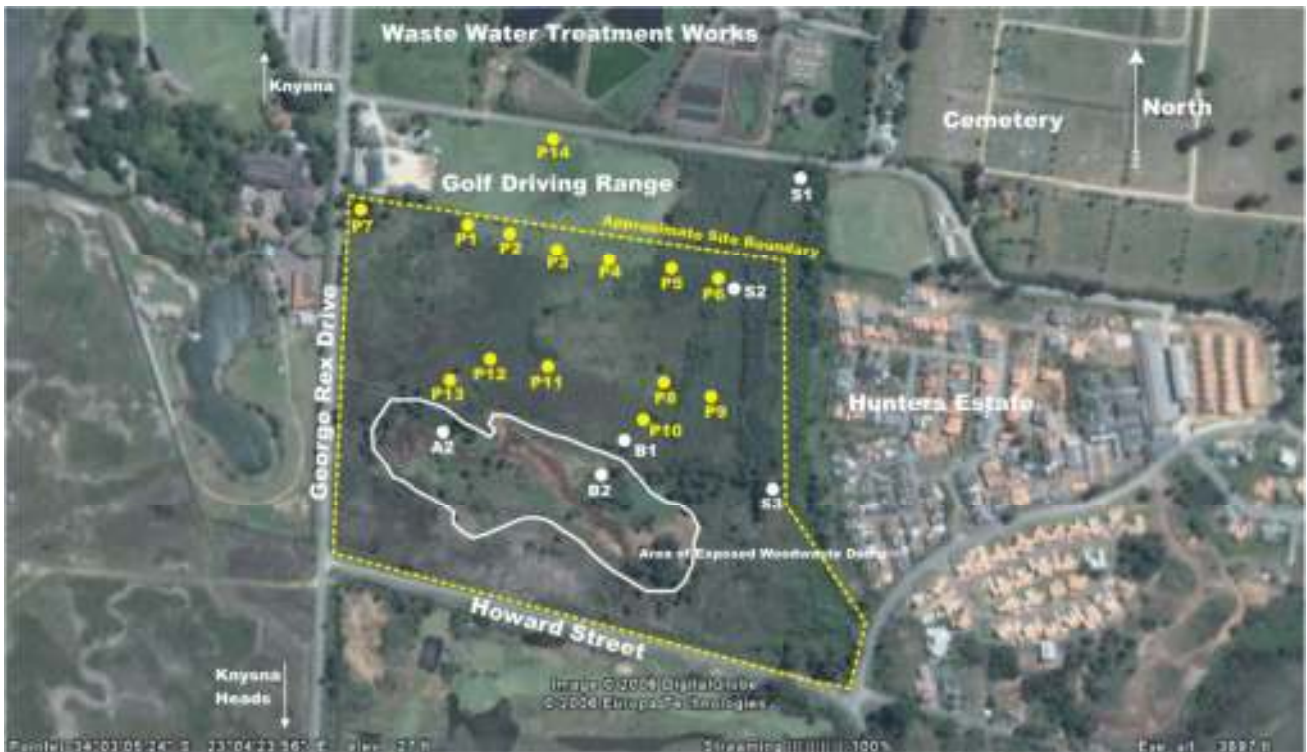
**Figure 6.6: Position of piezometers (P1-14) for the 2006 groundwater study of WSP Environmental.**

A plume of elevated Total Coliform values (i.e. elevated above historical records) is evident entering the site along the north-eastern boundary and extending in a south westerly direction. There are three sources of potential microbial contamination on the site, namely sub-surface seepage from the WWTW, the cemetery directly upgradient from the site, and impacted stormwater runoff from the upgradient industrial area and including the adjacent WWTW (see **Figure 6.8**). An evaluation of the chemistry associated with cemeteries suggested that the cemetery is not a significant contaminant source.

Test results indicated the presence of elevated microbial activity associated with subsurface seepage from the WWTW, but presence of elevated faecal coliforms within the central portion of the site indicates that poor stormwater quality entering the site at the north-eastern corner also represents a significant source of microbial contamination. The quality of stormwater runoff from the upgradient areas would be expected to have been particularly poor during the flood event just prior to sampling, and the levels of faecal coliforms reported are thus considered to represent worst case conditions (WSP Environmental, 2006). **Figure 6.7** is a cross-section across the site, showing contaminant areas and the approximate extent of the contaminated plume as in 2006 (WSP Environmental, 2006).

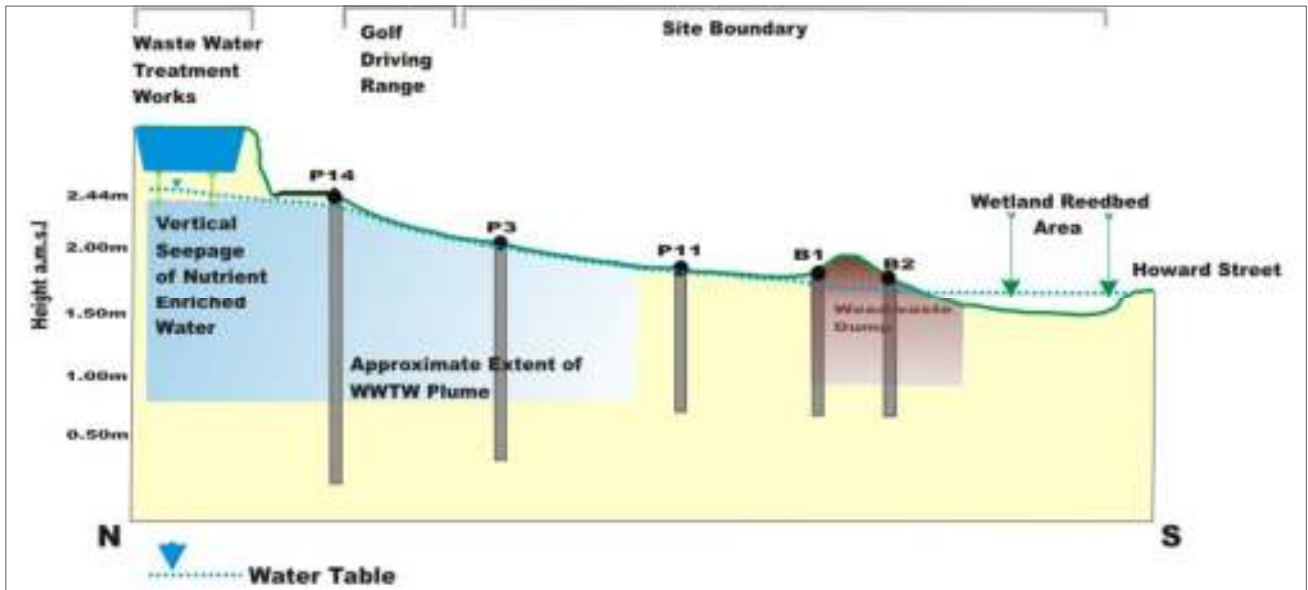
Figure 6.7: Site cross-section, showing contaminant plume and seepage from the WWTW (WSP Environmental, 2006).

However, recent data on the quality of the final effluent from the STP (**Table 6.1**) indicate that although there may have been an improvement in the quality of effluent leaving the WWTW or STP after the upgrades of 2013, **there is still a nutrient load leaving the plant**, as well as periodic high faecal coliform levels. It is therefore expected that the George Rex wetland would still be performing a nutrient scrubbing function on any effluent which may seep through the wetland.

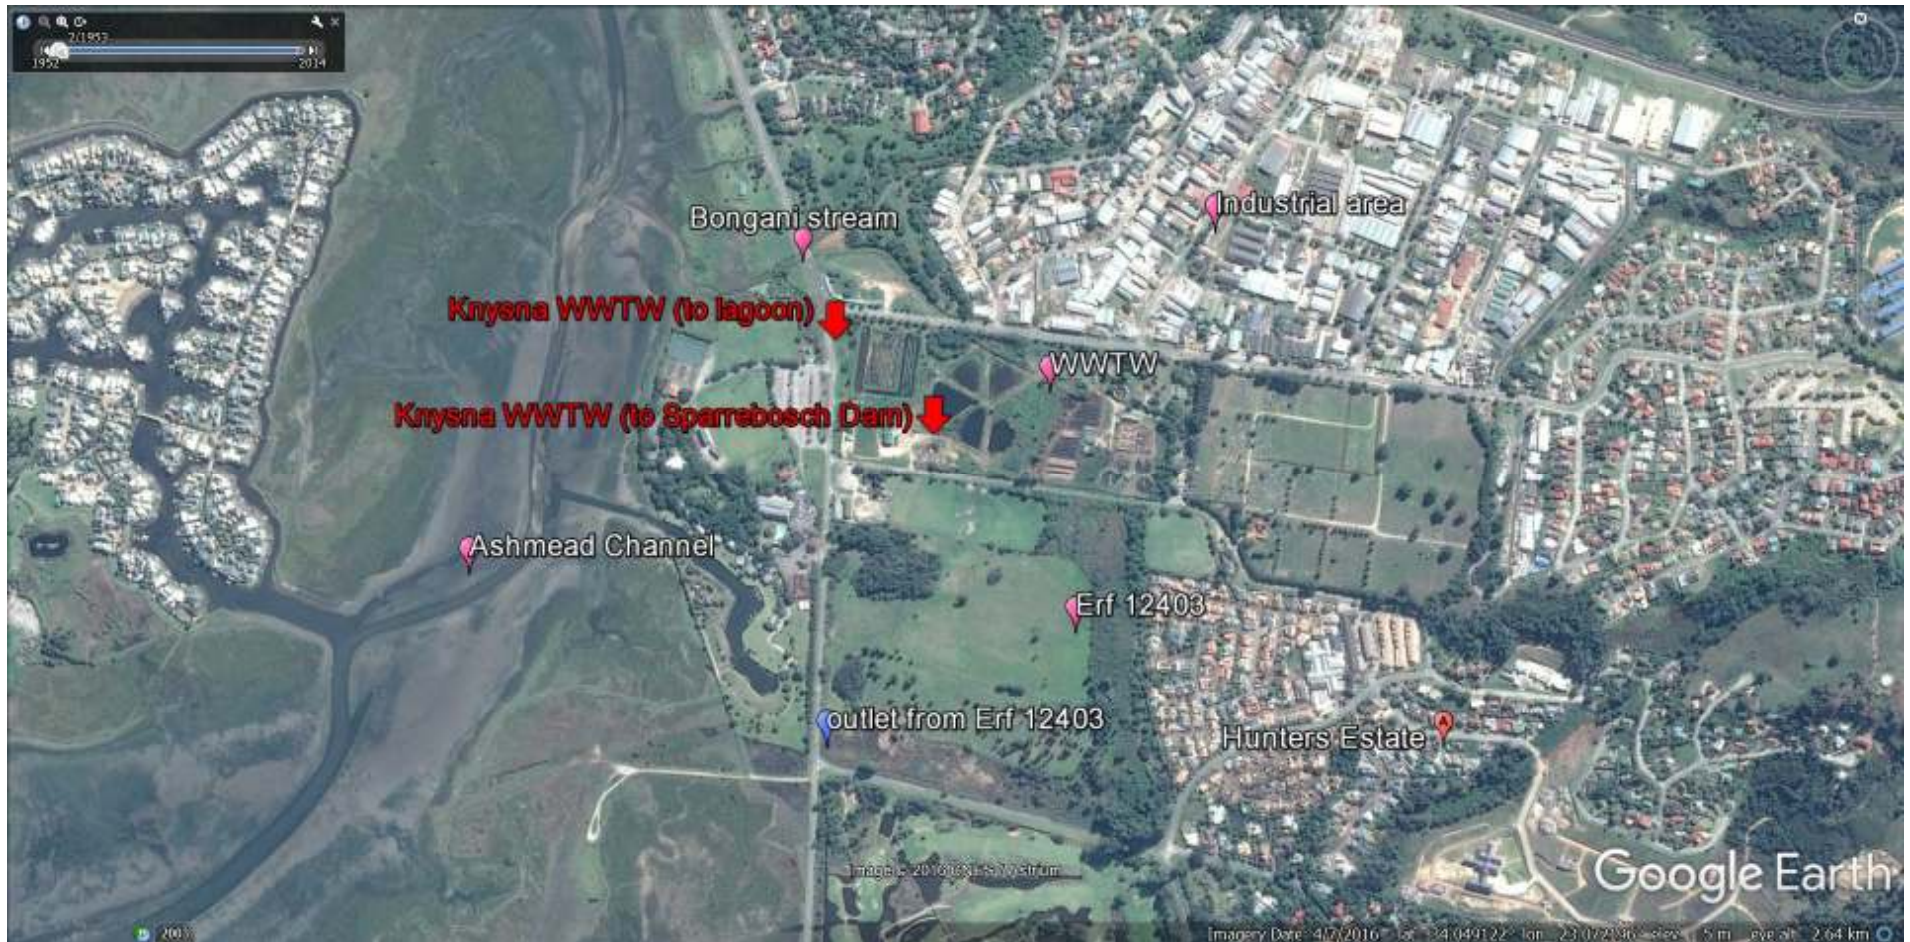
Figure 6.8: Areas of interest in relation to Erf 12403, including activities impacting on water quality.
