GEOTECHNICAL REPORT

GEOTECHNICAL SITE INVESTIGATION FOR THE PROPOSED NEW DEVELOPMENT OF ERF 12403, KNYSNA

27 JANUARY 2015

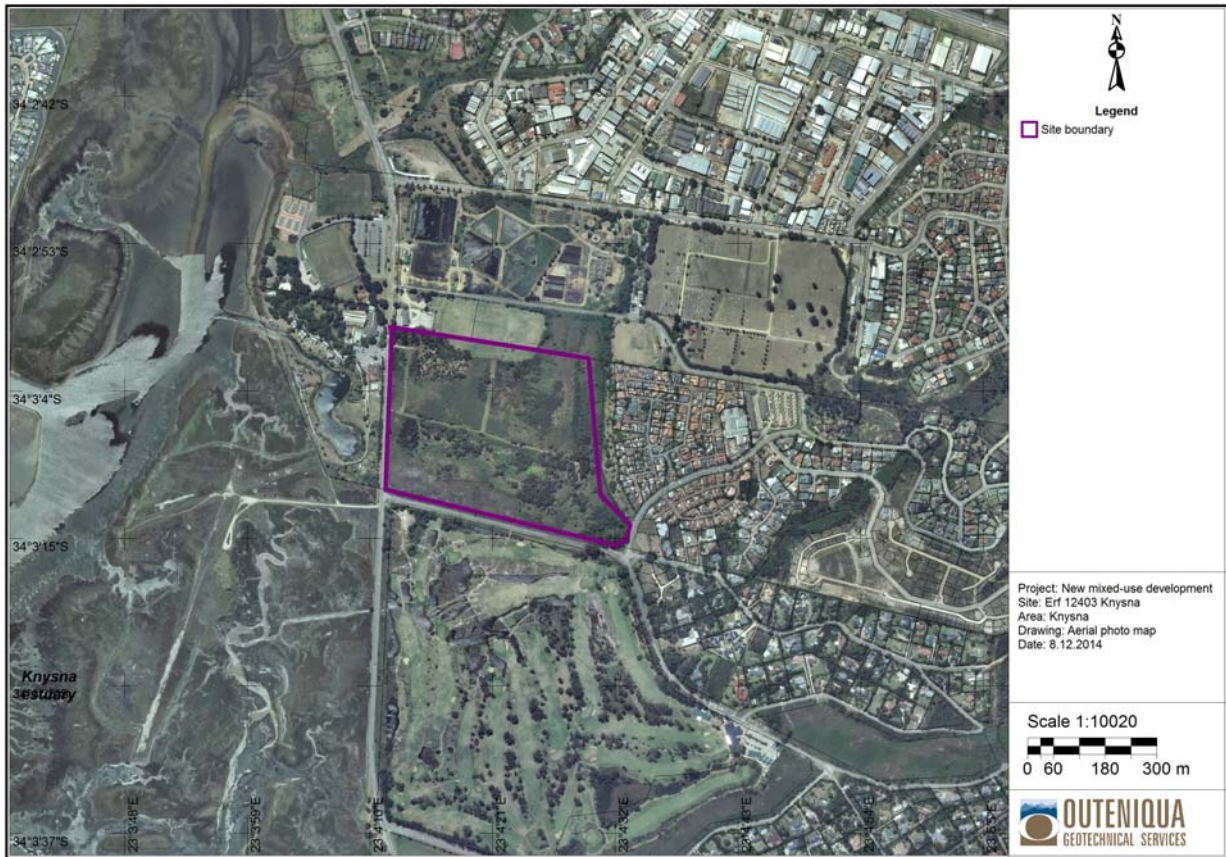
Figure 2: Aerial photo of site

The site is located along George Rex Drive in Knysna which is a causeway that was constructed many decades along the edge of the Knysna estuary (see **Figure 2**). The site is 19.5Ha in extent and is characterised by fairly flat terrain (<1:100) which drains very slowly in a south and westerly direction into the Knysna estuary. Surface ponding of rainwater was noted in many areas which restricted access across site with machinery. Approximately 7Ha of the site consists of a permanent marsh/wetland and the central portion of the site is usually dry and covered by grass and scattered alien trees. The site is vacant with the exception of one derelict small house (see **Figure 3**).

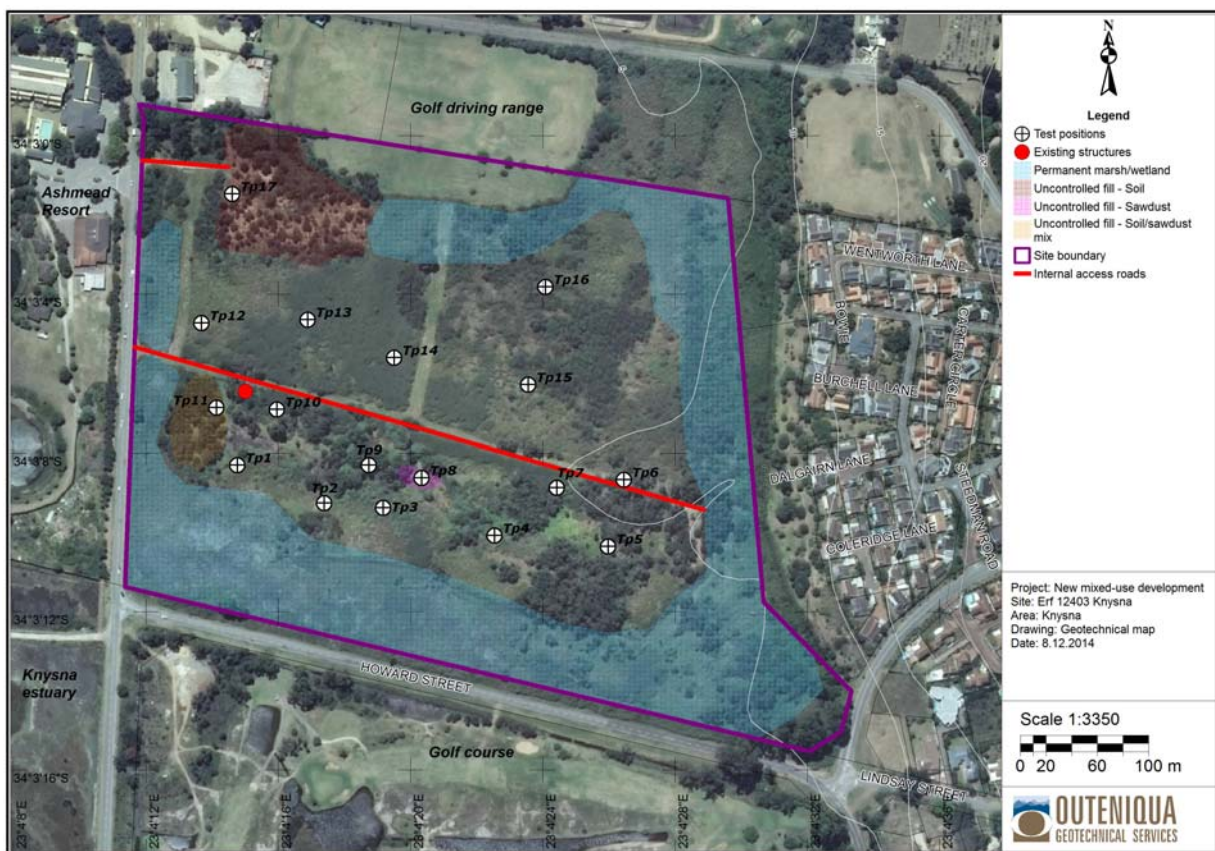
Figure 5: Geotechnical map

There is a small isolated heap of superficial sawdust on the site, as indicated on the geotechnical map (**Figure 5**) at TP8. The estimated area of the heap is 400m² and the average thickness is estimated at 500mm, therefore the insitu volume (excluding bulking) is estimated at 200m³. This material is unsuitable for engineering purposes and should ideally be removed or spread very thinly (<100mm thick) out across the site.

There is also a heap of fill material indicated on the geotechnical map at TP11 which appears to be a mix of soil & sawdust. This heap is estimated to be 2400m² with an average thickness of 1m, therefore the insitu volume (excluding bulking) is estimated at 2400m³. It is estimated that 50% of this fill can be selected out for general fill purposes during construction, but will require further testing.

There is a large heap of imported fill soil indicated on the geotechnical map near TP17 which appears to be mainly soil (possibly imported from excavations at the Knysna Mall in about 2003). This heap is estimated to be 9400m² with an average thickness of 2m, therefore the insitu volume (excluding bulking) is estimated at 18800m³. It is estimated that 80% of this fill can be selected out for general fill purposes during construction. Large blocks of concrete may have to be crushed or used as rock fill.

Environmental input is recommended.

- Strip all organic and foreign material (rubbish and rubble) over footprint areas.
- No structures should be placed on uncontrolled fill.

- Uncontrolled fill should be carted to spoil or recompacted as directed by the engineer.
- Localised depressions requiring filling should be filled with suitable local or imported material and compacted to the same degree and level as the surrounding density.
- Do not try to compact saturated soil. Rather rip and dry or remove and replace.
- Foundation trenches should be inspected by the engineer to approve founding conditions, such as soil types, density and moisture levels.
- Due to the low-lying nature of the site, it is recommended that floor levels should be raised to prevent flooding and damp problems associated with a shallow water table.

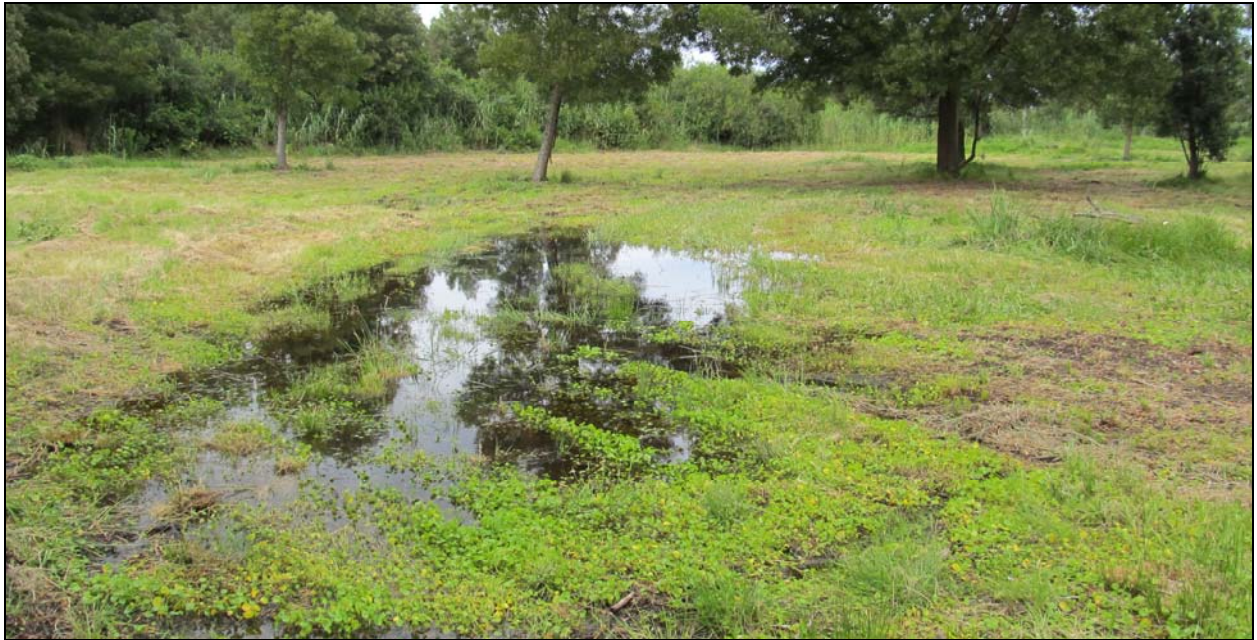
Figure 6: Photo of standing water on site after rains

The soil has a medium to low permeability and persistent rainfall will tend to pond on surface (see **Figure 6**). Effective storm water systems will therefore be required to accommodate flood events recurring every 10 years. A well-planned road layout can significantly reduce stormwater system costs. Raised barrier kerbs, mountable or semi-mountable kerbs or open side drains (swales) along roads are recommended in order to evacuate storm water. Regularly spaced inlets are recommended to prevent storm water from overflowing kerbs and flowing into adjacent properties. Subsoil drains along roads are not deemed necessary.
