**Aquatic Specialist Impact Assessment for the Section 24G
and Water Use License Applications required for Portions
4 and 9 / 232 Redford Farm, Knysna**

Prepared by Dr. Jackie Dabrowski of Confluent Environmental (Pty) Ltd

October 2021

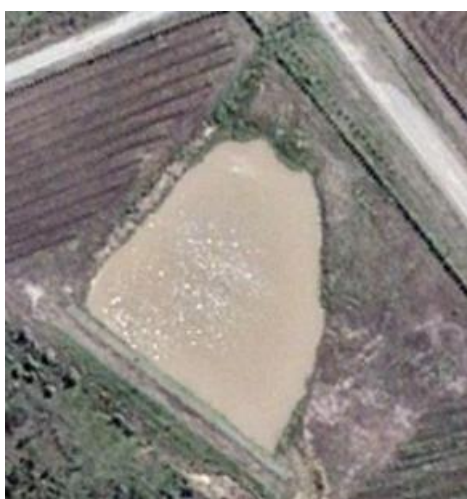
Figure 1. Dam 3 constructed on Portion 1 pictured in 2009 on Google satellite imagery.

Portion 1: One instream dam (Dam 3) was constructed by the previous owner of the property without environmental authorisations between 2006 and 2009 (Figure 1). The current landowner recently (2021) cleared sediment and littoral vegetation from the dam to maintain its capacity.

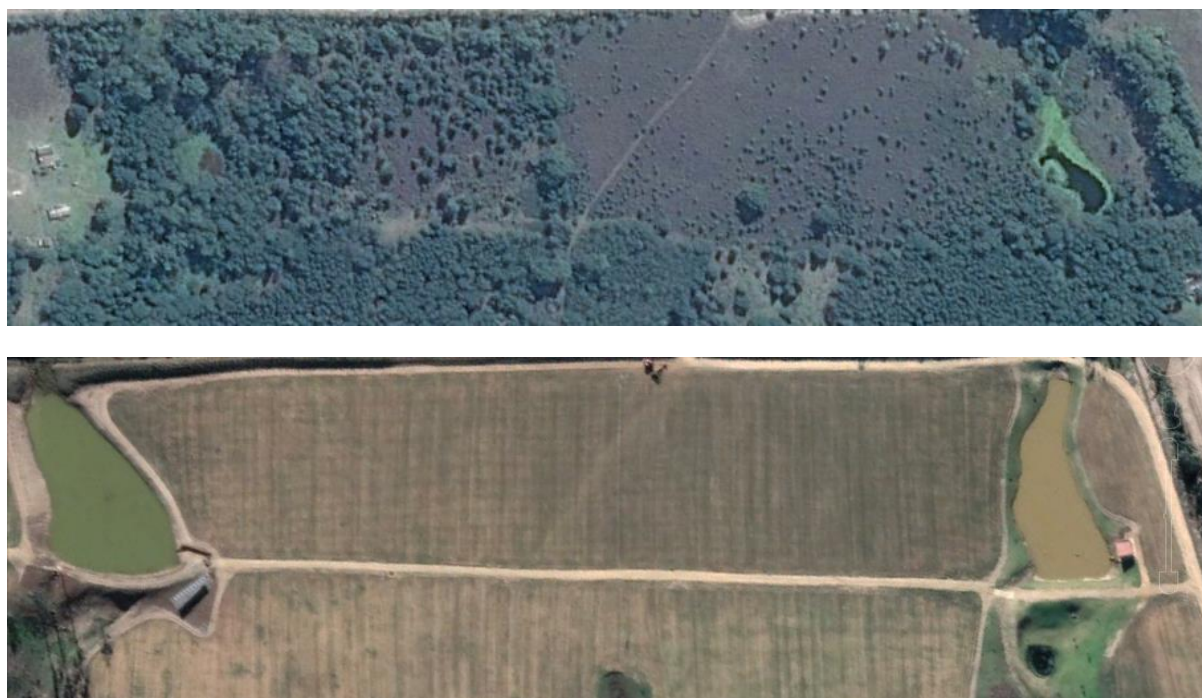
Figure 2. Two dams on Portion 4 present in 2016 (above) and enlarged in 2021 (below). The left dam is referred to as Dam 4 and the right dam is Dam 2.

Portion 4: Two instream dams were constructed pre-1998 (Dam 2 and Dam 4). The current landowner recently cleared out both dams to remove sediment and littoral vegetation. Both dams were enlarged from their previous capacity during this process, which occurred during 2020 and 2021.

- Despite these aspects of degradation, the amount of littoral and aquatic vegetation observable in the historical image of the dams on Portion 4 (Figure 2) suggest that the dams may have provided habitat for a range of biota (birds, macroinvertebrates, amphibians etc.).

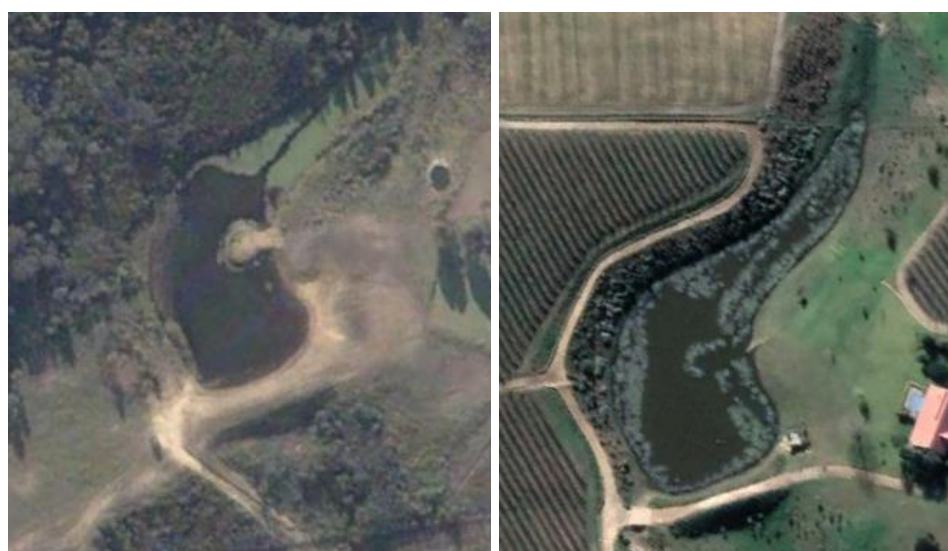
Figure 3. Dam 1 on Portion 9 shown in 2009 (left) and in 2021 (right).

Portion 9: One instream dam (Dam 1) was constructed between 2000 and 2004 by the previous landowner with no environmental authorisation. The current landowner cleared sediment and littoral vegetation predominantly from the dam's inlet during 2018 and enlarged the dam during this process.

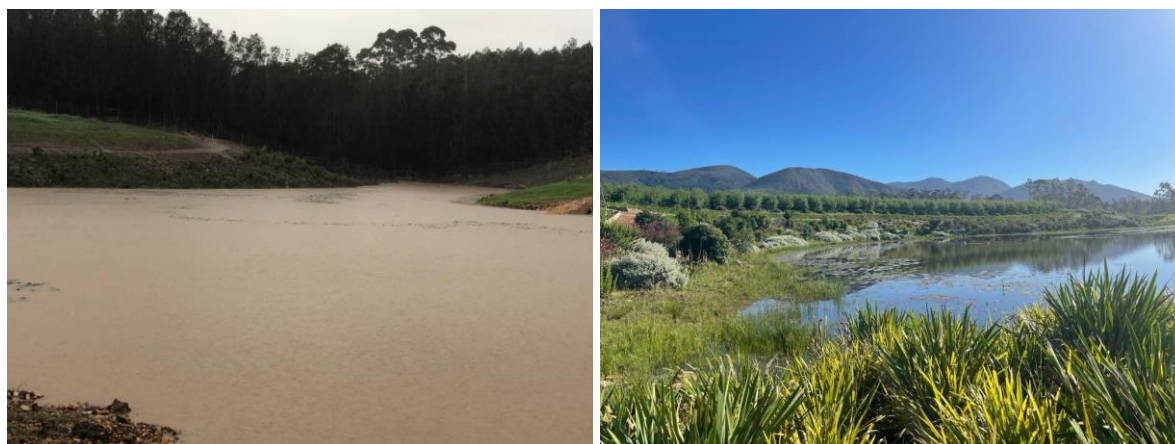
Figure 10. Photos of Dam 1 taken in 2018 (left) and 2021 (right) showing the extent of alien vegetation compared to revegetation with indigenous plants.

While it is safe to say the wetlands were degraded prior to the unauthorised activities, the removal of all vegetation from Dams 2, 3, and 4, and wetland areas with heavy machinery reduced the opportunity for remnant indigenous flora and fauna to recover from more sensitive intervention methods. In this sense, one set of negative impacts have been replaced with another. The PES of the watercourse prior to development was therefore likely to be similar to what it is presently. The PES of Dam 1 may have been improved through the process of revegetation of large areas of shoreline with indigenous vegetation, and due to the fact that it was not excavated to the same extent as the other 3 dams.

The landowner has subsequently spent in the region of R387 000 on indigenous plants (many of which are listed in the recommended plant list in Table 13) which have been planted around primarily Dam 1 at this stage (Figure 10 and Figure 11). Future planting is planned for indigenous and wetland zones (including riparian buffers recommended in this report) which have been planned around the two watercourses. In this sense a reasonable degree of ecological structure and function (related to biodiversity) will be actively preserved and managed in the future, with further passive regeneration by flora and fauna expected to occur naturally from surrounding areas. It is therefore likely that the future ecological state of the wetlands will be an improvement on their pre-development state.

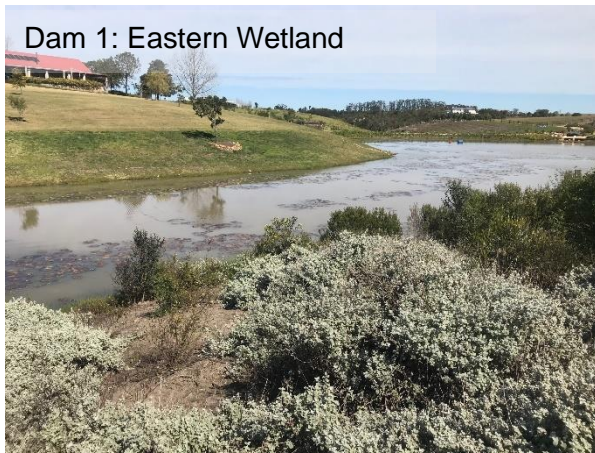
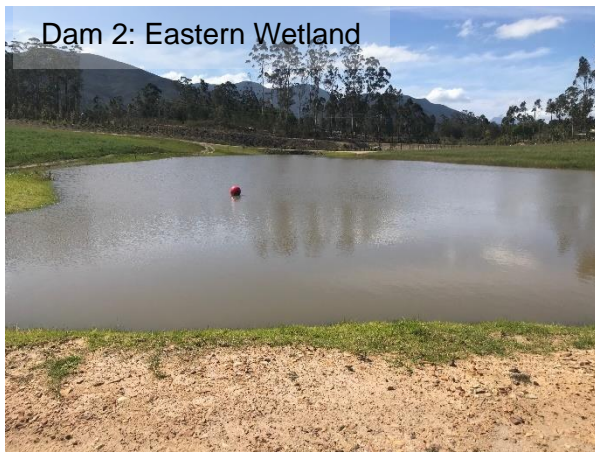
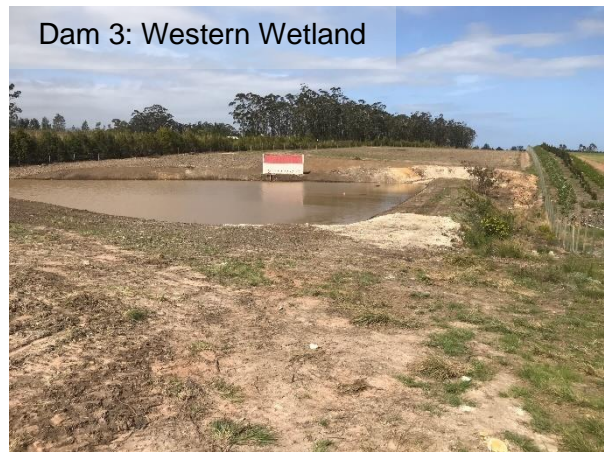
Figure 11. Photos of watercourse areas at Redhaus Farm showing various aspects of the dams.

In addition to the two dams on Redhaus Farm, the neighbouring property has recently (in 2020 or 2021) constructed a small instream dam and diverted stormwater from the road into the watercourse above the Redhaus Dam. This has resulted in very high turbidity of the water and will lead to rapid sedimentation and volume reduction of the dam on Redhaus Farm.
