GEOTECHNICAL SOIL TEST REPORT

Client: Mr Coetzee

Project: Erf 2003, Wilderness

Date of test: 23.7.2021

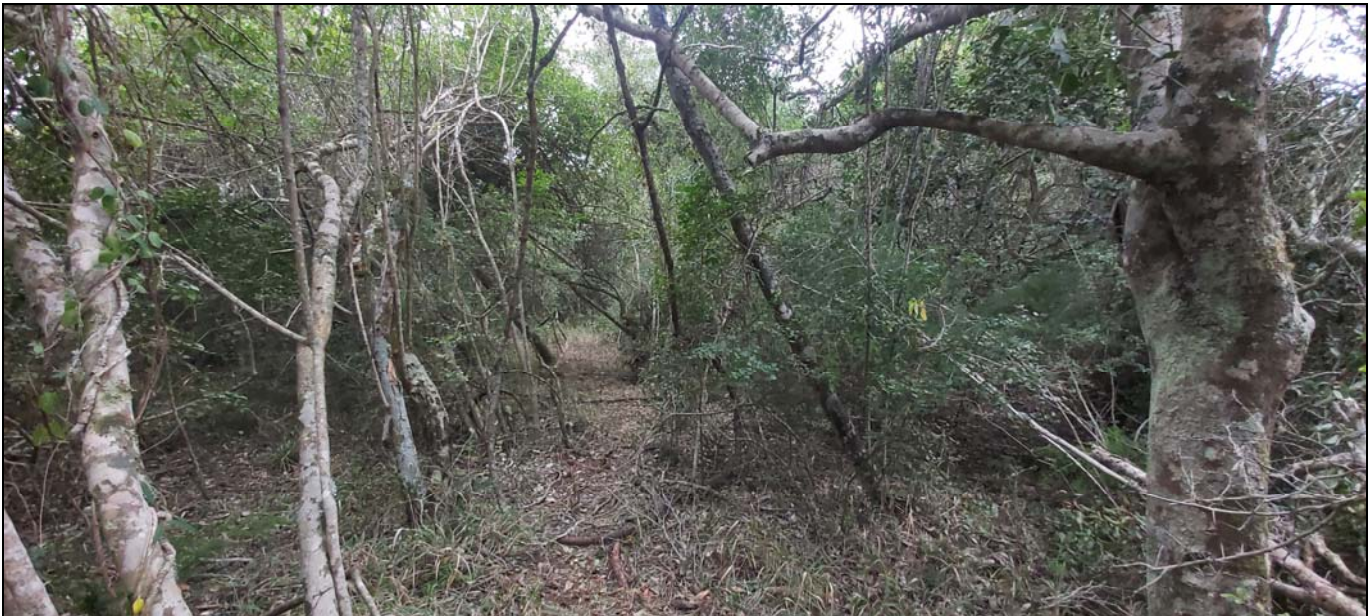
Figure 1: View of site from the access point on the NE corner

The topography of the property is quite variable and is characterised by a south- and southeast-facing moderate slope which becomes steeper towards a natural drainage line in the middle of the property. The proposed development consists of 4 chalets and a main residence along the northern and north-eastern side of the site. At the time of the investigation, the site was covered in thick indigenous vegetation and entry onto the site was restricted to access on foot (see Figure 1). The ground surface conditions in the proposed development area were generally dry with no signs of groundwater seepage or any significant slope stability problems.

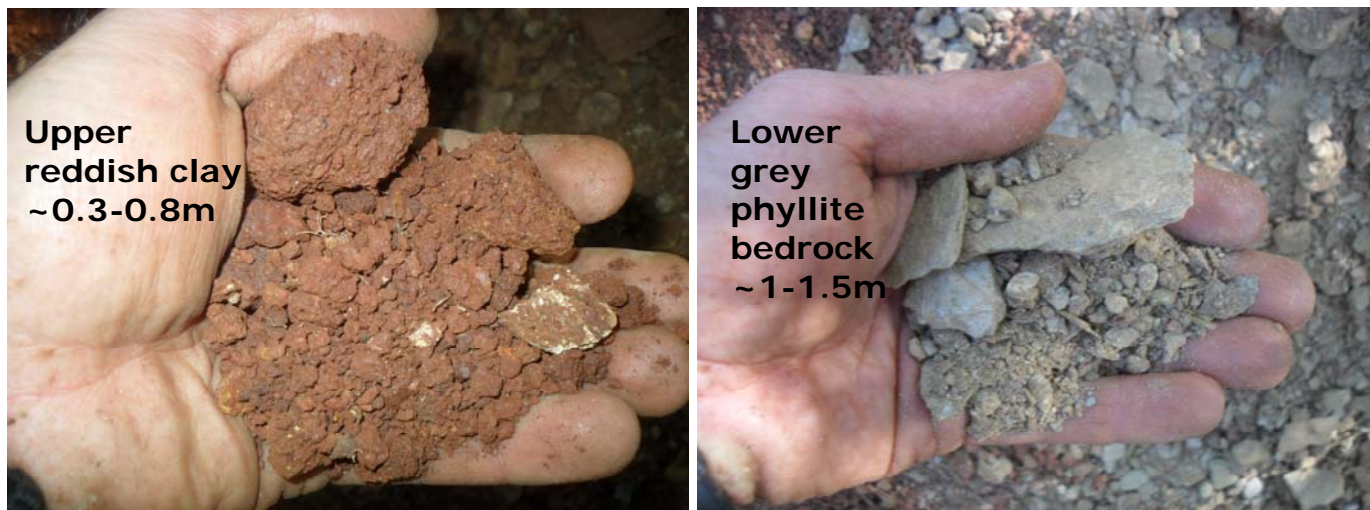
Figure 3: Soil types encountered in test pits

0-0.3m: Dark brown, firm, gravelly sandy clay/clayey sand – ***colluvium (topsoil)***

0.3-0.8m: Dark reddish brown, stiff, shattered, sandy silty clay - ***colluvium***

0.8-1.0m: Light grey to dark brown, dense to very dense, silty clayey gravel - ***residual completely weathered phyllite***

>1.0m: Light grey, very highly fractured, highly weathered, very soft to soft rock – ***phyllite bedrock***

The test pits were terminated due to difficult excavations or refusal on phyllite bedrock (see Fig 2). The depth to the bedrock is variable, and becomes shallower towards the west, but generally occurs at a depth of 0.8-1.5m. Large boulders or fragments of bedrock may also be encountered at this depth. No groundwater was encountered in test pits, but seepage can be expected in wet weather periods.

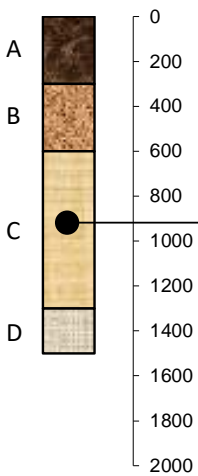
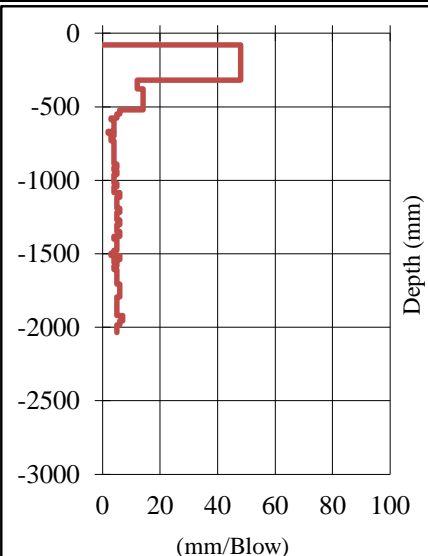
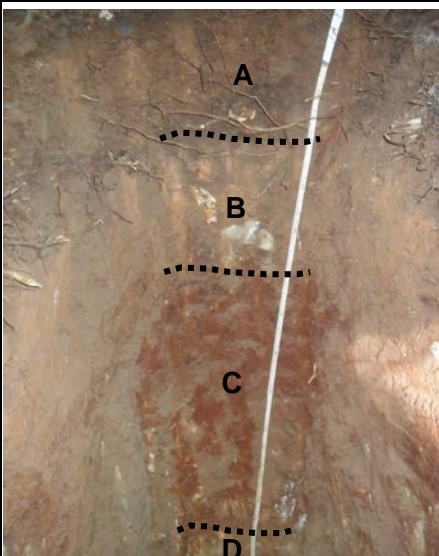
<p>A 0 200 B 400 600 C 800 1000 1200 D 1400 1600 1800 2000</p>	TP 1	Key to symbols: ● Sample taken	☒ Groundwater

<p>Depth (mm) 0 -500 -1000 -1500 -2000 -2500 -3000 (mm/Blow) 0 20 40 60 80 100</p>

<p>A B C D</p>
	(0 to 300) Slightly moist, dark brown to dark reddish brown, firm, shattered/pinholed, SANDY SILT & CLAY , colluvial/topsoil (with abundant roots & organic material) (300 to 600) Slightly moist, dark reddish brown, stiff, micro-shattered, SANDY SILTY CLAY , colluvial (with traces of fine to coarse gravel) (600 to 1300) Slightly moist, dark red, stiff to very stiff, micro-shattered, SLIGHTLY SANDY SILTY CLAY , colluvial (with traces of fine to coarse gravel) (1300 to 1500) Slightly moist, dark reddish & yellowish orange, very stiff, intact/fissured, SILTY CLAY , residual phyllite (with some fragments of very soft rock phyllite) TP stopped No water seepage

In situ DCP tests conducted next to test pits from NGL indicate that the upper ~0.4m of the soil profile is loose, but firms up quickly below this depth and most tests refused on rock or boulders at a max depth of 1.5m. The DCP at TP1 penetrated in stiff material to 2m depth, indicating deeper rock at this position.

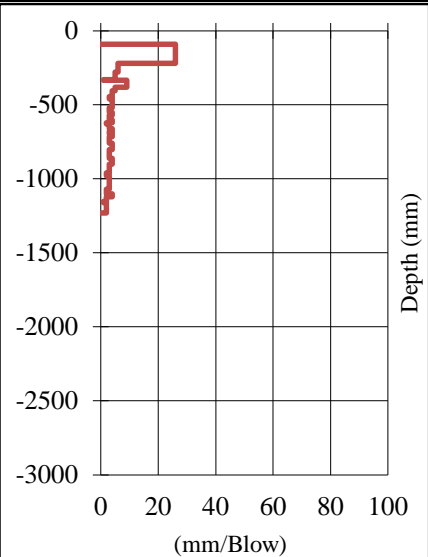
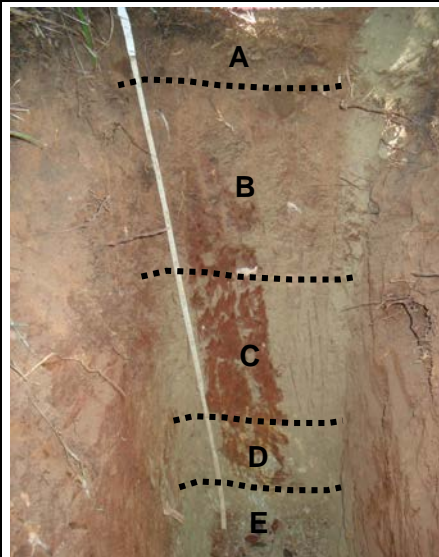
<p>A 0 200 B 400 600 C 800 D 1000 E 1200 1400 1600 1800 2000</p>	TP 2	Key to symbols: ● Sample taken	☒ Groundwater

<p>Depth (mm) 0 -500 -1000 -1500 -2000 -2500 -3000 (mm/Blow) 0 20 40 60 80 100</p>

<p>A B C D E</p>
	(0 to 200) Slightly moist, dark brown to dark reddish brown, firm, shattered/pinholed, SANDY SILTY CLAY , colluvial/topsoil (with abundant roots & organic material) (200 to 600) Slightly moist, dark reddish brown, stiff, micro-shattered, SANDY SILTY CLAY , colluvial (with some roots & traces of gravel) (600 to 1000) Slightly moist, dark red, very stiff, shattered/micro-shattered, SANDY SILTY CLAY , colluvial (with scattered weathered gravel) (1000 to 1250) Slightly moist, dark reddish & yellowish orange, very stiff to hard, shattered/fissured, GRAVELLY SILTY CLAY , residual (with some very soft rock to soft rock remnants) (1250 to 1350) Light brown to light olive, highly weathered to completely weathered, foliated, very highly fractured, very soft to soft rock PHYLLITE . Near refusal on very soft to soft rock No water seepage

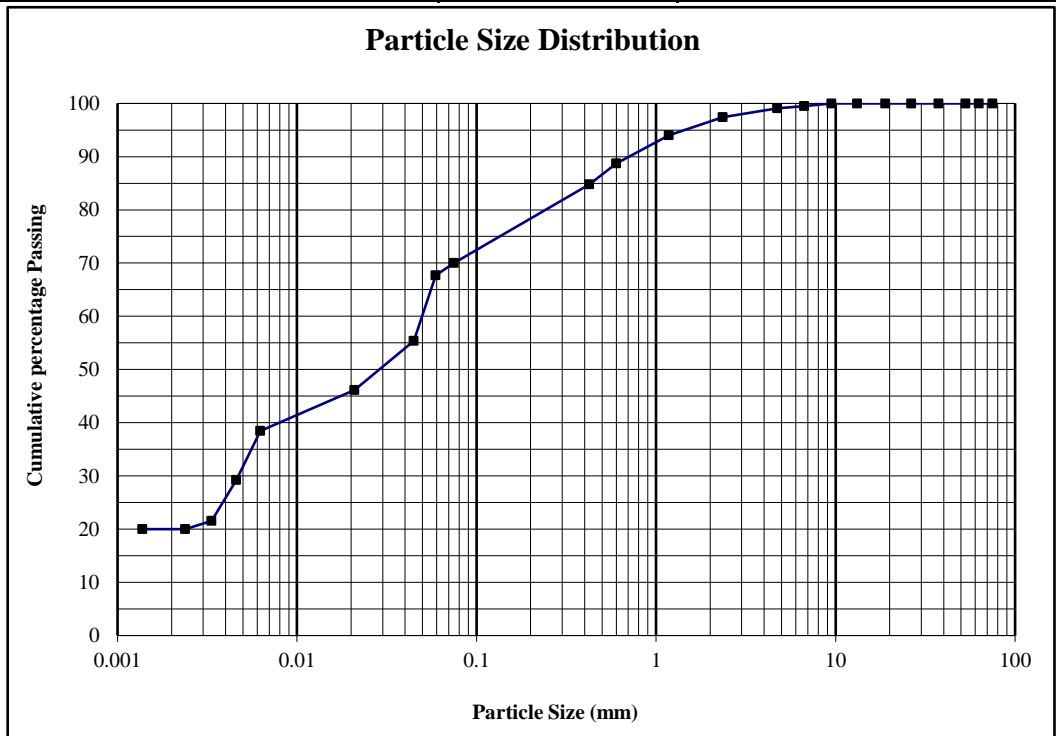
Material Description:	Dark Red Clayey Sandy Silt	Sample Number:	81971		
Position:	TP1 - Layer 2	Liquid Limit	55	Linear Shrinkage	12
Depth:	600-1300	Plasticity Index	24	Insitu M/C%	22

Sieve Size(mm)	% Passing
75.0	100
63.0	100
53.0	100
37.5	100
26.5	100
19.0	100
13.2	100
9.5	100
6.7	100
4.75	99
2.36	97
1.18	94
0.600	89
0.425	85
0.075	70
0.0591	68
0.0447	55
0.0209	46
0.0062	38
0.0046	29
0.0033	22
0.0024	20
0.0014	20

% Clay	20	% Silt	48	% Sand	28	% Gravel	4
Unified Soil Classification		MH		PRA Soil Classification		A-7-5

Observations in test pits and subsequent lab tests indicates a slightly expansive nature of the clayey soil cover above the bedrock, but this horizon is generally limited in thickness and the overall heave potential of the site is low.
