# GEOTECHNICAL REPORT

FOR THE PROPOSED RESIDENTIAL APARTMENTS ON  
ERF 3420 ST FRANCIS BAY (THE ADMIRAL)

5 September 2022 (Rev 0)

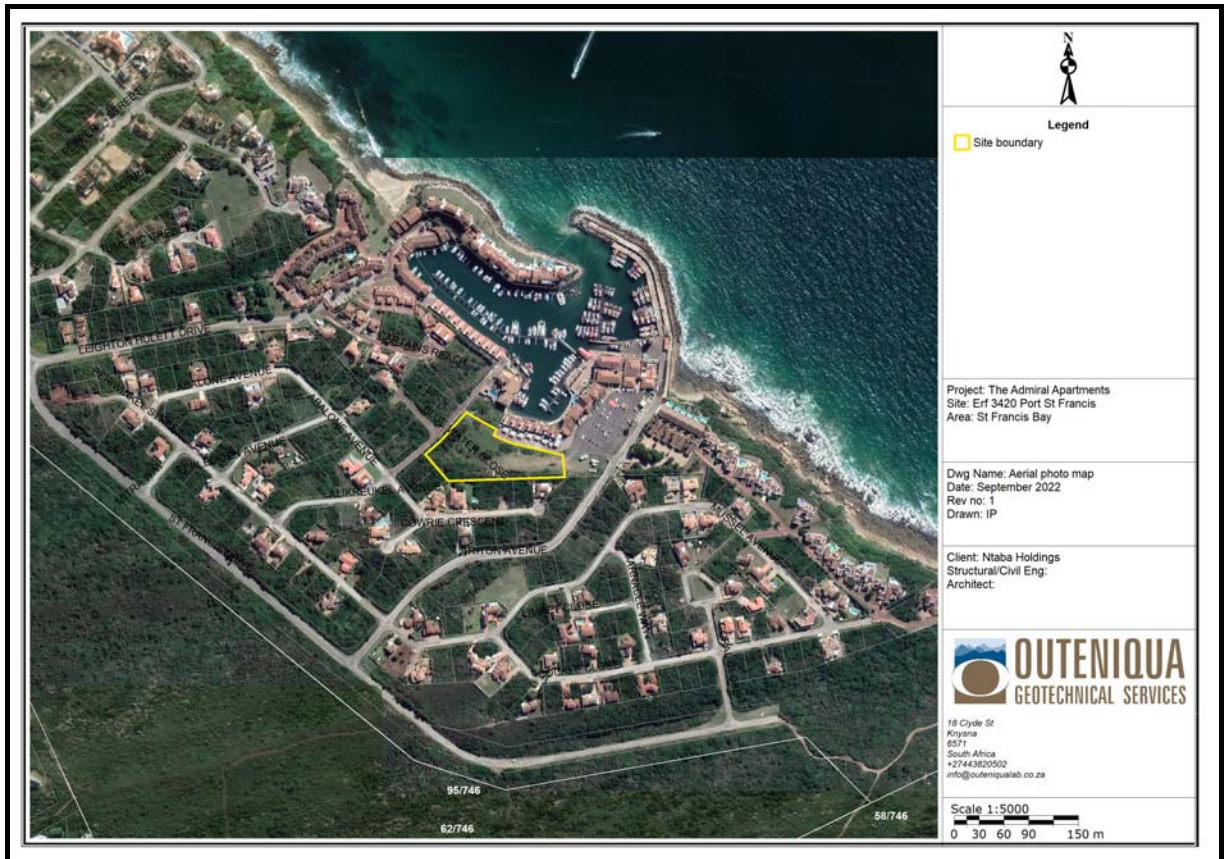
Figure 2: Aerial photo map of the site

The proposed site was located close to Port St Francis harbour area, to the north of the site (see **Figure 2**). The proposed site was vacant at the time of the investigation and sloped very gently toward the north, although the northern edge of the site had clearly been artificially raised with a block retaining wall up to 5m high (see **Figures 3-4**). The vegetation on the site consisted of long grass, small shrubs and medium to large bushes along the southern and western boundary (See **Figures 3-6**). The ground conditions were generally dry but the surface was irregular in places, with some fairly large depressions (see **Figure 6**), indicating historical filling/dumping of soil and rubble. The site was easily accessible with vehicles from the entrance road on the eastern side of the site.

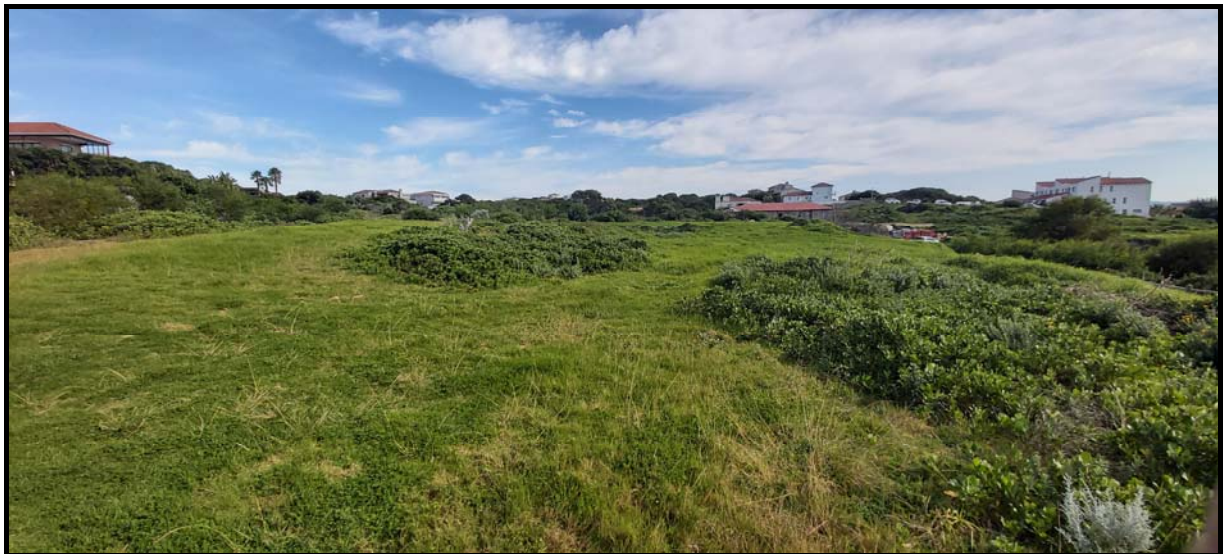
Figure 3: View of the site, looking to the west

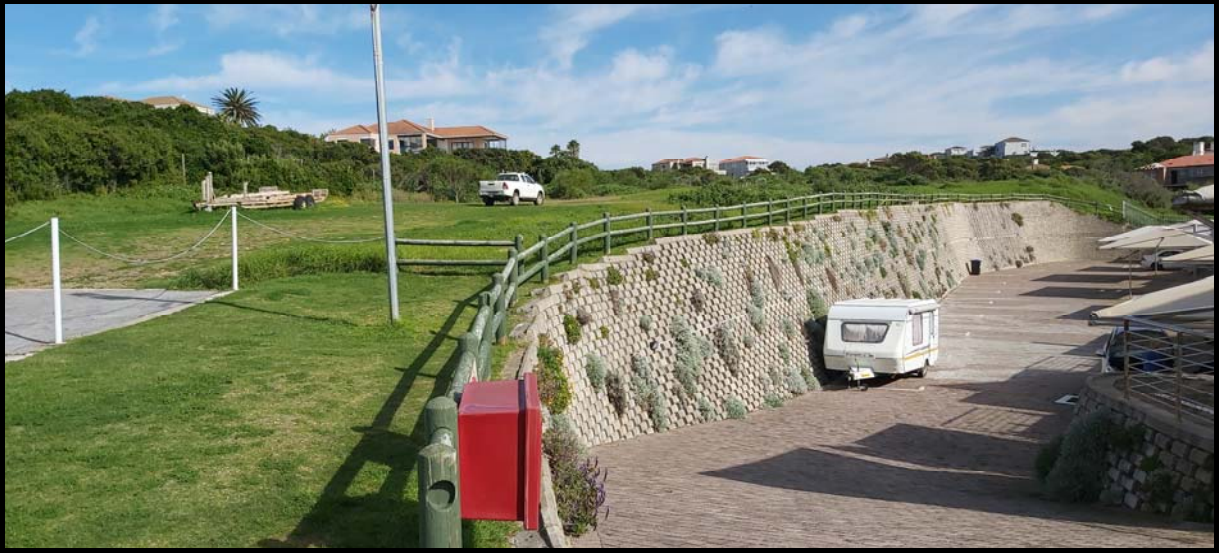
**Figure 4: View of the retaining wall along the northern boundary, looking to the west**

No slope stability issues were identified or expected from the site. The existing retaining wall along the northern boundary appeared to be in good condition.

Caution should be taken when working near the existing retaining wall on the northern side of the site, as excavations may disturb any reinforcement behind the wall or cause a surcharge loading on the wall.

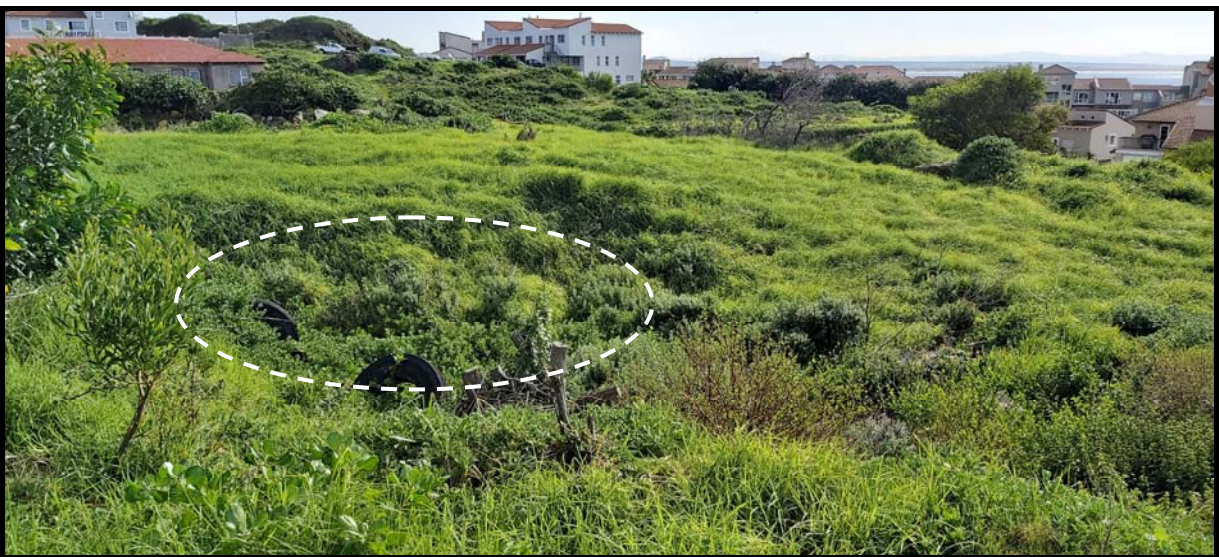
**Figure 6: View of the western side of the site looking northwest (note hollow in foreground)**

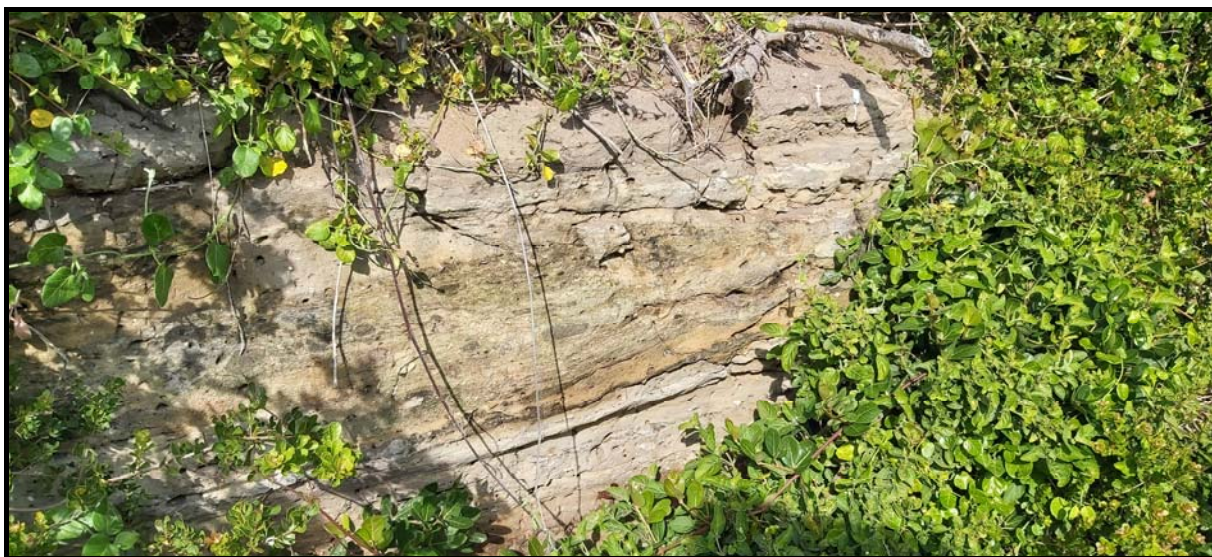
Figure 8: Possible outcrop of calcarenite rock on the site

Local observations on the site indicated some possible outcrops of calc-arenite (calcareous sandstone) on the southern boundary of the site (see **Figure 8**).

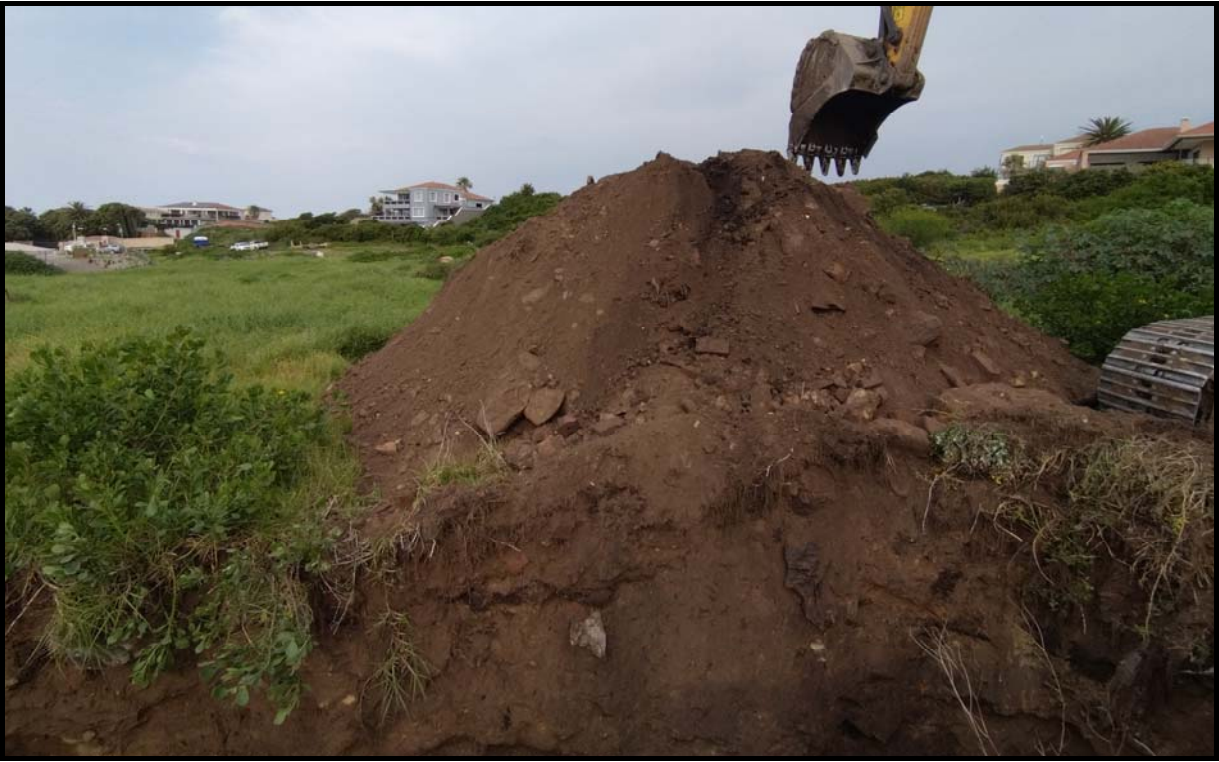
**Figure 9: Gravelly sandy fill material encountered below surface in all pits**

- 0-1.5m: Moist, light-dark red brown, loose-medium dense, voided, SILTY GRAVELLY SAND, imported (fill with rubbish and rubble - See **Figure 9**).
- 1.5-3.0m: Moist, light brown/yellow, medium dense to dense, intact, SILTY FINE SAND, aeolian. See **Figure 10**.
- >3.0m: Light brown, dense, GRAVELLY SAND, COBBLES & BOULDERS OR very soft rock CALCRETE rock. See **Figure 11**.

DCP tests indicated potentially loose consistency of the uncontrolled fill (>40mm/blow), although several tests refused on coarse particles in the fill. The tests indicated that the underlying insitu aeolian sand was typically medium dense to dense (10-20mm/blow – refer to tests TP1, TP3 and TP6 which managed to penetrate the fill).

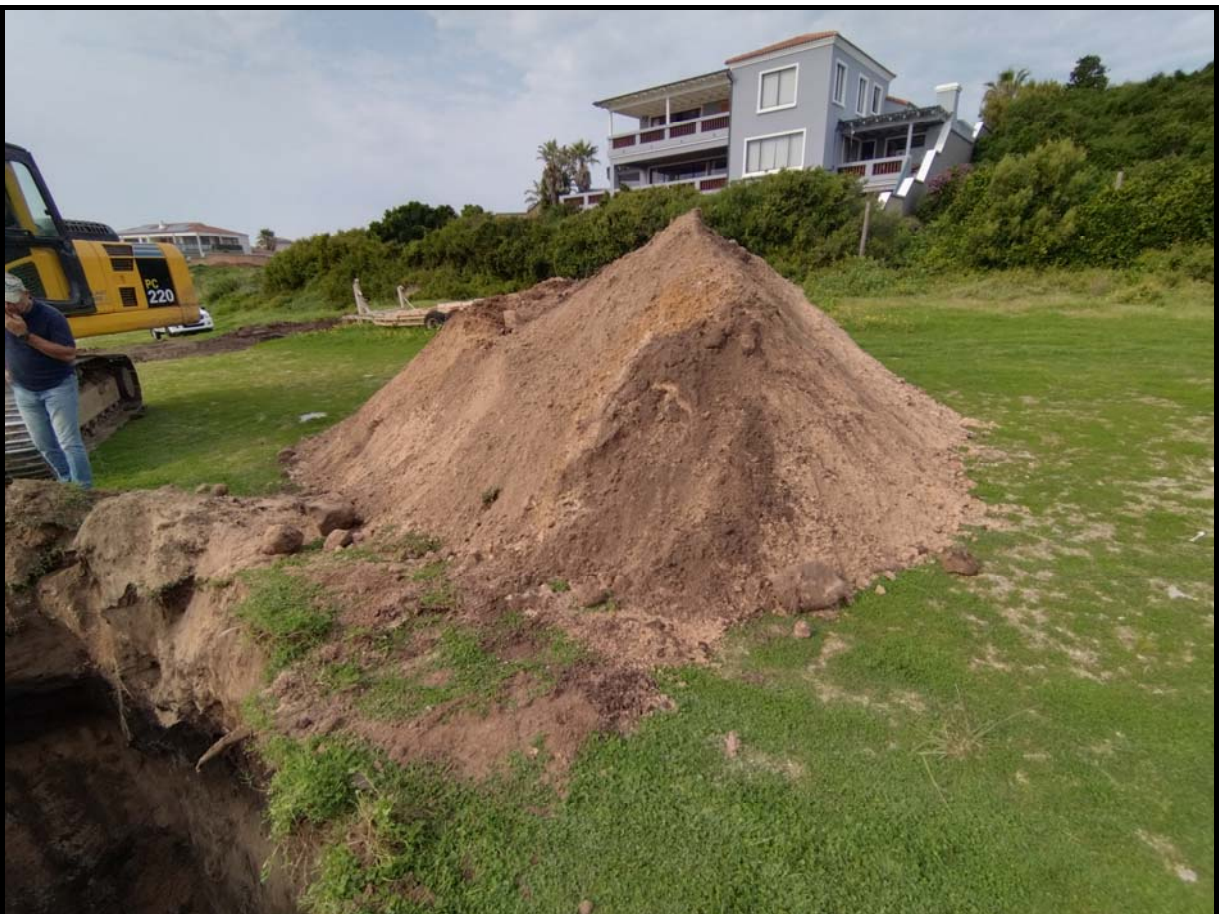
**Figure 10: Typical insitu aeolian silty sand encountered in the test pits**

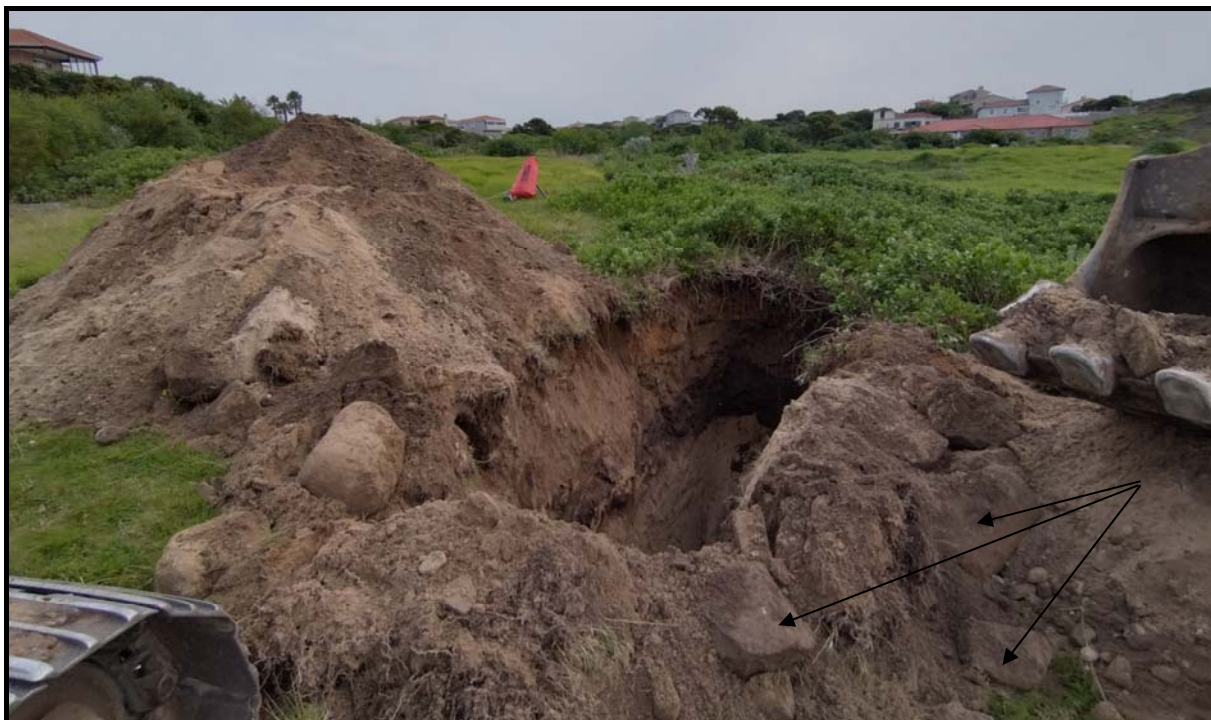
**Figure 11: Boulders and calcrete/calcarene rock encountered at the base of some pits**

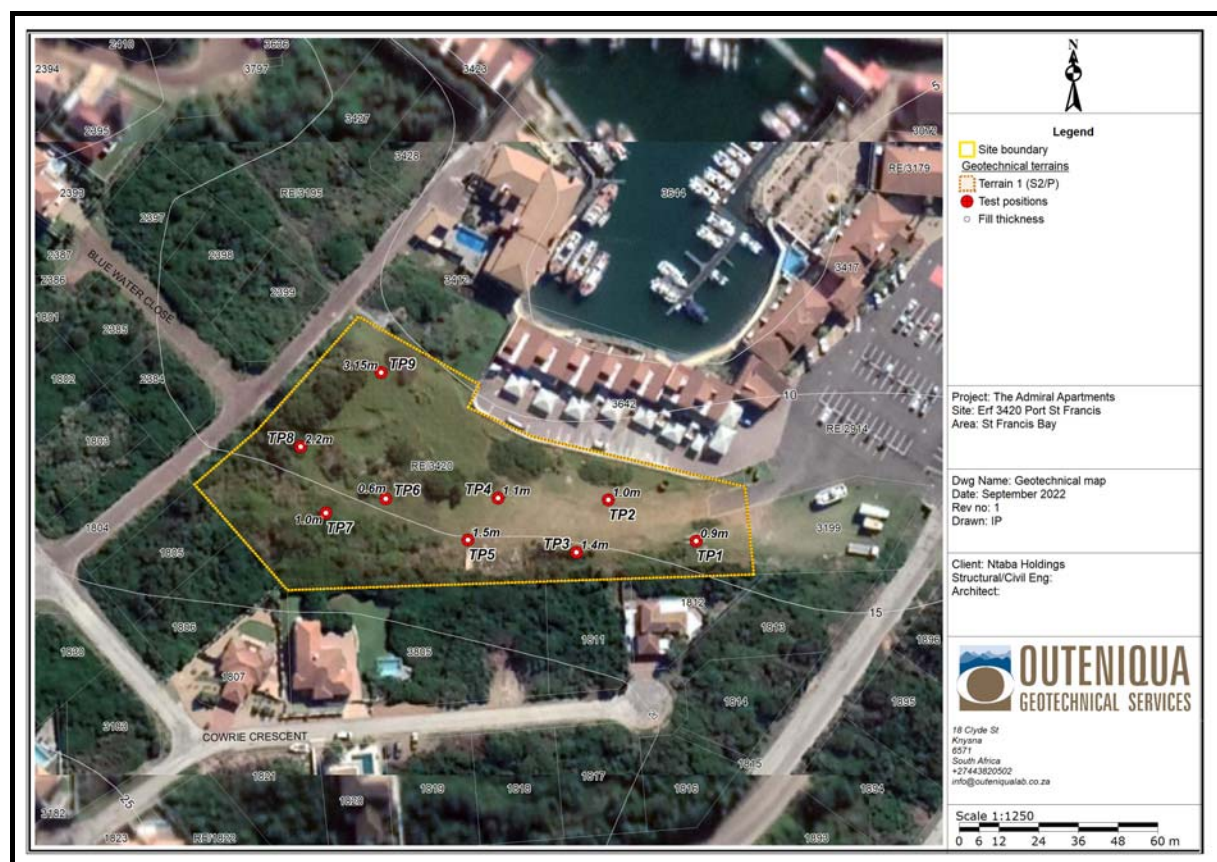
Figure 12: Geotechnical Map

Due to the broadly consistent profile and conditions, the entire site was mapped as “Terrain 1” which included potentially highly compressible soils (S2) and uncontrolled fill material (P).
