FRESHWATER COMPLIANCE STATEMENT

Portion 91 of Farm 304, Matjesfontein, Plettenberg Bay.

Prepared for EcoRoute

Updated to address DEA&DP feedback and detailed SDP, April 2023

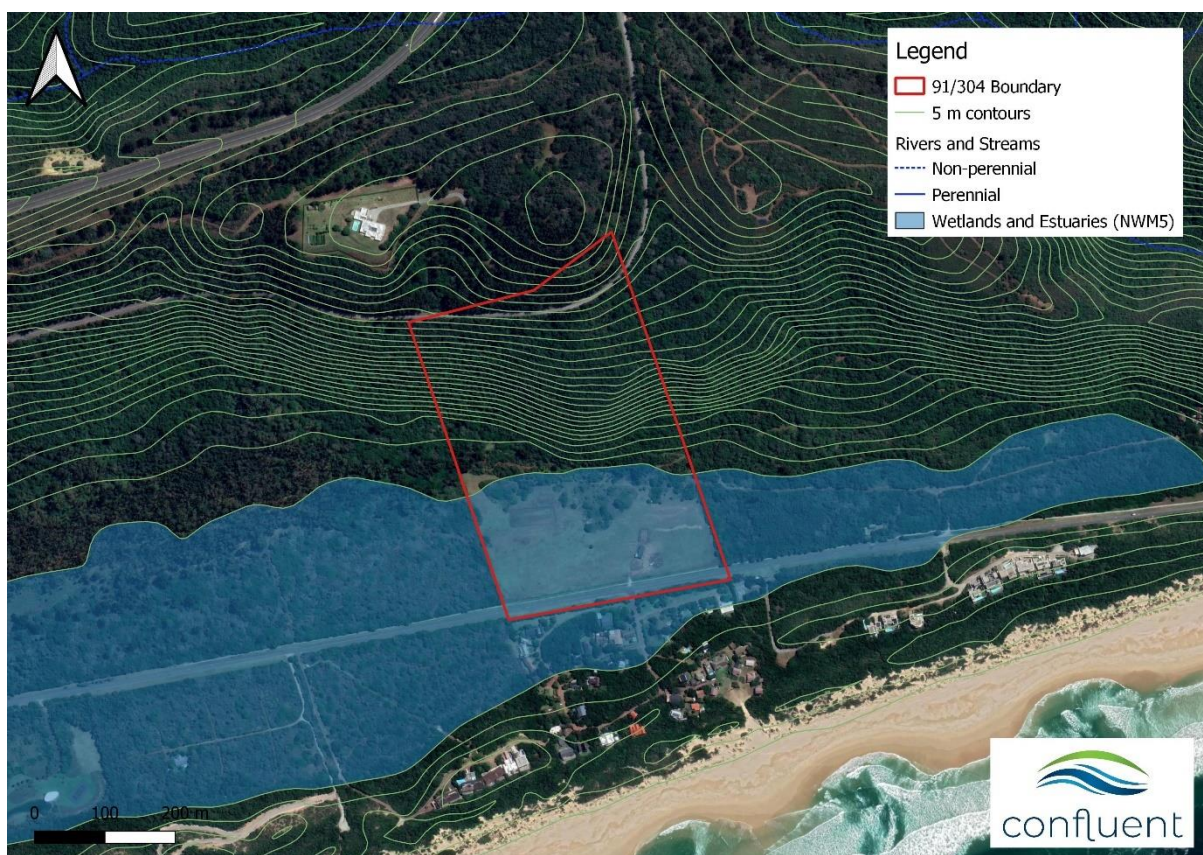
Figure 5: Location of the property in relation to mapped freshwater features.

The site falls within quaternary catchment K60E. No freshwater features such as drainage lines, rivers or wetlands are indicated to occur within the footprint of the property or within close proximity to the property (Figure 5). The only mapped aquatic feature is the Estuarine Functional Zone (EFZ) which is identified as any area below 5 m.a.m.s.l. (metres above mean sea level). The northern portion of the property is fairly steep and forested, while the southern portion is very flat with pasture grazed by horses (Figure 5). The development will be focussed on the southern, flatter portion of the property.

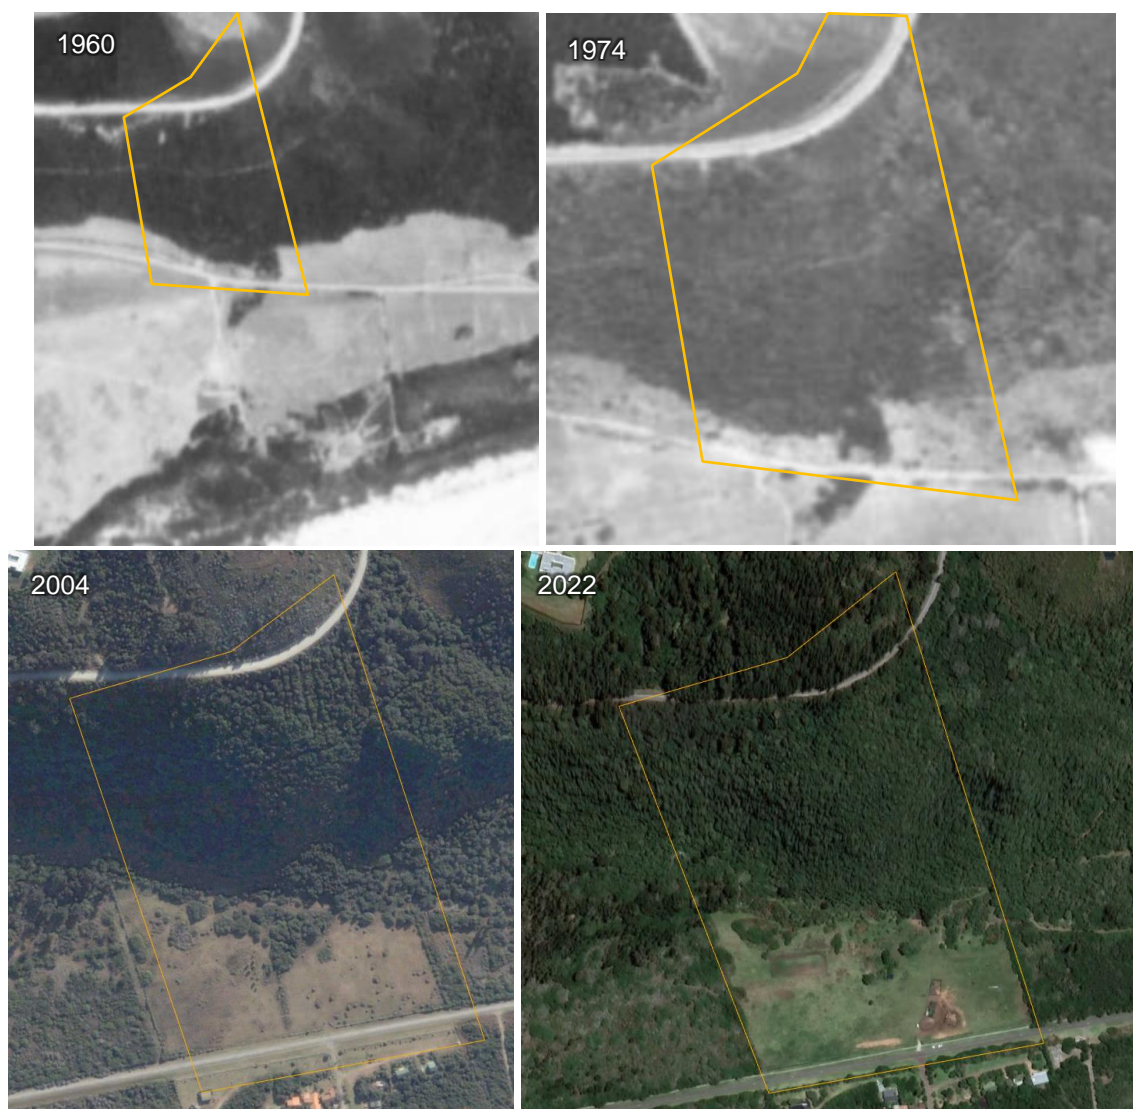
Figure 6. Historical aerial imagery of the property

The historical assessment used aerial imagery provided by the CD:NGI (National Geo-spatial Information) and satellite imagery available from Google Earth. Early images of the site in 1960 and 1974 show that while vegetation clearing had been undertaken on the southern portion of the site, it was to a lesser extent than the present. The vegetation that was present consisted of dense thicket / forest, and the cleared area appears to be pasture. The 1960 image indicates that clearing was widespread across the original Matjesfontein Farm, and the present vegetation cover has recovered substantially in the area.

Vegetation cover has remained consistent at the site for approximately the last two decades as the 2004 image indicates a similar pattern of cover as the present.

No typical wetness/wetland indicators are evident on the southern portion of the site in any of the aerial photos. As the dominant vegetation cover was historically forest / thicket this also suggests that there was no estuarine habitat on the site either, as this typically presents as open vegetation.

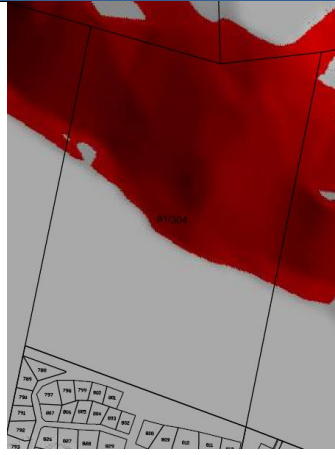
KELASP recommendations and guidelines	Graphic
<p>Development on steep slopes with a gradient > 1:4 is not supported. The area highlighted in red represents the steeply sloping land on 91/304.</p>

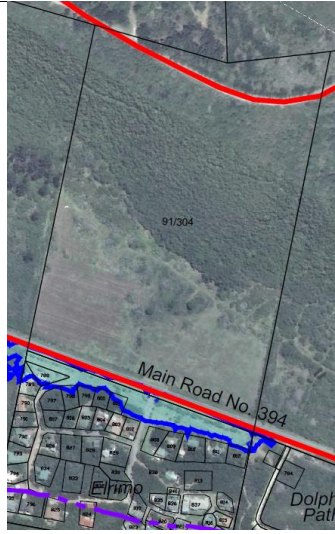
<p>Development is not supported in areas below the 1:50 and 1:100 year floodline. Lines indicated are: dark blue = 1:100 year floodline, and light blue area is an 'island' below the 1:50 year floodline. The purple line is the 100m urban coastal setback line.</p> <p>The proposed development area is located outside of all these features, and is therefore not flagged from a heightened flood risk perspective.</p>

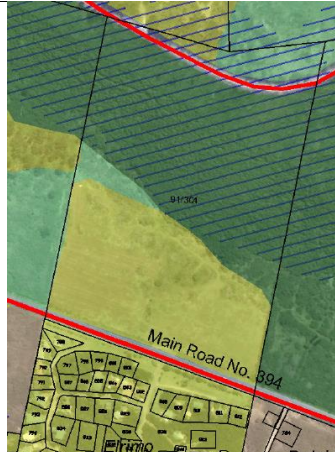
<p>Development is supported in transformed areas. The related graphic maps the southern portion of the site (proposed for development) as a 'Transformed Area' less sensitive to disturbance with opportunities for development and no natural habitat remaining. The relevant area is mapped in light green.</p>

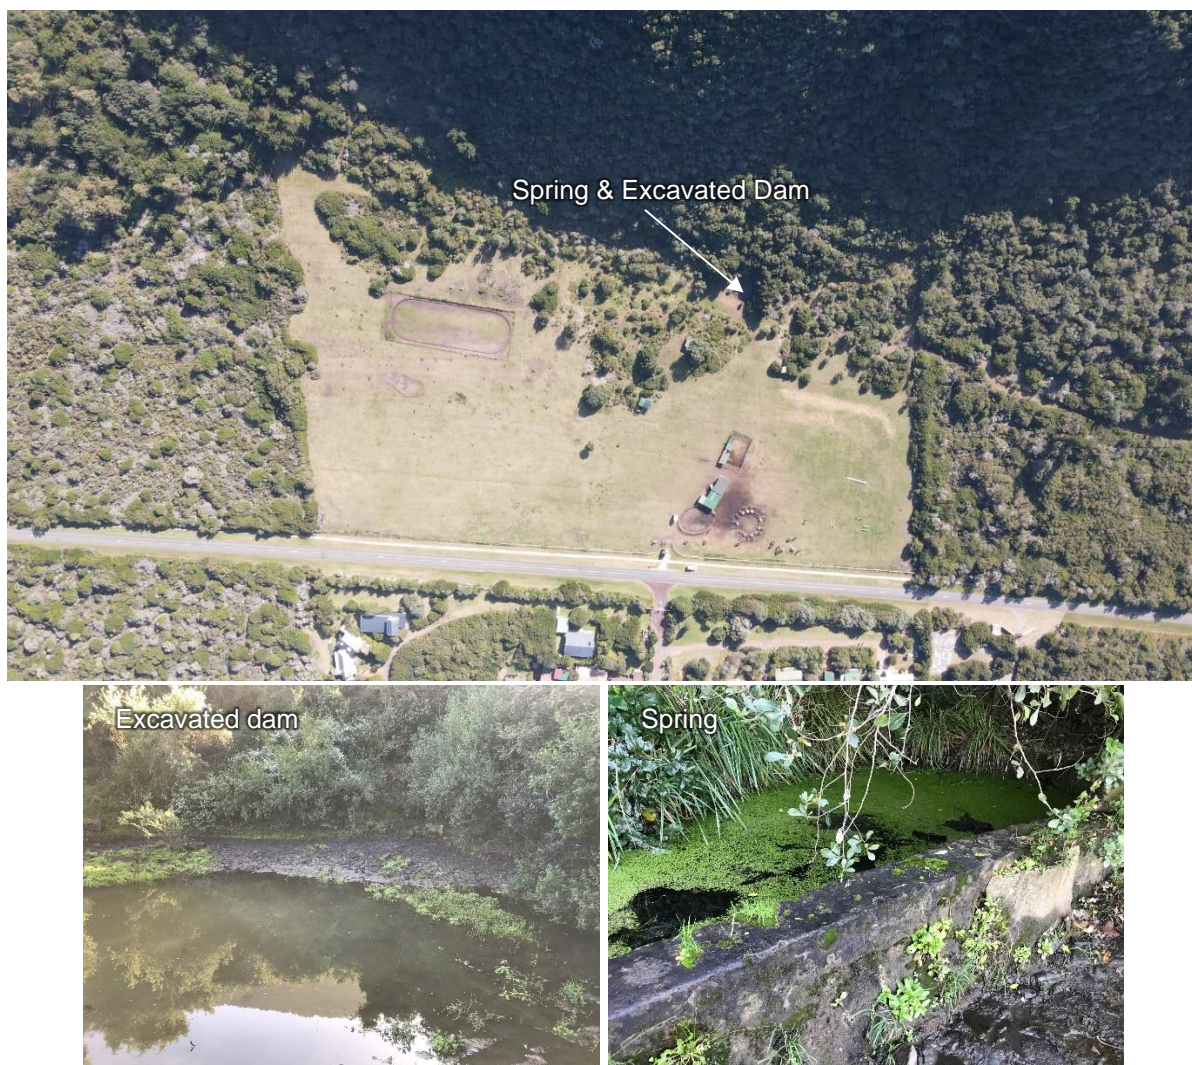
Figure 8. Photographs indicating the location of the spring and associated dam.

A small natural spring is present on the site and was identified by the landowner. Water flowing from the spring is stored to a minor extent in a small, excavated dam (Figure 8).

Soil is very sandy on the site and should therefore be relatively well drained. The dam is roughly circular, and measures approximately 90 m² in extent.

The dam and associated spring are identified as a watercourse as defined in the National Water Act. According to GN509 of the NWA, the regulated area of a spring or dam is classified as the outer edge of 1:100 year floodline or and/or delineated riparian habitat (whichever is greater) from the middle of the spring or dam. As the floodline is not relevant in this situation, and riparian vegetation was indistinguishable from the surrounding vegetation, a buffer of 10 m for this feature is recommended. Development should be planned to exclude this buffer area during the construction and operational phase.

- While a natural spring and dam are present on the site, they are very small in extent and can be adequately protected from the development by implementing the 10m buffer during the construction and operational phases as indicated in this report. The presence of this feature is not sufficient to increase the sensitivity of the site to Very High, and it has been excluded from the development area in both SDP options. No stormwater should be put into this dam as the water is of high quality.

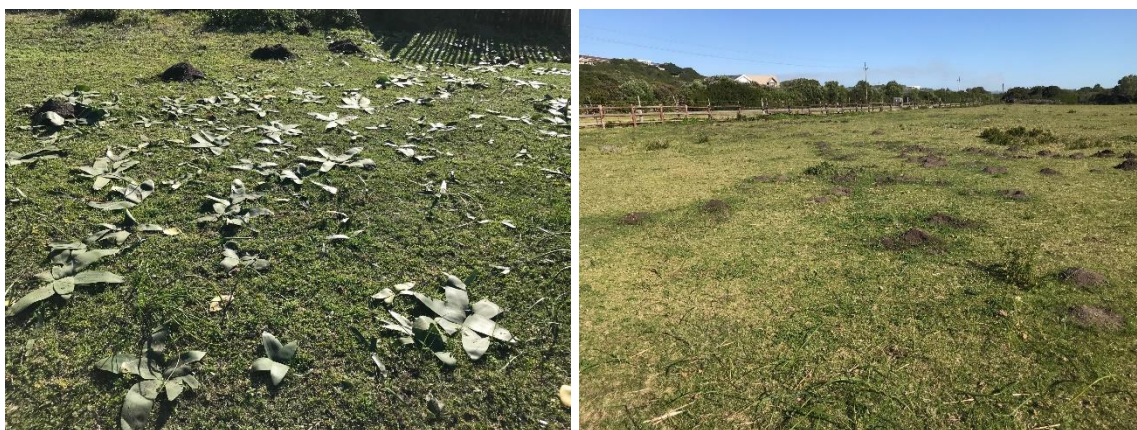
Figure 10. Typical vegetation in the grazed open area.

Remnant patches of vegetation were present on 91/304 and these contained a couple of large specimens of Milkwood trees (*Sideroxylon inermeis*) intermingled with *Searsia* sp. Shrubs which make up thicket areas. In the grazed open area which corresponds with the mapped EFZ, the dominant plant species are numerous bloodlilies (*Haemanthus sanguineus*), *Stenotaphrum secundatum* (Buffalo Grass), *Mesembryanthemum* spp. (ice plants), *Romulea* spp. (Froetangs), *Carprobrotus* sp., *Searsia crenata* (Dunekraibessie), *Salvia aurea* (brown sage), and *Massonia longipes* (coastal hedgehog lily).

While these species are typically associated with coastal, sandy habitats, they are not strictly associated with estuarine systems including the upper extent of the tidal zone. Furthermore, no estuarine species from any of the tidal habitats including saltmarsh or supra-tidal vegetation were identified at the site. These species would typically include rushes and sedges such as *Juncus kraussii*, *Cyperus laevigatus*, or *Phragmites australis*.

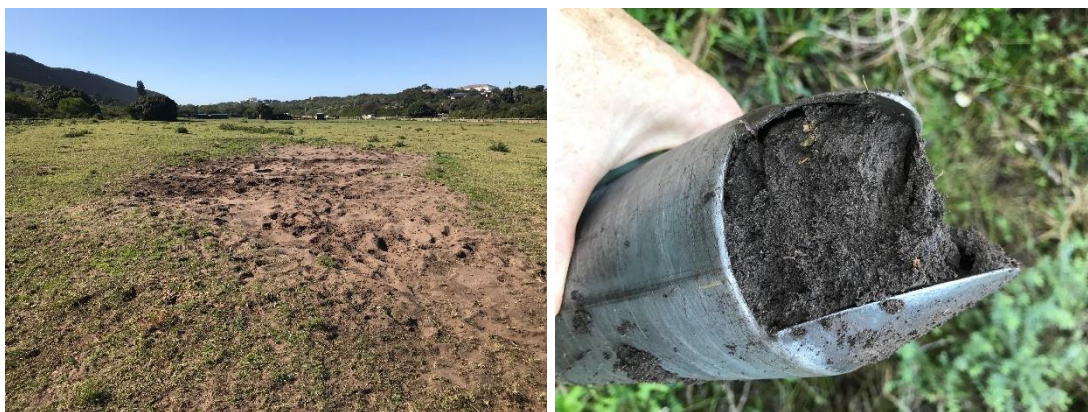
Figure 11. Sandy soils present at the site with no indicators of permanent or seasonal saturation.

Soil augering at the site indicated deep, sandy, fairly well drained soil with no textural change at 50 cm which could promote the development of wetland habitat (Figure 11). This is consistent with the mapped soil type in the area which is described as soils with limited pedological development (young soils with minimal organic matter), and a low clay content (< 15%).

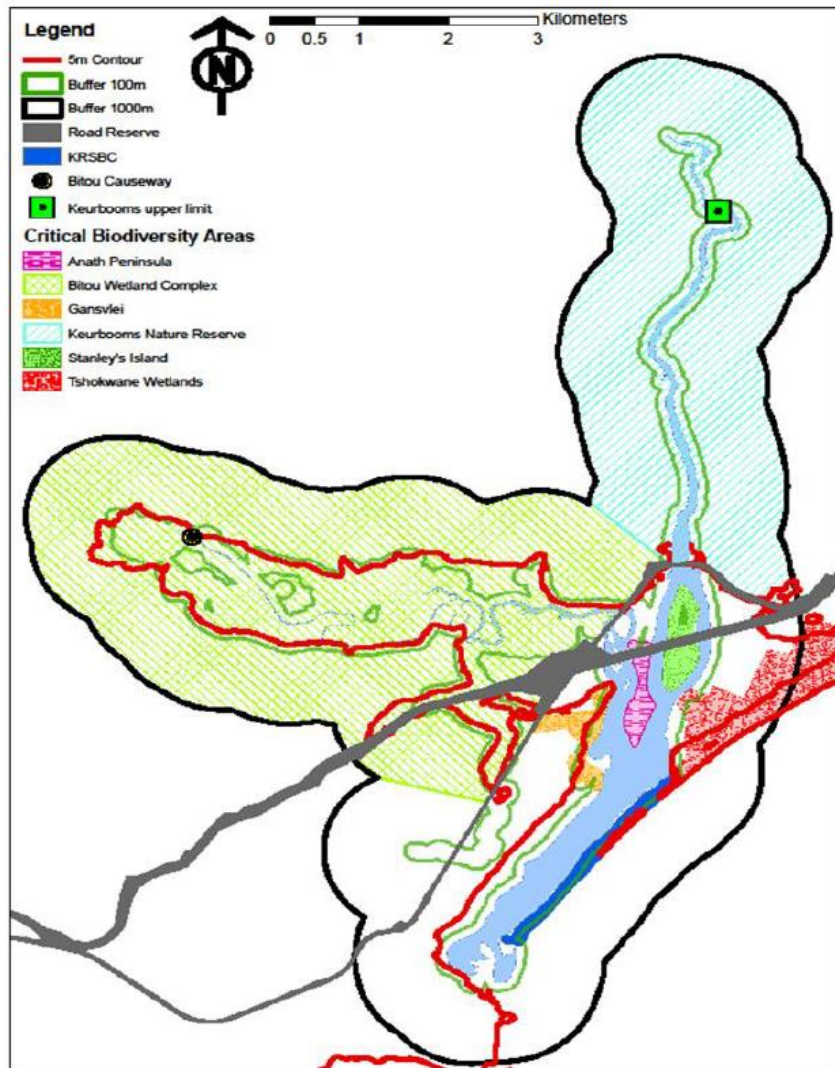
Figure 12. Mapped geographical boundaries, buffer zones, and Critical Biodiversity Areas of the Keurbooms-Bitou system (Estuarine Management Plan, 2018).

Findings that the site is largely terrestrial are consistent with the spatial assessment provided in the Keurbooms-Bitou Estuary Management Plan (K-BEMP; Figure 12). This figure excludes the floodplain area from the 1000 m buffer around the Keurbooms-Bitou estuary. The EFZ as defined by the 2014 EIA Regulations (GNR985) under the NEMA as “*the area in and around an estuary which includes the open water area, estuarine habitat (such as sand and mudflats, rock and plant communities) and the surrounding floodplain area...*”.
