Freshwater Assessment – Plettenberg Bay Country Club, Western Cape.

DRAFT FINAL REPORT

Confluent Environmental

March 2023

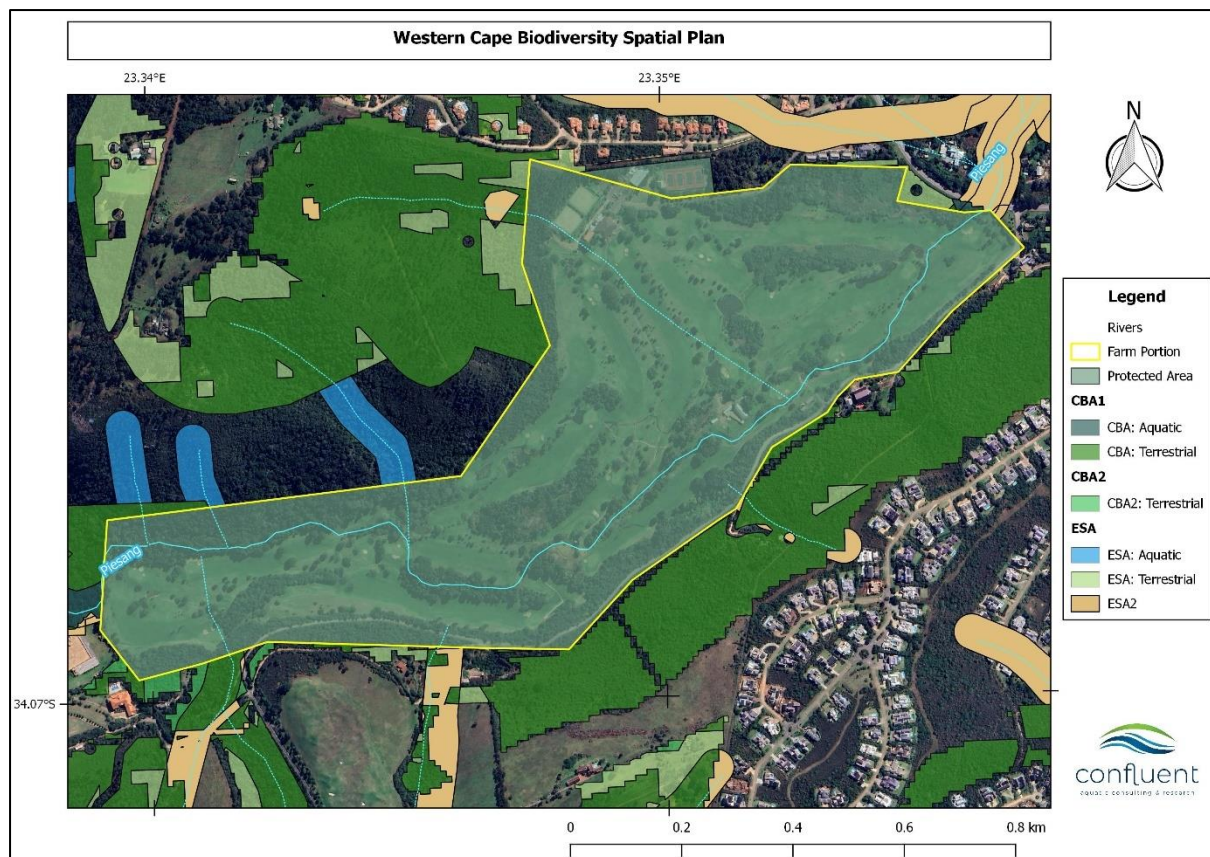
According to the Bitou WCBSP the entire golf course falls within a protected area known as the Plettenberg Bay Country Club Private Nature Reserve (Figure 3).

Figure 3: Map of the golf course in relation to the Western Cape Biodiversity Spatial Plan (WCBS).

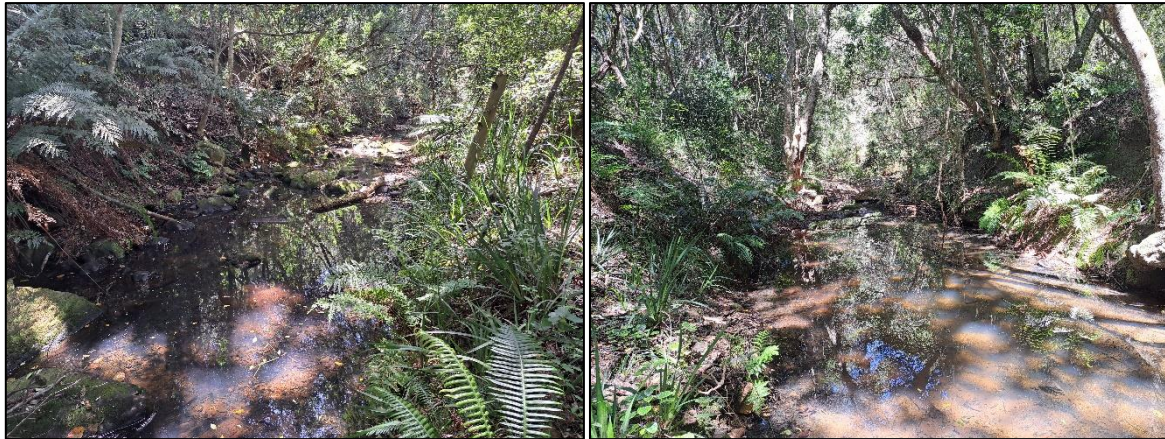
Figure 4: Photographs of the Piesangs River downstream of the Roodefontein Dam, showing a dense riparian canopy and a mixed boulder and cobble river substrate.

The entire reach of the Piesang River below the Roodefontein Dam that flows through the golf course can be classified as a perennial river. At a landscape level, the river flows through a relatively broad valley and the river is characterised by an active channel, with clearly discernible bed and banks. The geomorphological zonation is Upper Foothill, and is characterised by a moderately steep, cobble-bed or mixed bedrock-cobble bed channel, with plane bed, pool-riffle or pool-rapid reach types (see Figure 4). The more undisturbed sections of the river (immediately below the Roodefontein dam) are well shaded by a dense riparian zone comprising of tall indigenous trees. As the river flows through the golf course, the riparian zone becomes far more diminished and is also absent along some stretches.

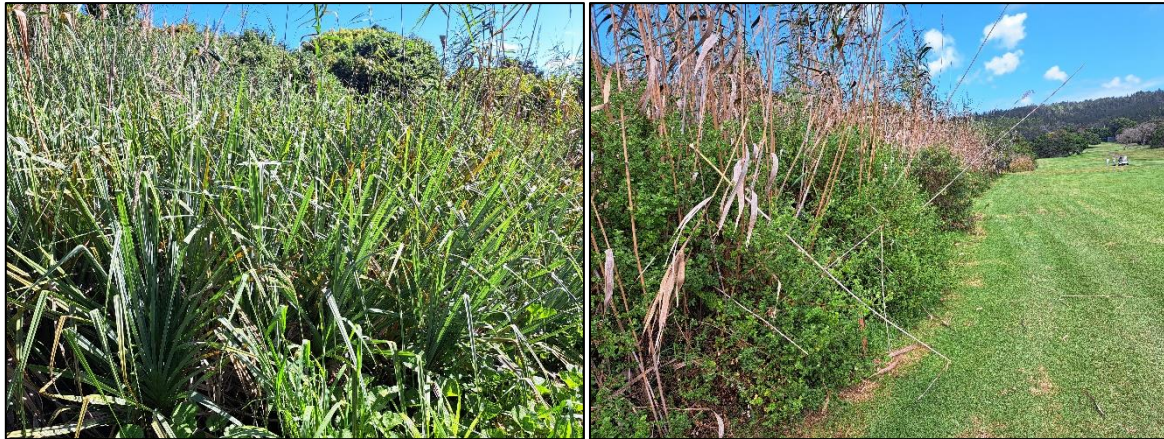
Figure 7: Photographs illustrating the dense wetland vegetation in the eastern-most remnant of the wetland seep.

In addition, vegetation in the eastern most remnant wetland area is encroaching onto the fairway of the 4th hole (see Figure 7) and needs to be controlled.

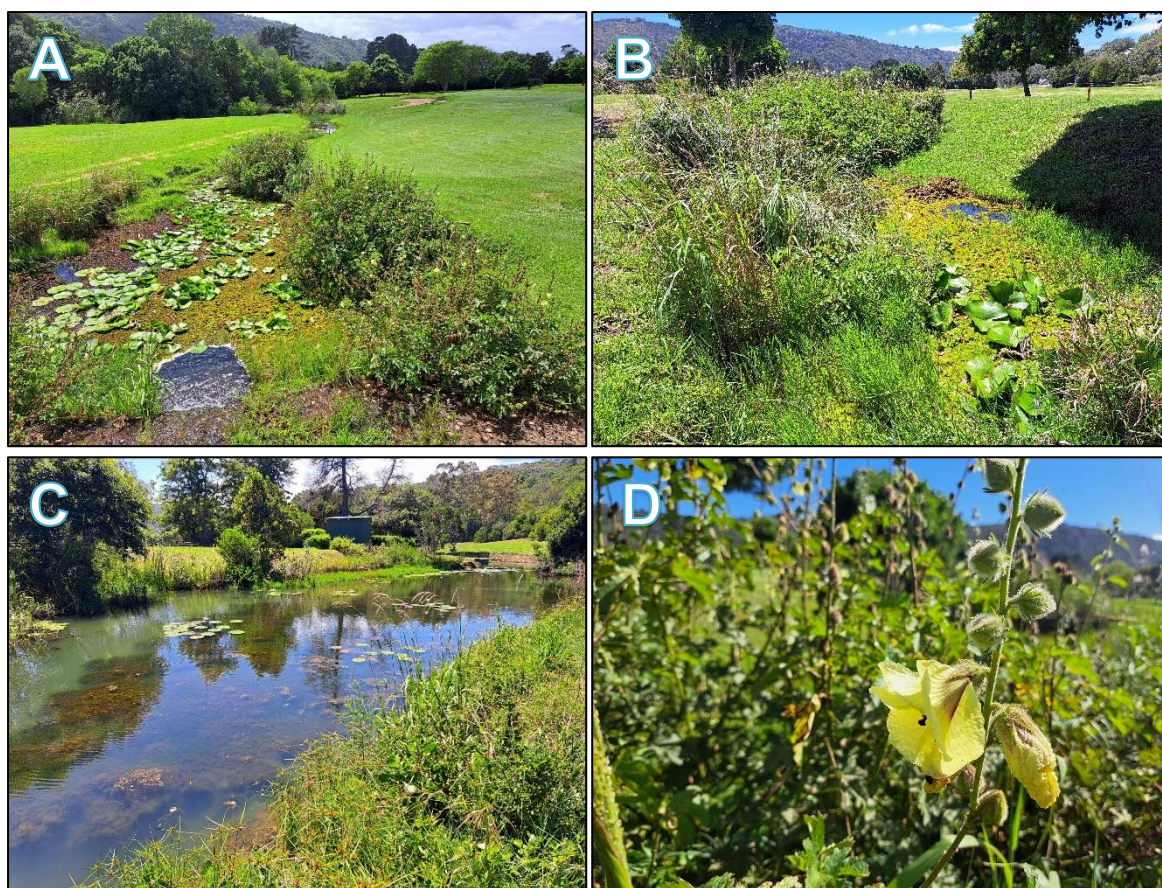
The most serious impacts on the Piesang River are related to the regulation of flow caused by the Roodefontein Dam and the historical establishment of the golf course itself (Table 1). Below the dam, the river initially runs through a section of indigenous vegetation and shows geomorphological characteristics typical of an Upper Foothills system, comprising of a relatively steep system with a cobble and boulder substrate. The river is shaded by a dense riparian canopy and instream emergent or aquatic vegetation is negligible. Once the river enters the golf course it becomes distinctly narrower, with steeper, higher banks, mostly grassed with kikuyu. The dense riparian canopy has been mostly removed along most of the length of the river through the golf course. Increased sunlight, together with modifications to the river substrate (which is more dominated by sediment as opposed to cobbles and boulders) and flow regime (i.e. reduced frequency and magnitude of flood events) has led to establishment of abundant instream vegetation (e.g. most notably *Typha capensis* as well as other sedges and grasses) which chokes long lengths of the river. The invasive water fern, *Salvinia molesta* was abundant throughout the river reach. A small instream dam is also located in the river which is used to abstract water for irrigation of the golf course. Remaining stretches of riparian vegetation are comprised of a mixture indigenous and alien vegetation (including Blackwood – *Acacia melanoxylon*, Black Wattle – *Acacia mearnsii*, Brazilian Pepper Tree - *Schinus terebinthifolia*). In summary a large loss of natural habitat, biota and basic ecosystem functions has occurred in the lower reaches of the Piesangs River and the PES is therefore **D, Largely Modified**.

Figure 8: Photographs illustrating impacts on the lower reaches of the Piesangs River, including removal of the riparian zone, dense growth of instream aquatic vegetation (A and B), a small instream dam used for irrigation of the golf course (C) and the exotic *Hibiscus diversifolius* which was relatively abundant along the banks (D).

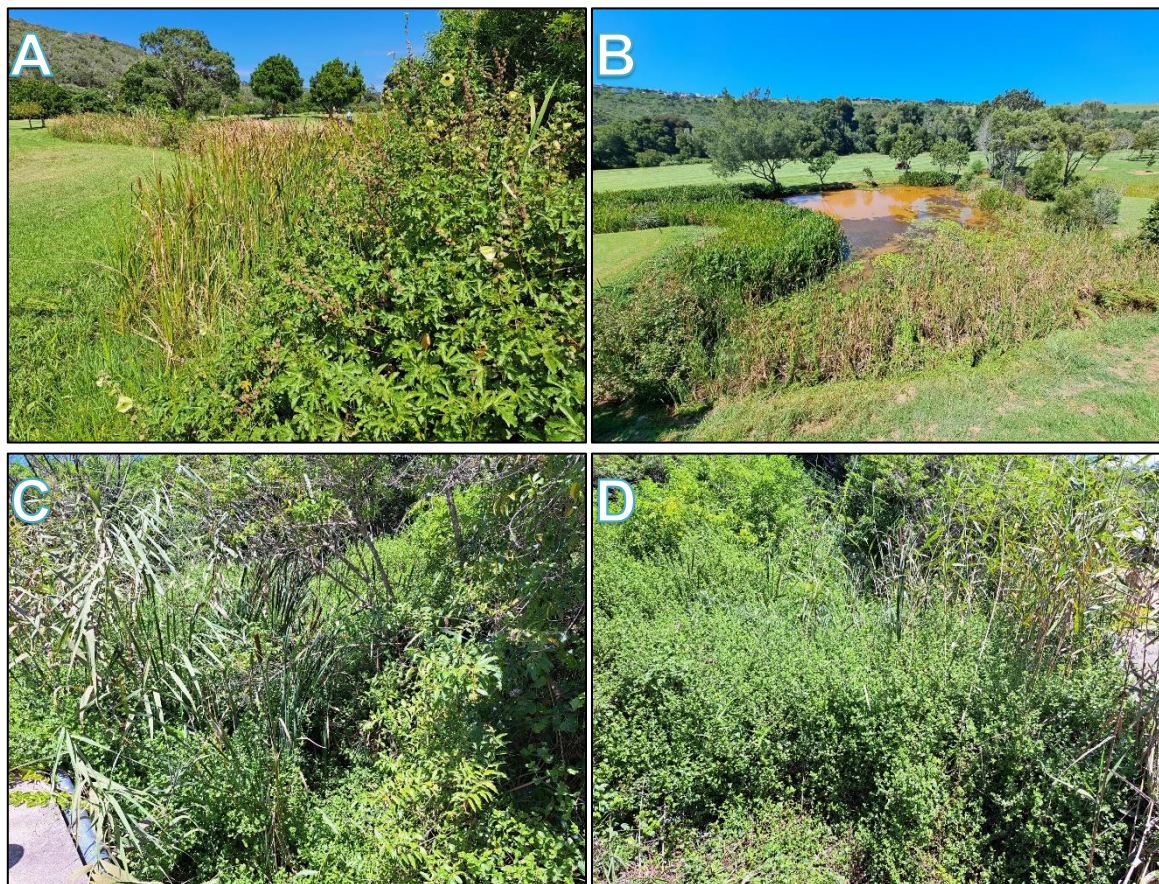
Water features and lower sections of the Piesang River have become heavily encroached with instream aquatic vegetation, most notably *Typha capensis* (Cape Bulrush). Nuisance growth of indigenous aquatic vegetation (such as bulrush) and other aquatic vegetation often needs to be managed in rivers where hydrological flows have been regulated by dams and high abstraction rates, which have the effect of reducing the magnitude and frequency of natural control measures such as floods. Removal of riparian zone results in higher light exposure of the channel which further stimulates growth of instream vegetation. Lack of grazing by large mammals and elevated supply of nutrients caused by use of fertilisers further leads to the encroachment of vegetation in watercourses. This vegetation needs to be routinely cut back and/or removed in order to facilitate improved drainage through the golf course and the river.

Figure 10: Photographs showing dense beds of *T. capensis* choking the Piesang River (A); dense reed beds in an artificial water feature on the golf course (B); and dense vegetation in the culvert below the Piesang River Valley Road obscuring the view of the channel (C and D).

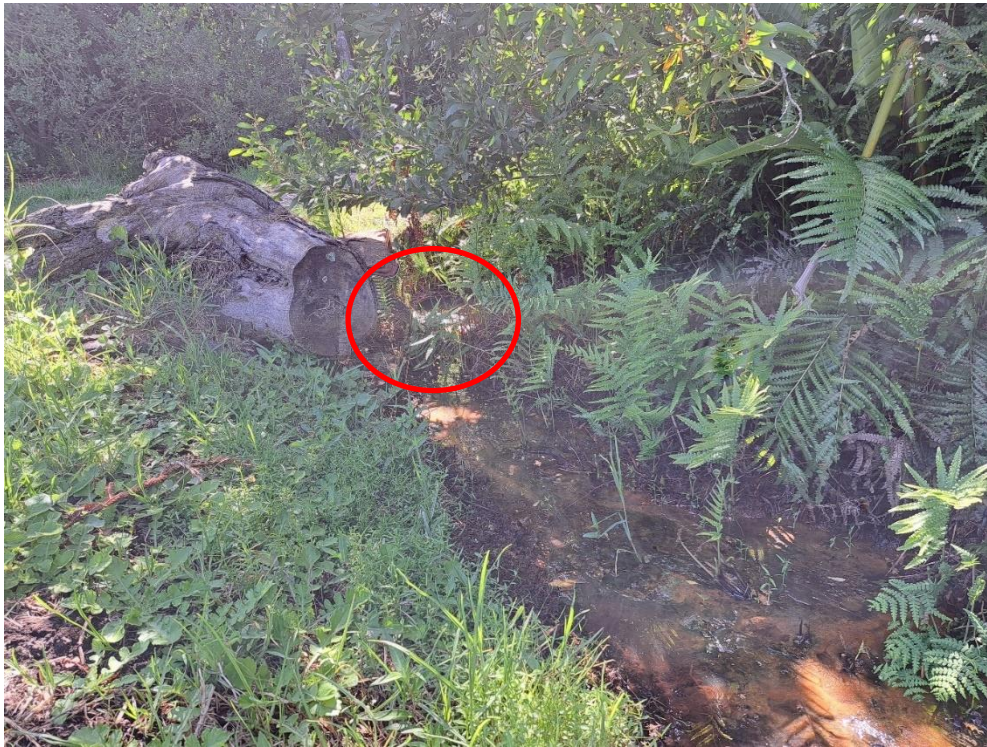
Some culverts and overflow pipes (that discharge water from the artificial water features) along the artificial drainage channel system are undersized and blocked, leading to localised flooding during heavy rainfall events (Figure 11). These culverts need to be enlarged to facilitate improved drainage through the channel (Figure 11). Main risks associated with replacing

culverts are sedimentation of downstream habitats and disturbance to the bed and banks which could lead to erosion.

Figure 11: Photograph of the western-most culvert blocked by vegetation and sediment.

- The activity is applicable to all culverts associated with artificial water features and drainage channels on the golf course.
- No culverts will be replaced within the Piesangs River.
- Replacement of culverts must take place during the drier season (May to July).

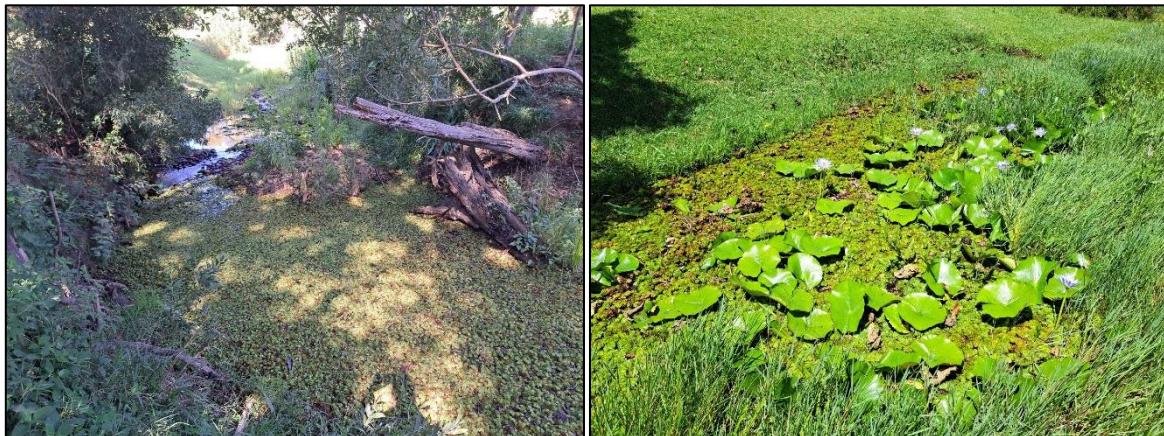
Salvinia molesta (Kariba Weed) is an aquatic, mat-forming, free-floating fern with horizontal stems up to 25cm long is abundant throughout all watercourses (including dams and the Piesang River). It can form dense mats up to 50 cm thick which can completely cover the water surface. The mats clog watercourses and irrigation equipment and reduce waterflow. The mats also reduce light penetration, reduce oxygen levels and result in poor water quality and threaten indigenous aquatic plant and animal life. It is classified as a Category 1 NEMBA Category 1b weed and the PBCC is therefore obligated to attempt to control the weed as far as possible. The release of the salvinia weevil (*Cyrtobagous salviniae*) has brought this weed under full biological control throughout most of South Africa. However, the weed continues to persist in cooler temperate coastal zones along the Southern and Western Cape due to the agent's sensitivity to cooler temperatures.

Figure 12: Photographs illustrating dense mats of *S. molesta* in the Piesangs River.

- The weed can be removed by any means (hand or excavator) from artificial water courses and by hand from the Piesangs River.
- Biocontrol using the *C. salviniae* biocontrol agent is recommended. Once an assessment of the estimated biomass of the weed has been undertaken, the Department of Forestry Fisheries and Environment (DFFE) must be contacted to arrange release of the biocontrol agent (contact Debbie Muir: dsharp@dffe.gov.za).
- Following the release of the biocontrol, routine monitoring must be undertaken to estimate the presence and absence, and numbers of the biocontrol agents to determine whether any supplemental release is required.
