PROPOSED RIVERBANK MAINTENANCE ON REMAINDER 1 of FARM 305 HANGLIP, PLETTENBERG BAY.

Estuarine and Plant Species – Specialist Assessment

Date: 18 April 2024

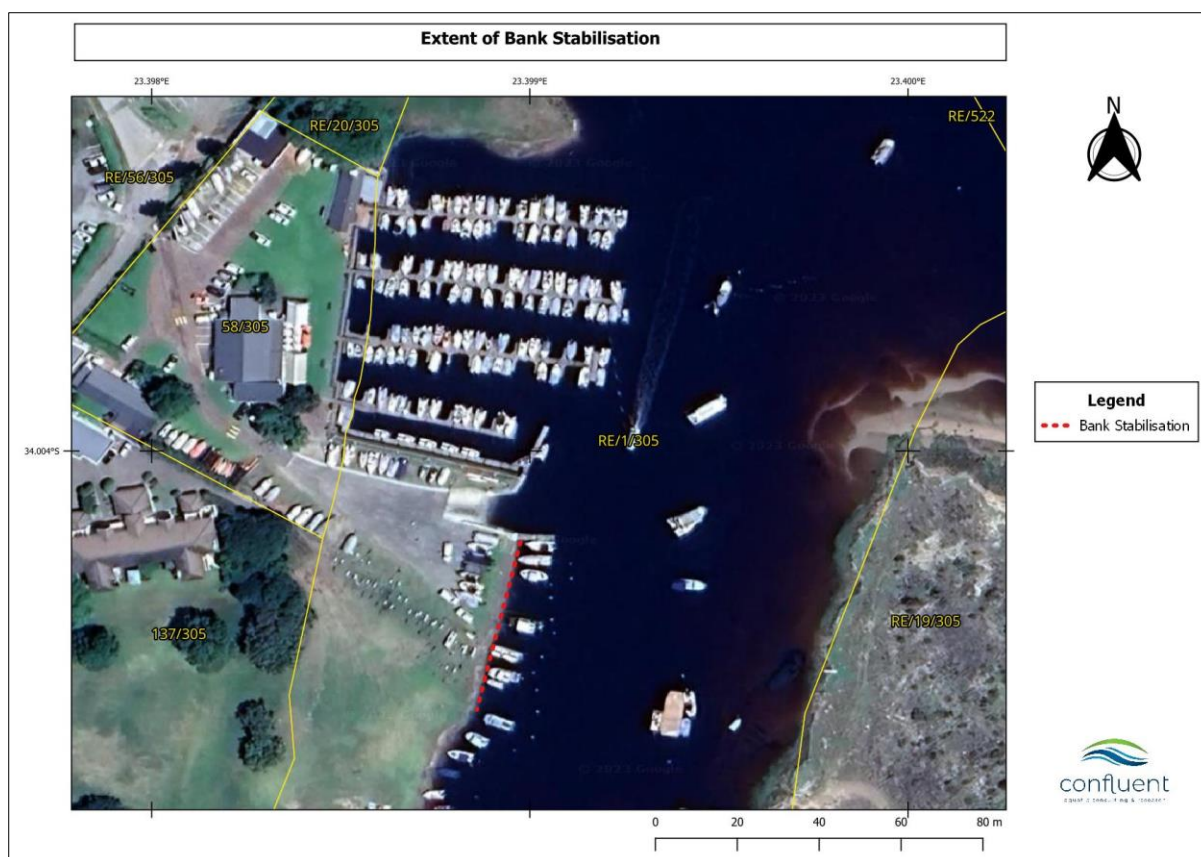
Figure 1: Map indicating the extent of the proposed bank stabilisation.

The PBAC is situated on the western bank of the Keurbooms Estuary (Figure 1). The proposed stabilisation will take place along an approximately 55 m stretch of the riverbank and associated intertidal zone. Boats are moored to poles anchored into the bank of the river. The Keurbooms Estuary is prone to episodic flooding that has significant consequences for landowners and infrastructure. Floodwaters cause extensive erosion, particularly in the lower reaches of the estuary where extensive urbanisation and surface hardening has taken place and natural vegetation and riparian zones have been cleared to make way for residential developments and resorts (CAPE Estuaries Programme, 2010). In particular, the removal of riparian vegetation destabilises the bank, resulting in undercutting and ultimately collapse into the estuary. As such, various bank stabilisation interventions have been implemented along the banks of the estuary over time. These range from vertical retaining walls to sloping banks constructed from a reno mattress over lying a stepped sandbag foundation.

For all options, the stabilisation will be restricted to the steeply eroded section of the embankment and will stop at the point where the gradient of the embankment flattens out and is not actively eroding (*Figure 1* and *Figure 5*).

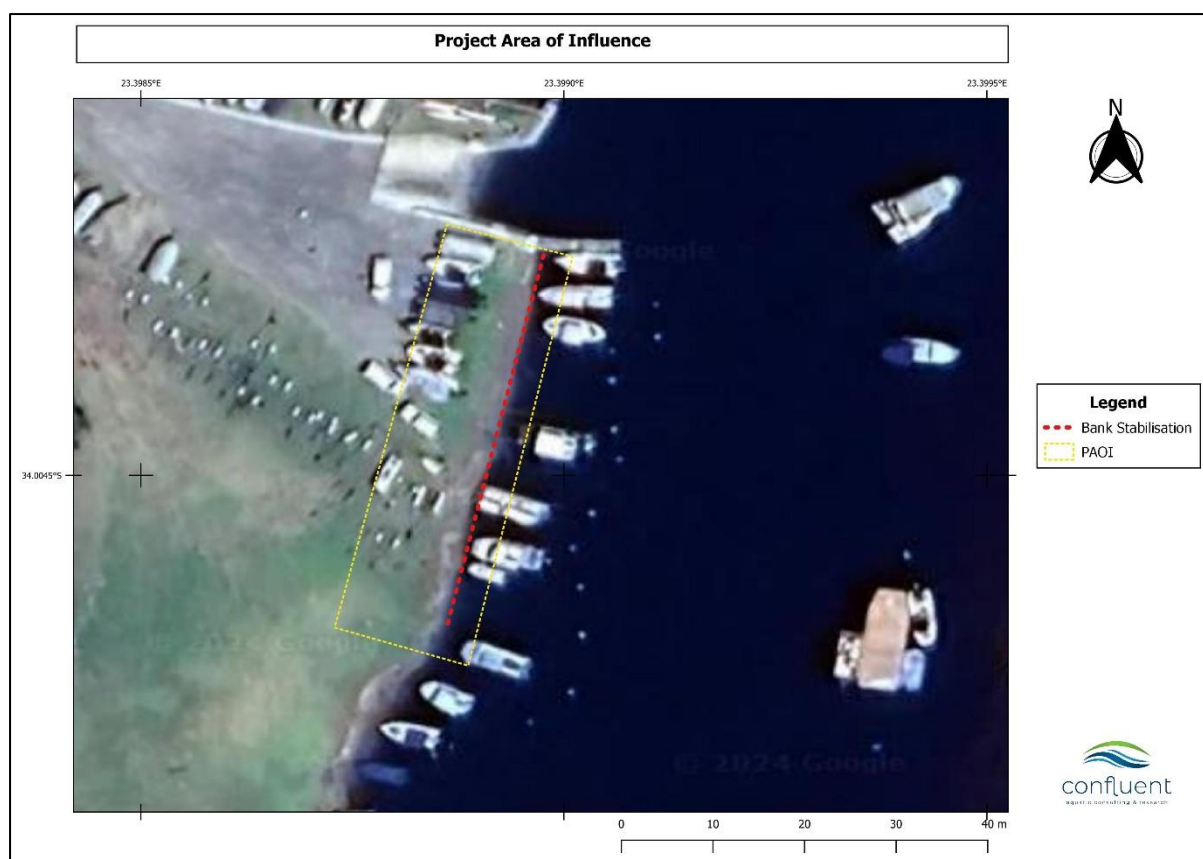
Figure 10: Map illustrating the extent of the streambank stabilisation and the associated PAOI.

The expectation of broader impacts occurring outside of the footprint of the streambank stabilisation structure is expected to be very low. Consequently, the PAOI is limited to an approximately 50 m length of the eroded bank of the estuary (where the bank stabilisation structure will be constructed) and, a distance of approximately 10 m inland from the banks and 5 m into the inter-tidal zone of the estuary (where habitat may be disturbed due to the construction activities and vehicles). The total surface area of the footprint of the PAOI is less than 1 000 m² (Figure 10).

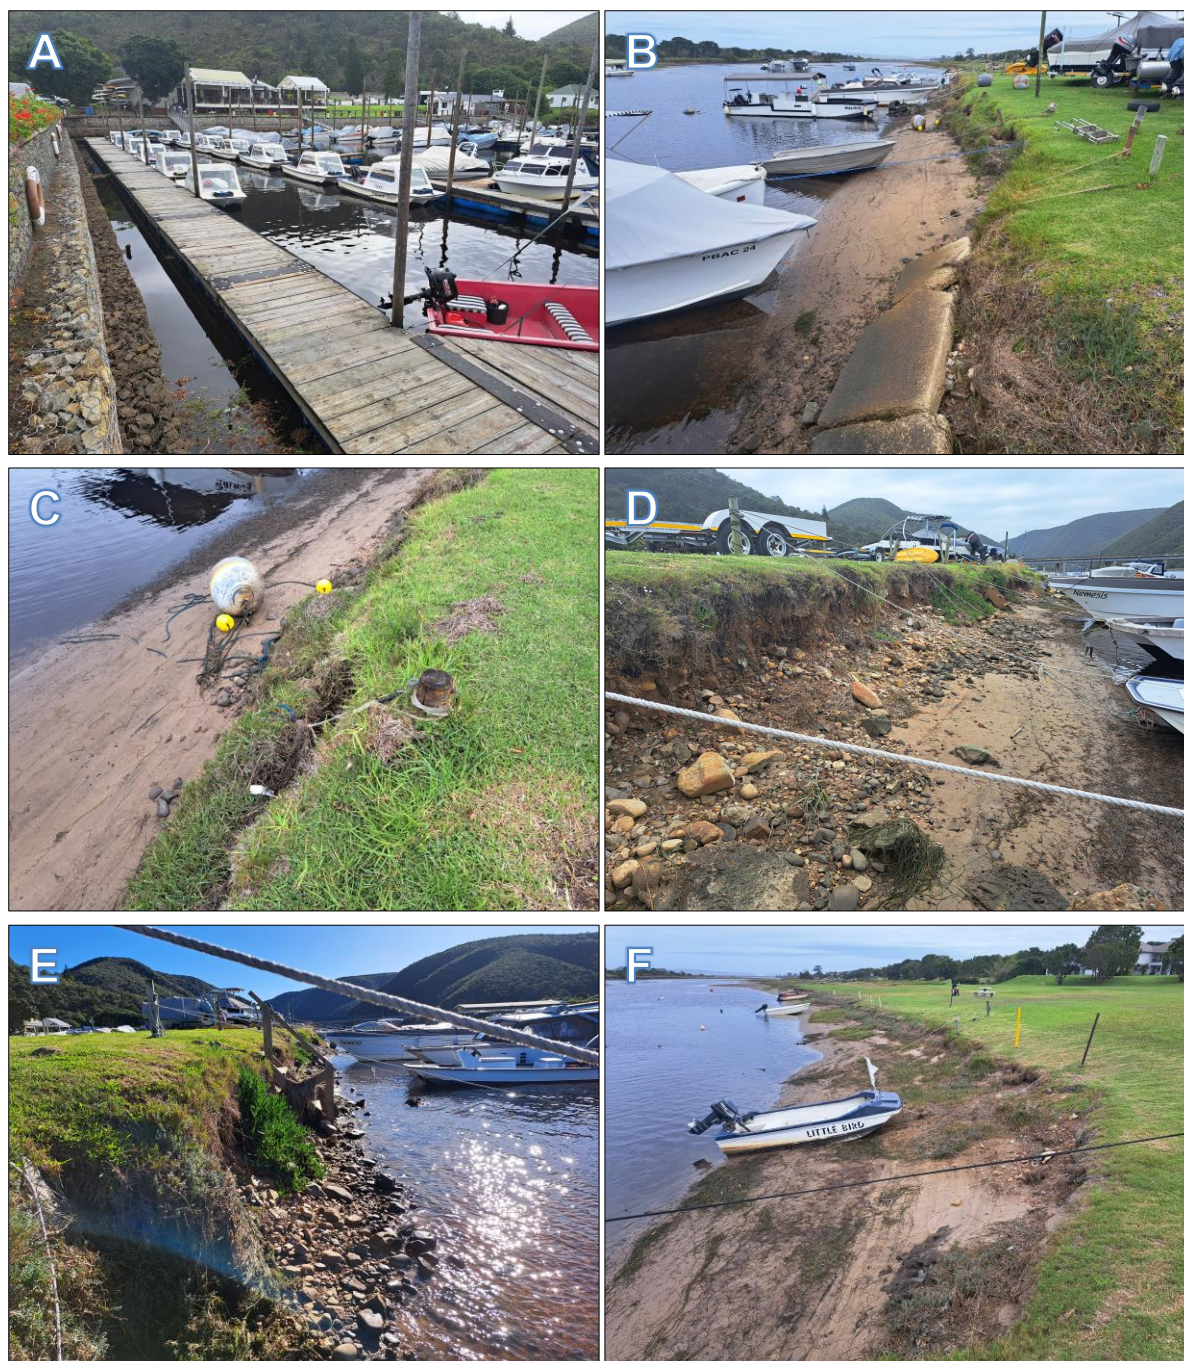
The PBAC consists of a small marina, slipway and wooden floating jetties to which numerous boats are moored. Almost the entire shoreline of the area comprising the marina has been stabilised with gabion basket structures (*Figure 11*). The site visit confirmed the presence of an approximate 55 m stretch of the estuary bank that is vertically incised (approx. 1.5 m high) and eroded and is actively slumping into the estuary. The most northern stretch is approximately 3 m from the edge a tarred parking area. The entire bank is devoid of any indigenous riparian vegetation and is covered by kikuyu lawn (*Cenchrus clandestinus*).

Figure 11: Photographs illustrating existing gabions and jetties at the PBAC (A); boats mooring along the eroded bank (B); actively eroding banks (C to E); and the estuary banks further downstream where erosion is not as severe (F).

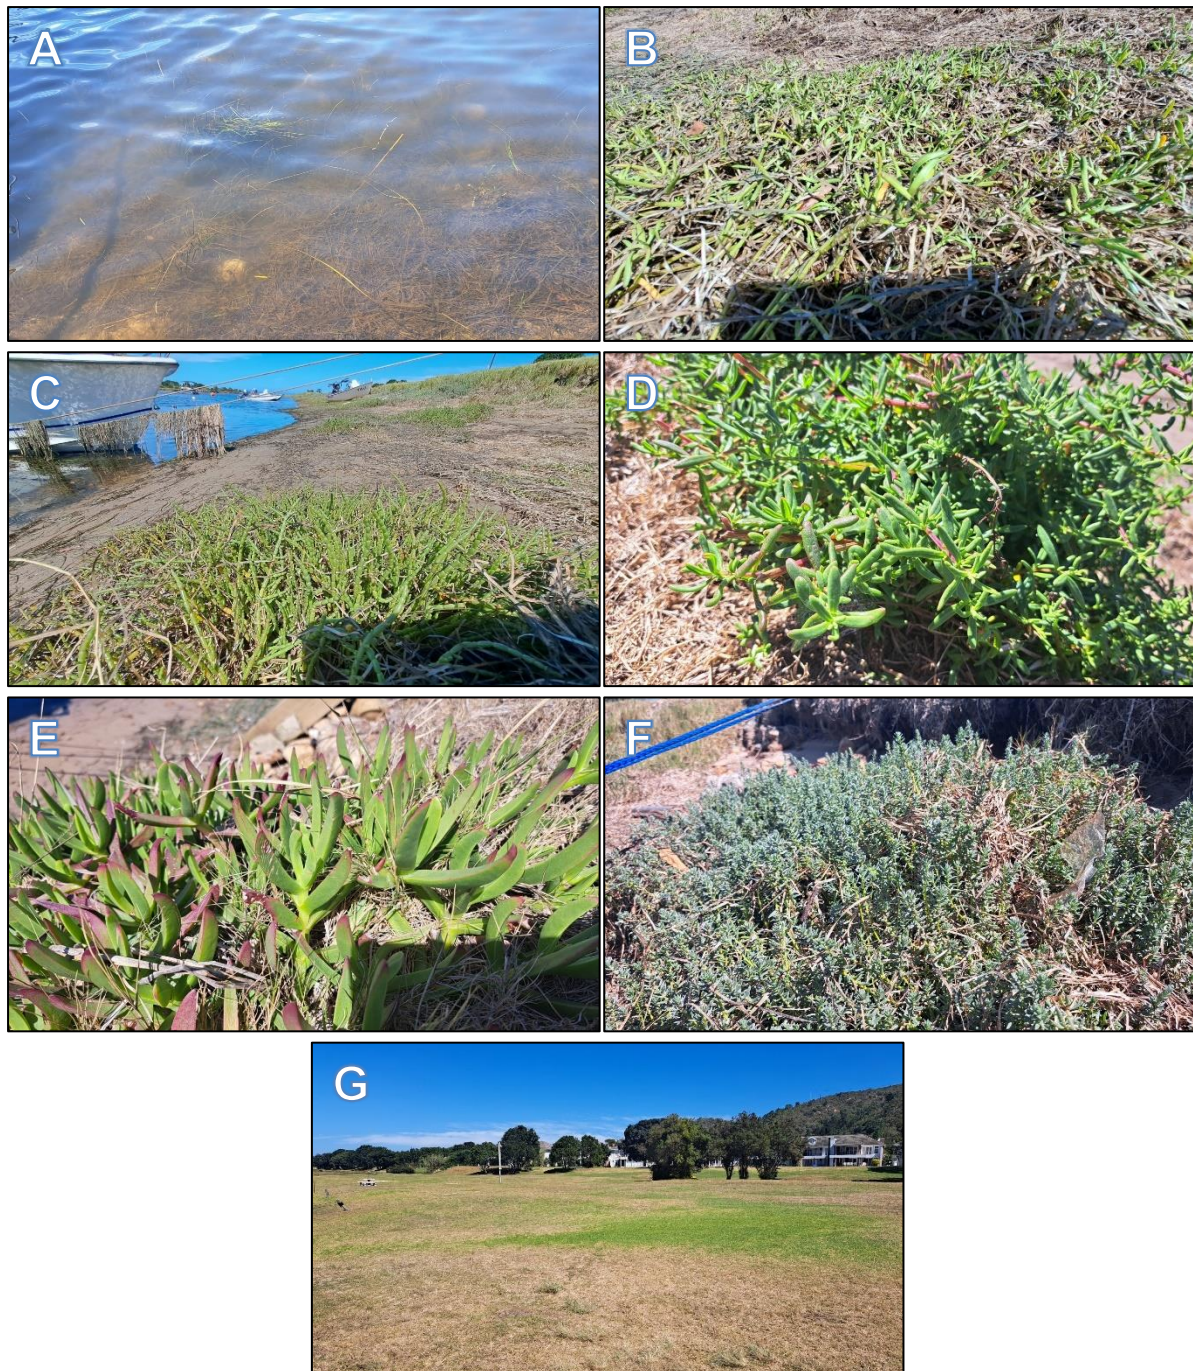
Figure 13: Plant species observed at the site, including *Z. capensis* (A) *Plantago carnosus* (B) *Salicornia* sp. (C) *Tetragonia fruticosa* (D) *Carpobrotus* sp. (E) *Chenolea diffusa* (F) and transformed terrestrial habitat adjacent to the bank of the estuary (G).

The terrestrial component of the PAOI consists of a large, open grass lawn comprised predominantly of a mixture of low growing grass species (invasive *Clandestinus cenchrus* and indigenous *Cynodon dactylon*). No trees or shrubs were present within or close proximity to the PAOI. The inter-tidal zone habitat is very narrow (exposed sand banks at low tide are less than 3 m in width) and is used to moor boats along the shoreline. Vegetation is limited, consisting of *Z. capensis* within the inundated subtidal zone of the estuary and isolated patches of salt marsh species along the outer edge of the inter-tidal zone (Figure 3). Other terrestrial/ estuarine species observed are illustrated in Figure 13. Apart from *Z. capensis* no other SCC were observed within the PAOI and are also deemed to have a very low probability of occurrence due to the complete transformation in natural terrestrial habitat that has occurred.

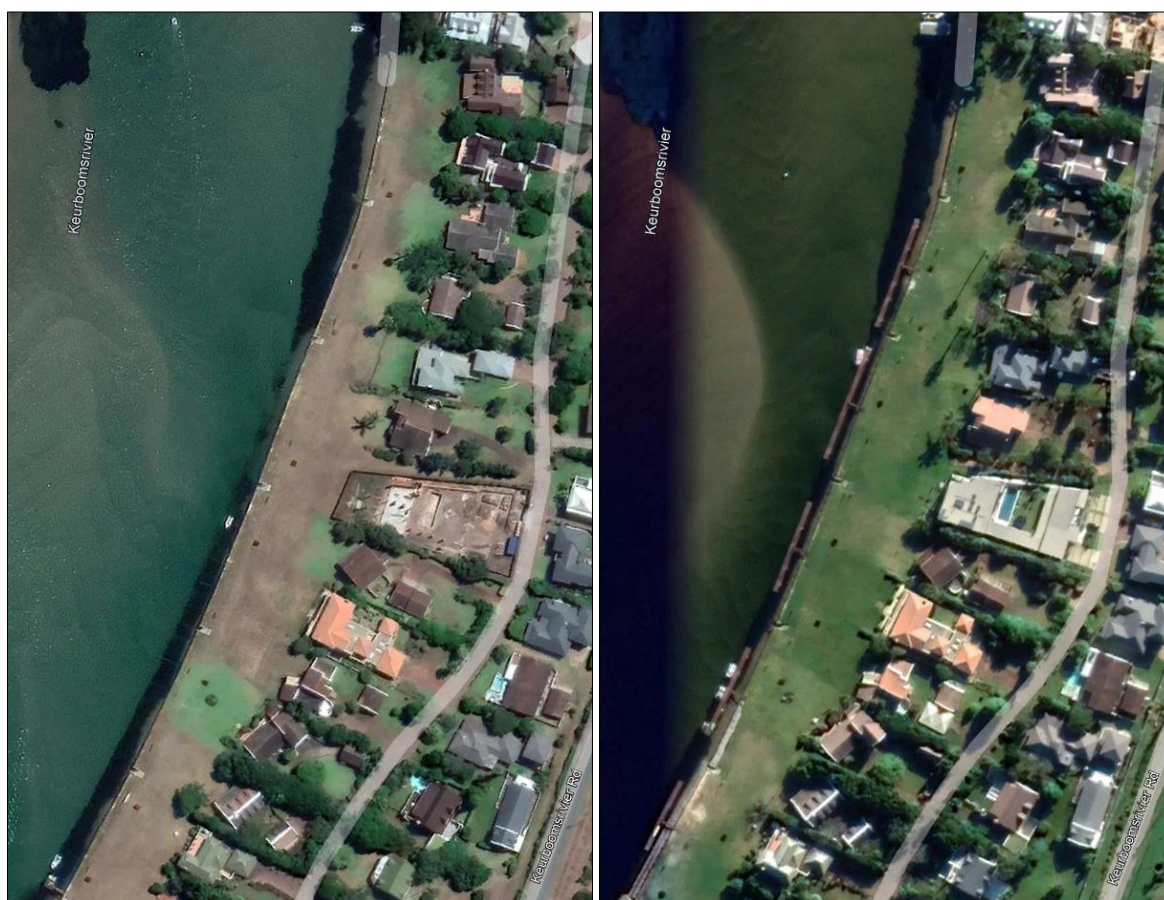
It is worth noting that similar bank stabilisation structures have been implemented at other locations along the estuary bank. This author has had experience with the San Marino Estate and the Silverstreams River Estate, both of which occur along the eastern bank of the estuary. In both these cases, a sloped reno mattress stabilisation structure, similar to Option 2 was implemented - in combination with the construction of floating jetties. In both cases, the reno mattress replaced a pre-existing vertical wooden bank stabilisation structure. The Silverstreams River Estate bank stabilisation commenced in the beginning of 2019 and was

completed in the same year. The bank stabilisation (and jetty construction) has not had a serious impact on *Z. capensis* beds which are still present post construction (*Figure 14*).

*Figure 14: Google Earth images showing *Z. capensis* beds pre (left) and post (right) construction of bank stabilisation and floating jetties along the eastern bank of the Keurbooms Estuary.*
