# Proposed Residential Development on Erven 7594, 2924 and 2925, Knysna, Western Cape.

Aquatic Biodiversity Site Sensitivity Verification and Compliance Statement

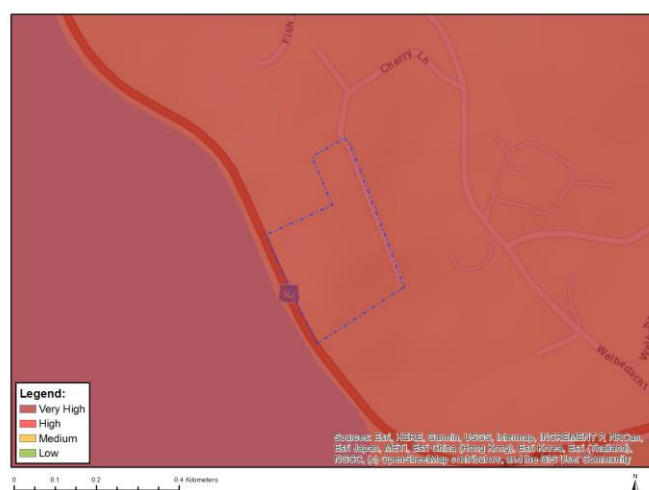
Figure 2: Results of the DFFE Screening Tool which indicate Very High Sensitivity of the Aquatic Biodiversity theme for the preferred development site on Erven 2924, 2925 and 7594.

According to the Department of Environment, Forestry and Fisheries (DFFE) screening tool, aquatic biodiversity at the site has a **Very High** sensitivity (Figure 2 **Error! Reference source not found.**). The sensitivity feature identified about the classification is:

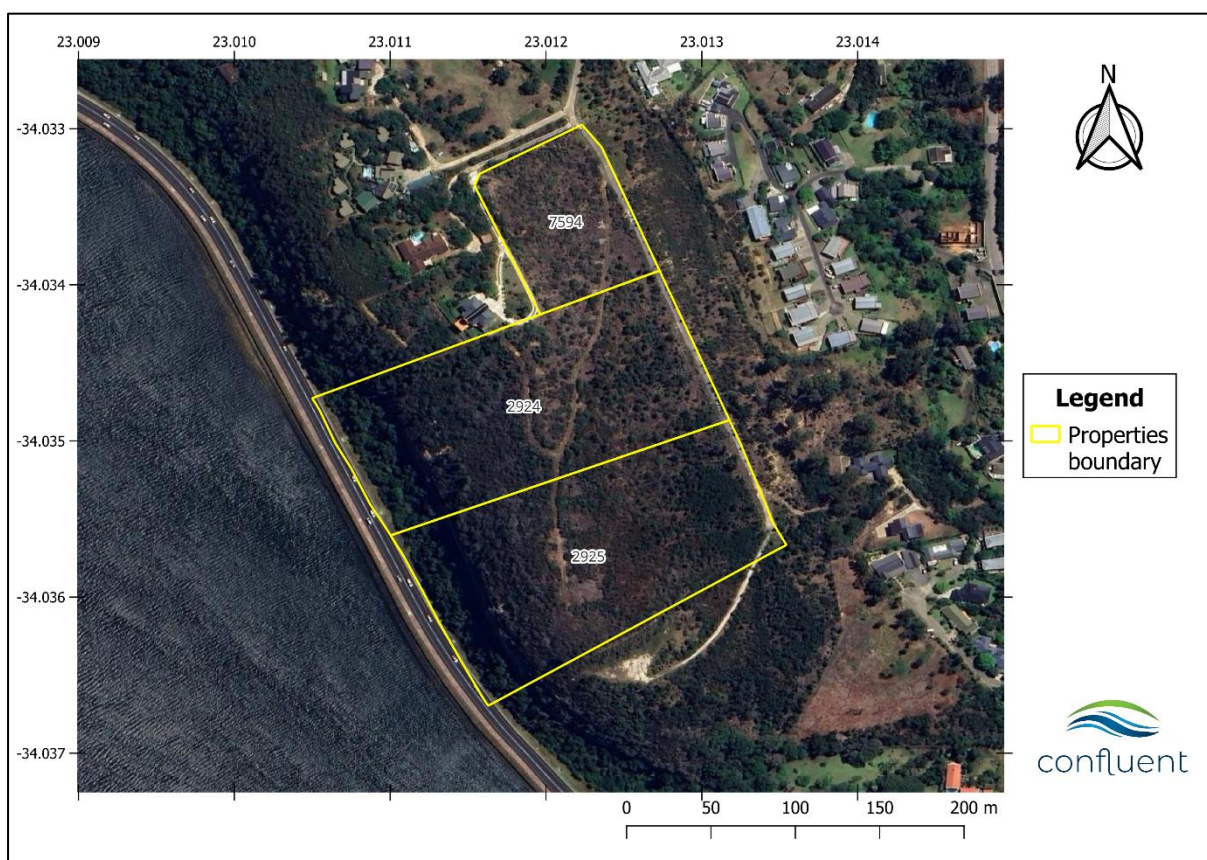
Figure 3: Erven 2924, 2925 and 7594 with access road.

Separate developments are proposed for each erf. On Erf 7594 a high-density residential development is proposed. On Erf 2924 one large single dwelling is proposed and on Erf 2925 a single dwelling is proposed. An existing access road, crossing all the erven can be seen in Figure 3

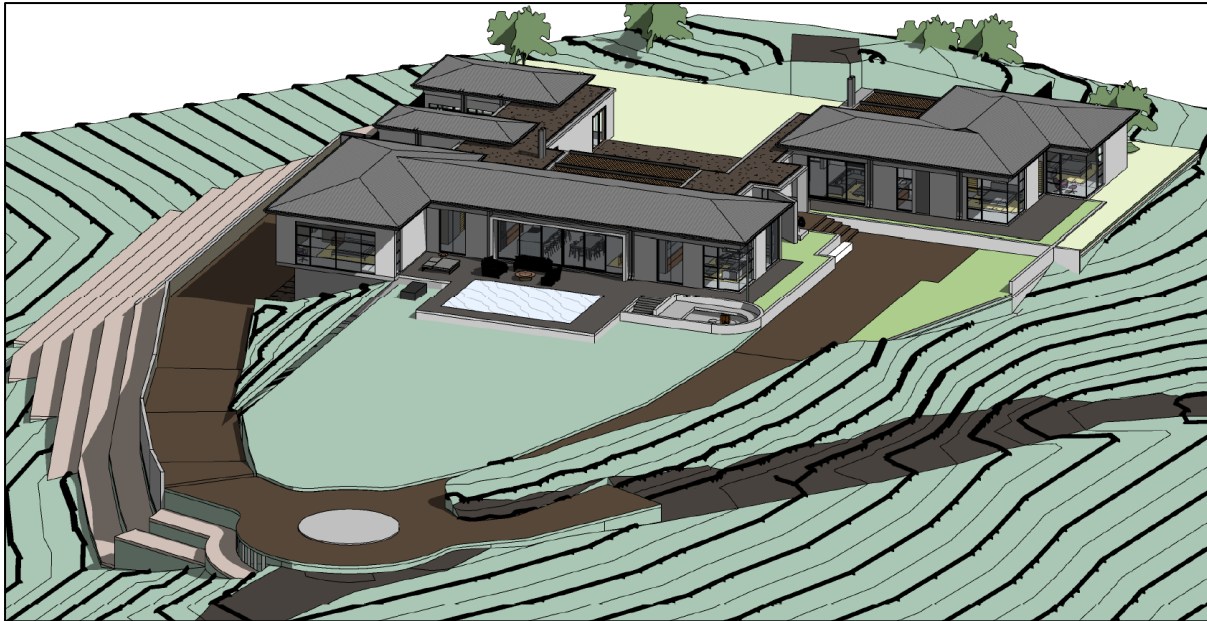
Figure 5: 3D model of the proposed dwelling on Erf 2924.

A single dwelling with a footprint of 789 m<sup>2</sup> as well as an access road and driveway with a footprint of 2329 m<sup>2</sup> is proposed to be developed on Erf 2924 (2.4 ha). The total development footprint includes fencing, a swimming pool, and cut and fill, covering a total of 10 450 square metres. A septic tank is also proposed for development, situated 5 m west of the main footprint (Figure 5 and Figure 6).

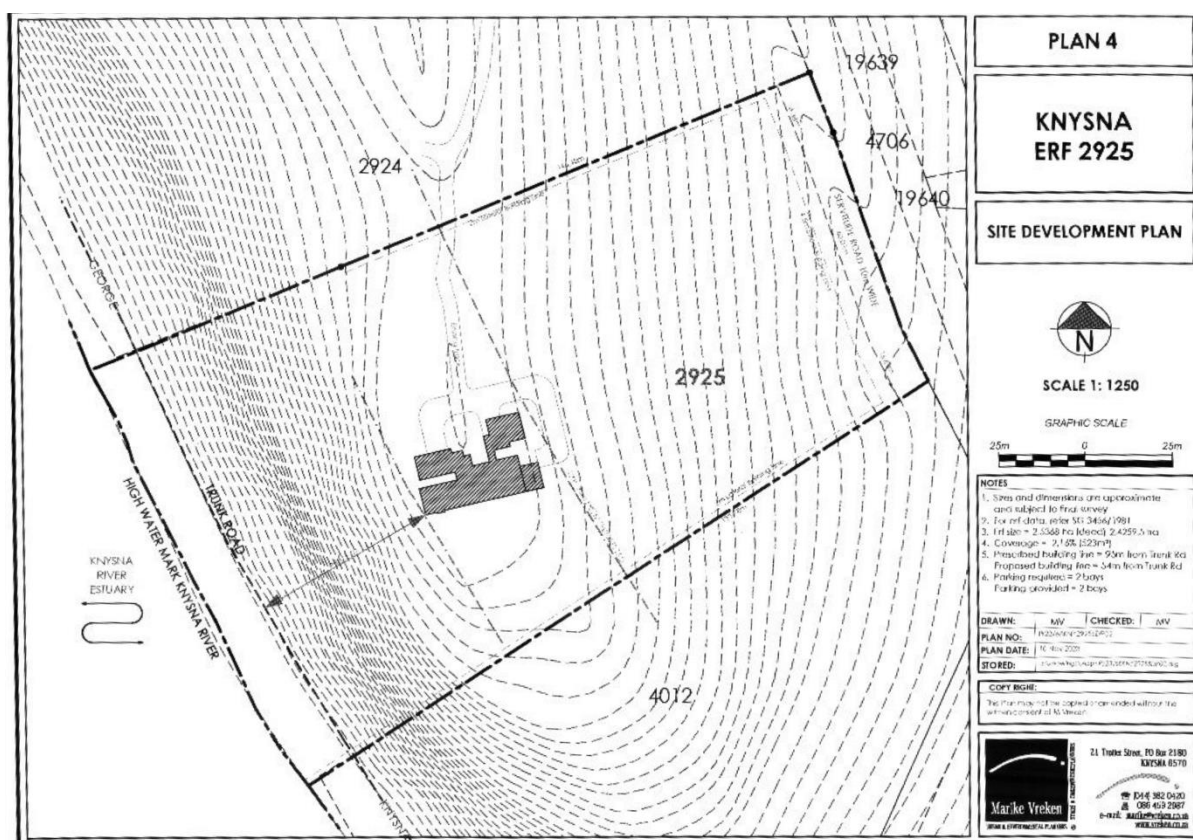
Figure 7: Proposed development plan for the single dwelling on Erf 2925

Erf 2925 (2.4 ha) would host a single dwelling. The exact size of the footprint has not been provided, but it is assumed to be around the same size as Erf 2924 also including an access road and a paved area (Figure ).

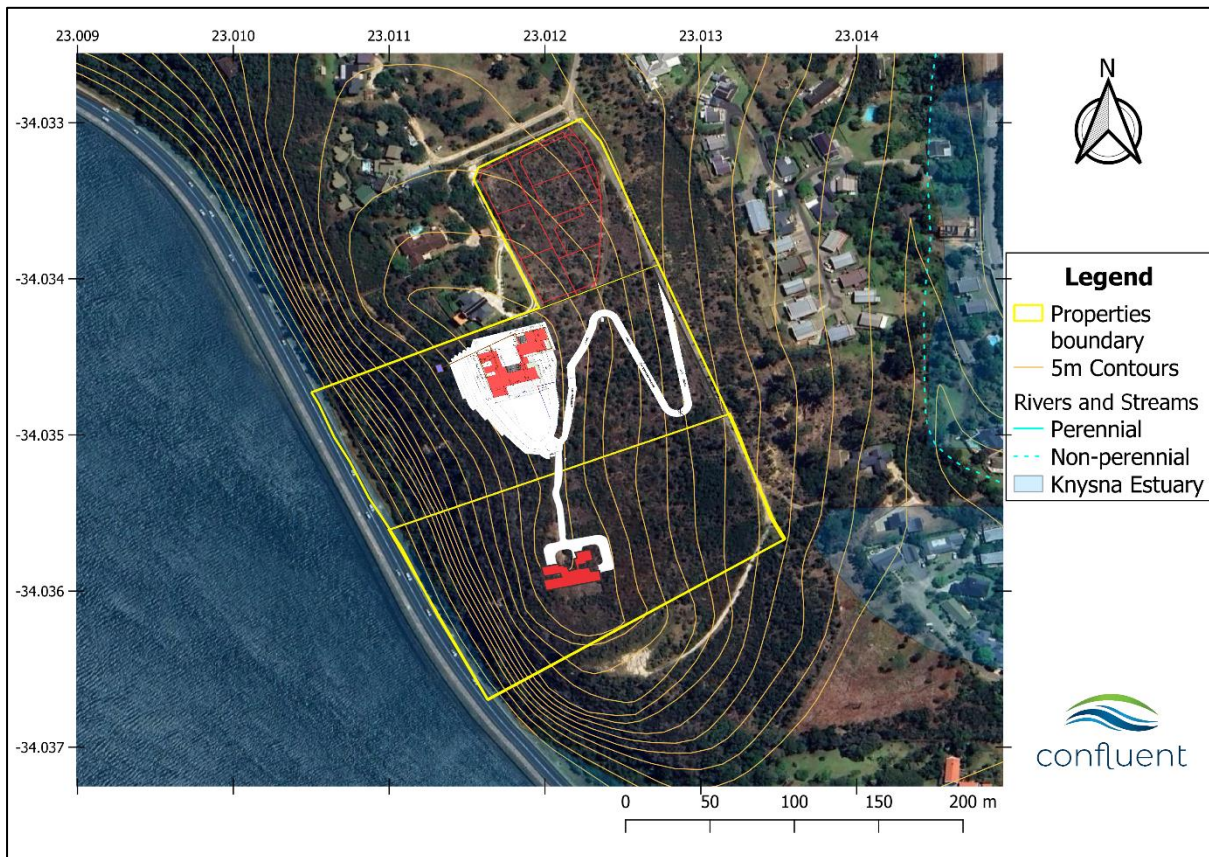
Figure 8: The proposed development sites in relation to mapped watercourses.

The mapped watercourses near the proposed development sites are one non-perennial drainage line approximately 121 m northeast of the proposed development sites and the Knysna Estuary south-west of the site with no wetland or streams mapped within any of the erven under assessment (Figure 8).

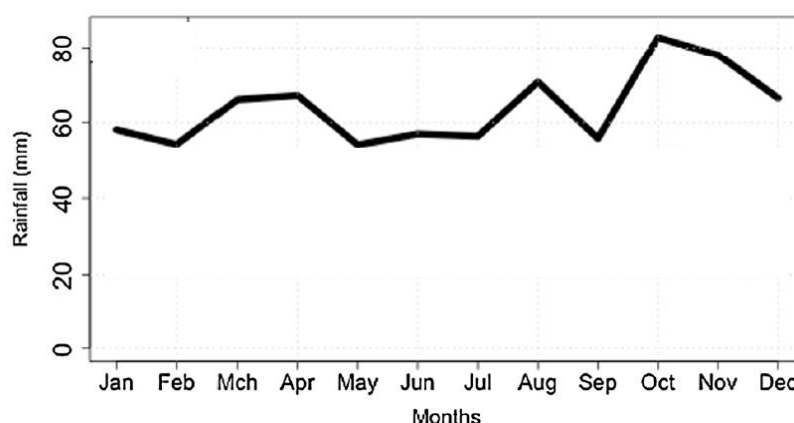
Figure 9. Area-averaged monthly rainfall for the coastal Southern Cape indicating peaks in Mar-Apr, Aug, and Oct. Data averaged between 1979 and 2011 (Engelbrecht et al., 2015).

Rainfall occurs year-round with seasonal peaks in spring and autumn (Figure 9).

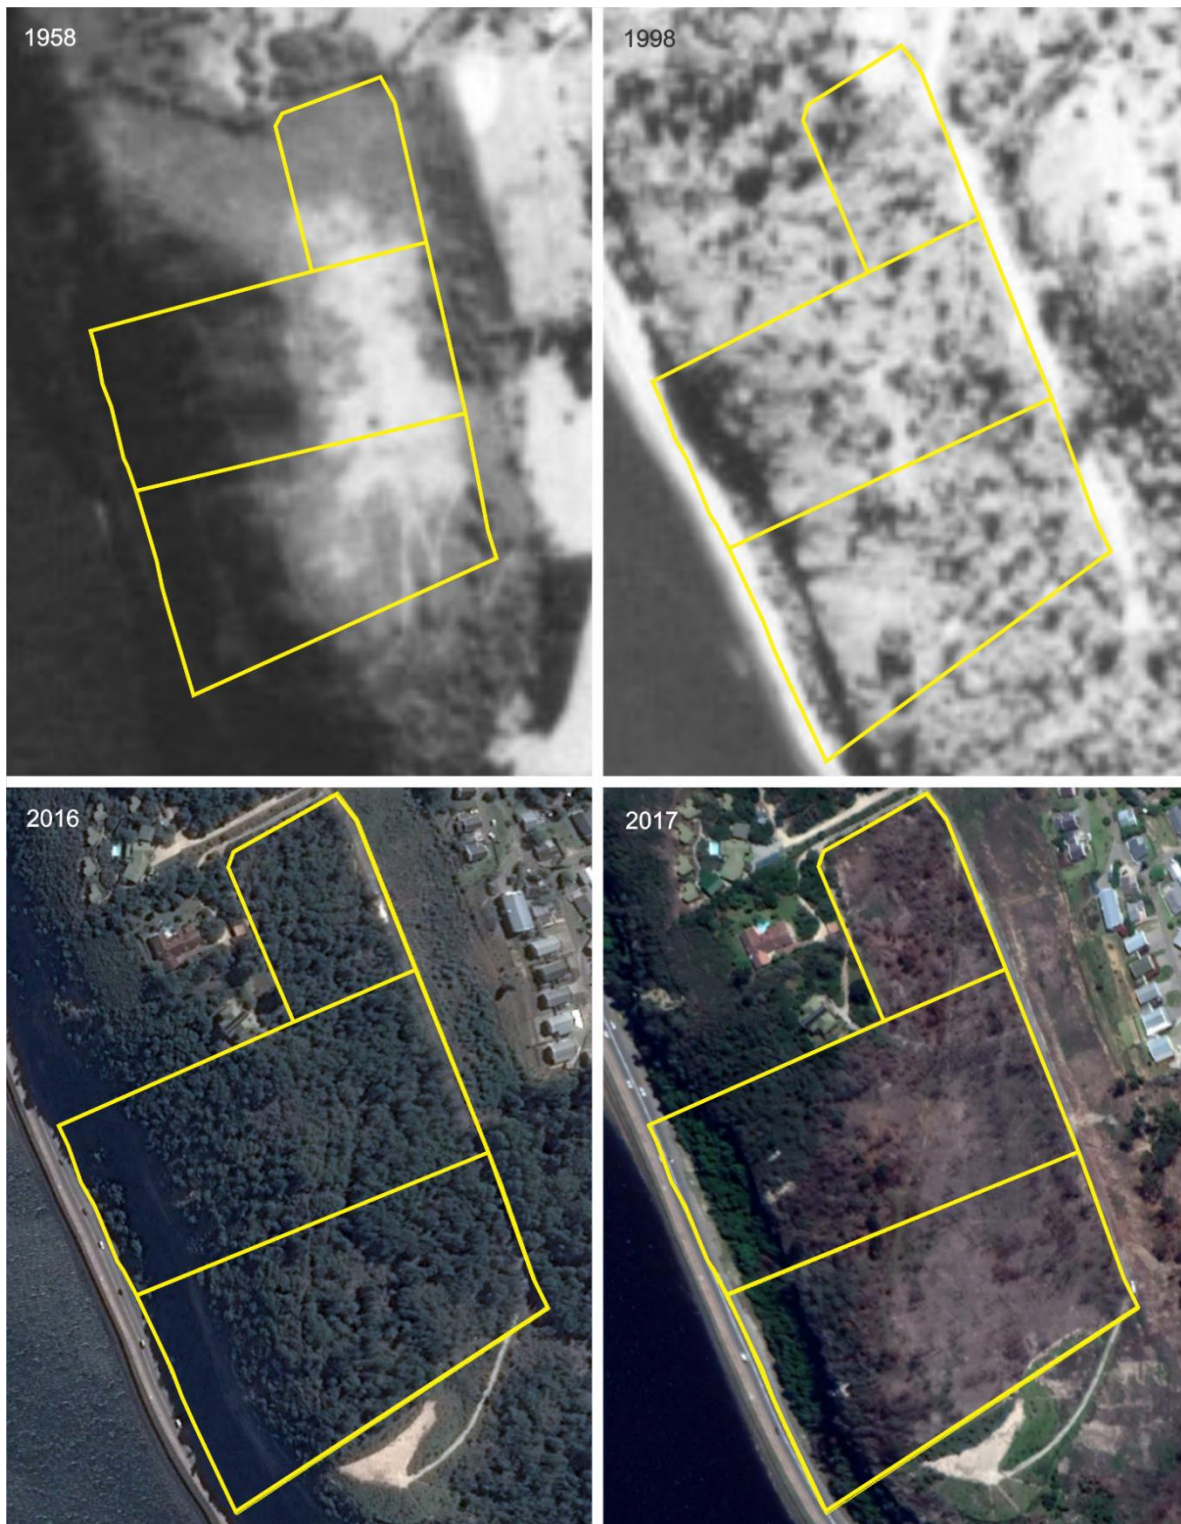
Figure 12. Historical photos showing Erven 2924, 2925 and 7594 through notable changes between 1958 and 2017 (CD:NGI & Google Earth imagery).

Historically Erven 2924, 2925 and 7594 have undergone no major anthropogenic changes throughout the past 66 years from 1958 to 2024. The properties seem to have been covered by alien vegetation at times in the past 66 years. The most notable disturbances on the properties were in 1958 and 2017. In 1958 the eastern part of the properties seemed to be cleared of vegetation and then recovered and revegetated in the years leading up to 1998. In 2017 the Knysna fires cleared almost the total of all three properties. The properties have since revegetated with areas dominated by alien vegetation (Figure 12). It is worth noting that the footprint of proposed dwellings on all three properties was completely burnt in the 2017 fires highlighting this factor as a significant risk that must be taken seriously and managed to reduce risks if the sites are to be developed.

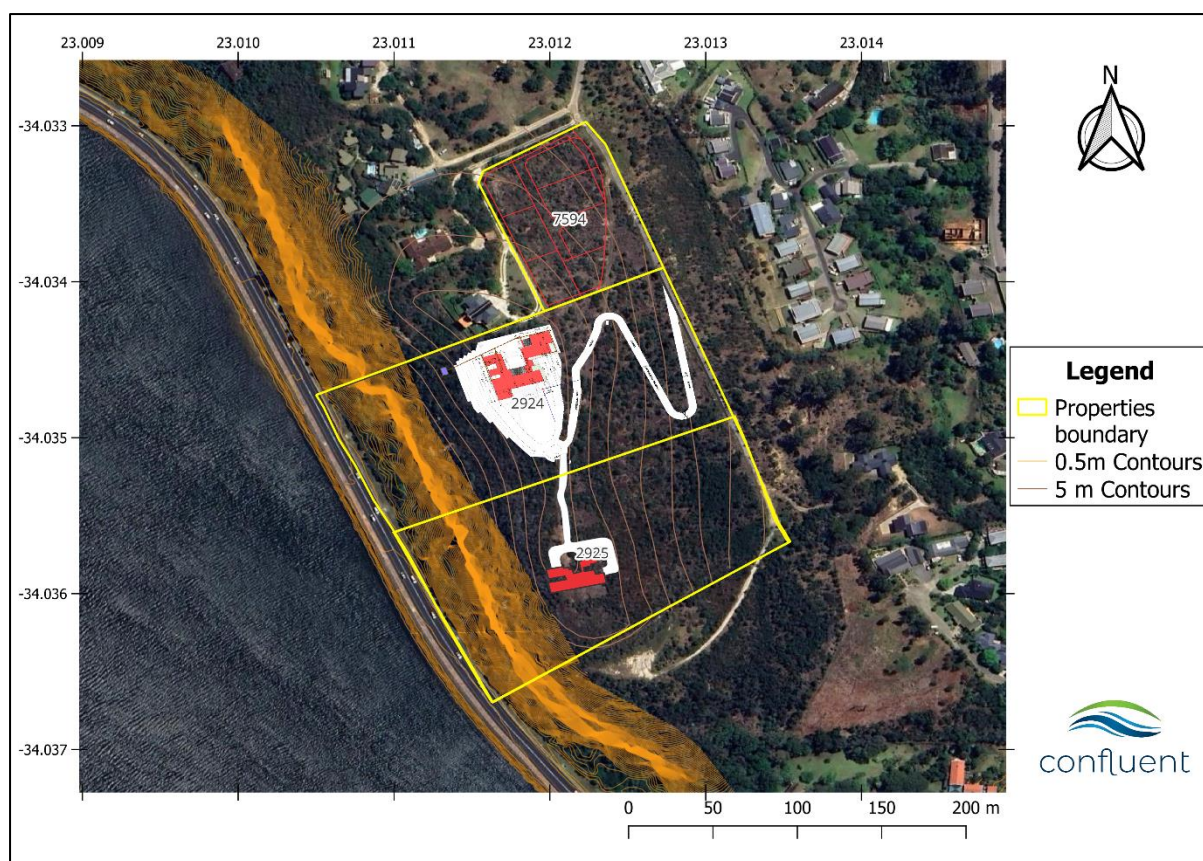
Figure 13: Properties in relation to 0.5 and 5 m contours.

The 0.5m contours supplied by the DEA&DP do not cover the entire site, but do provide some perspective on the steep gradients present along the southwest of the properties which lead to sandstone and conglomerate cliffs. The properties also slope to the northeast although this is a gentler gradient (Figure 13).

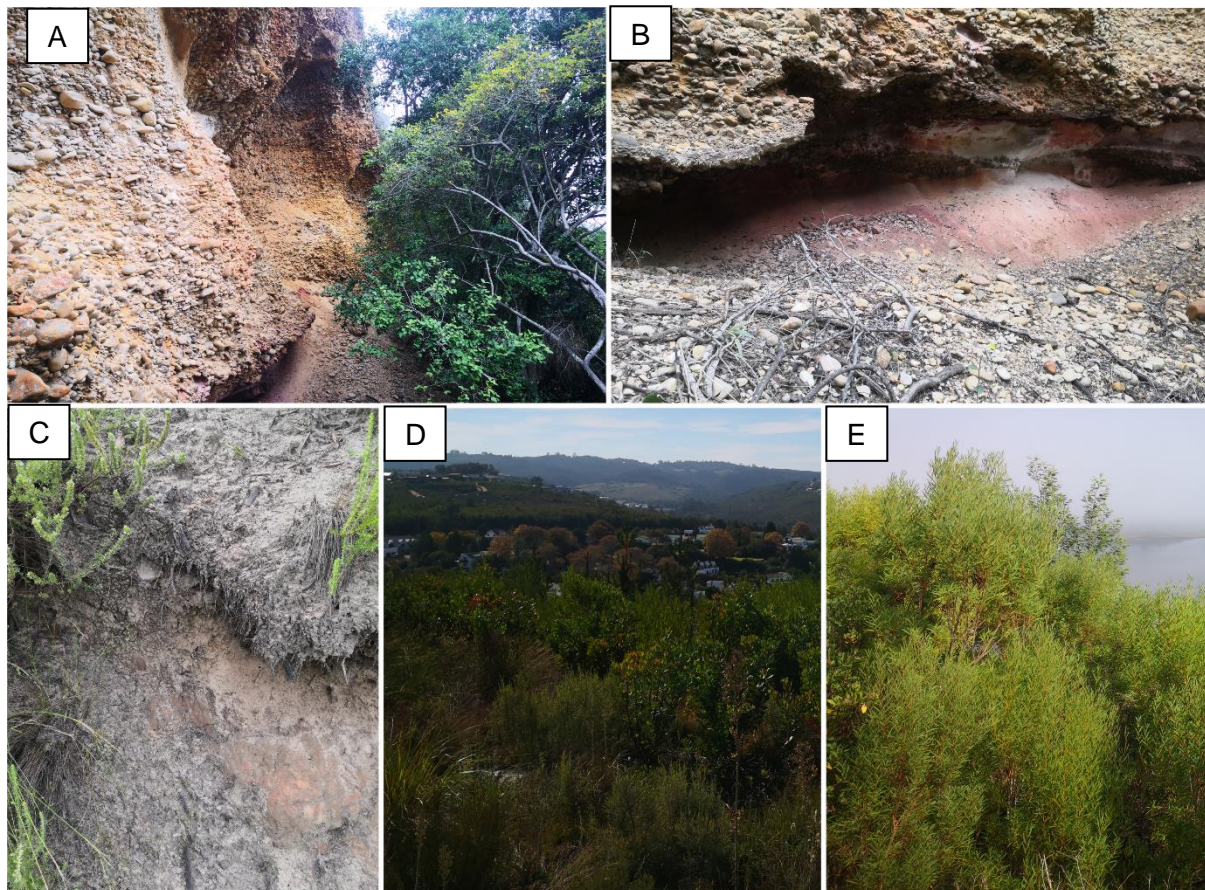
The site visit was conducted on the 19th of April 2024 during which time the entire extent of the proposed development footprint on all three erven were traversed by foot. At the time of the site visit the weather was overcast. The sandstone and conglomerate cliffs, show signs of erosion which could be exacerbated if new micro flow paths are created from the development area above (Figure 14: A & B). The soil on all the properties is sandy (Figure 14: C) and no hydro-geomorphological landscape features (depressions, confined valleys, channels etc.) indicating the presence of a watercourse (i.e. stream, river or wetland) within the proposed development sites were observed. The vegetation present on all three erven was moderately to highly invaded Garden Route Shale Fynbos with the dominant invaders being, *Acacia cyclops*, *Pinus sp.* and *Acacia melanoxylon* (Figure 14: D & E).

Figure 14: A & B - Sandstone and conglomerate cliff, C – Sandy soil present on site, D – vegetation present on site, E - Acacia cyclops.

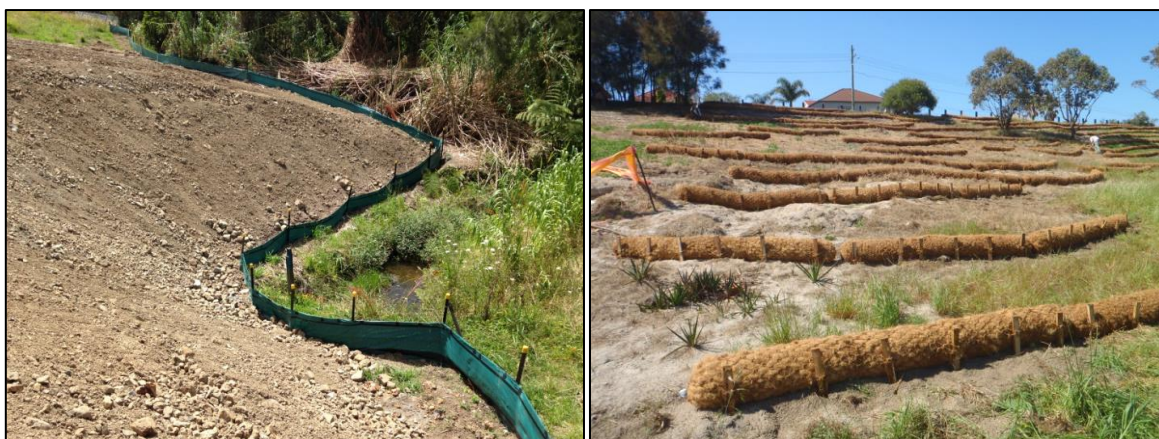
*Figure 18: Examples of silt fences (left) and coir logs (right) used to trap sediment mobilised from steep slopes.*

- Ensure that construction activities do not cause any preferential flow paths and concentrated surface runoff towards the southwestern cliffs during rainfall events.
- Clearly demarcate the construction area and ensure that heavy machinery does not compact soil or disturb vegetation outside of these demarcated areas.
- Reduce transport of sediment through use of structures such as silt fences and biodegradable coir logs or haybales placed along a contour below the development footprint (Figure 18).
