**RE: PROPOSED NEW CEMETERY FOR BITOU MUNICIPALITY ON PORTION 33 OF HILLVIEW
437, PLETTENBERG BAY**

GEOTECHNICAL REPORT FOR A PROPOSED NEW CEMETERY IN PLETTENBERG BAY (BITOU MUNICIPALITY), WESTERN CAPE

16 September 2013

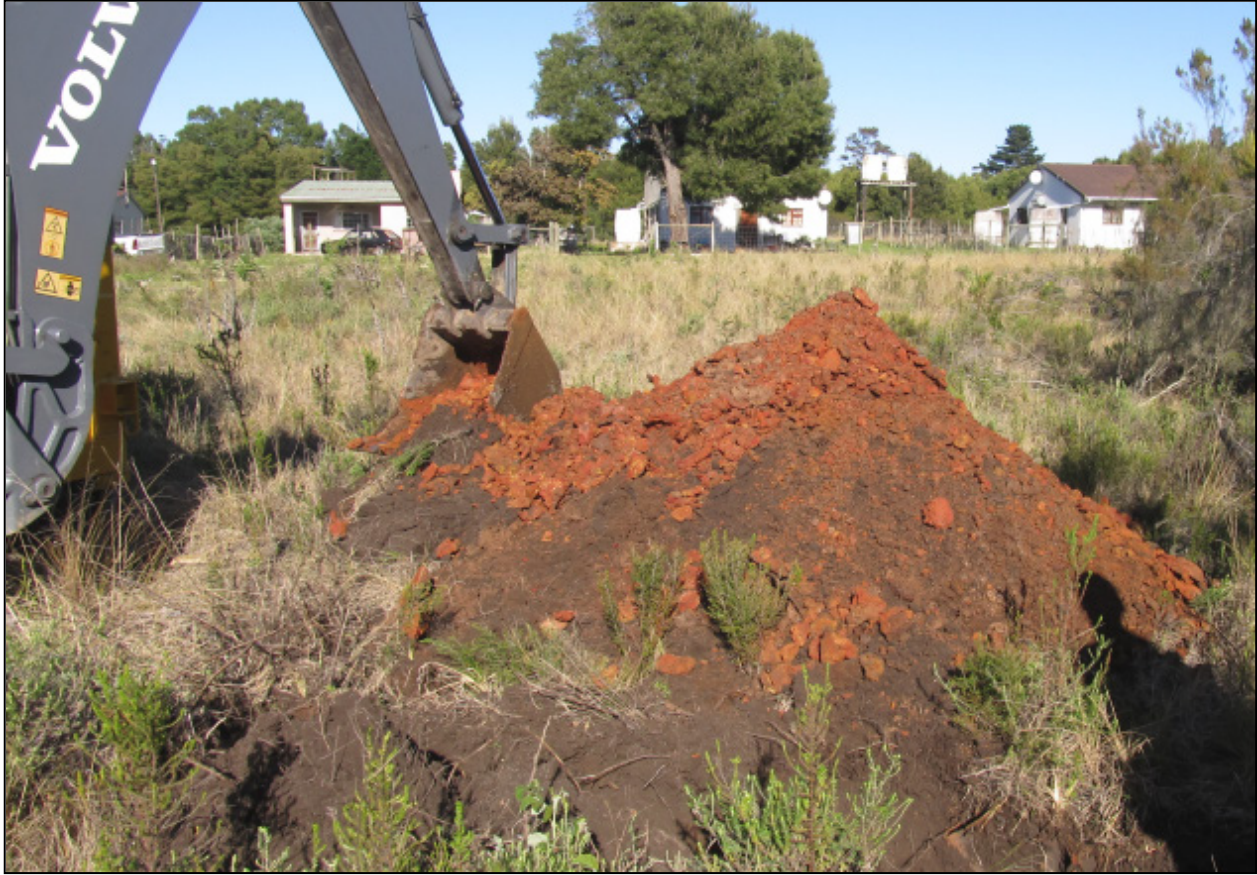
Figure 6: Photo of excavated soil from Site C (TP C5)

Grave excavation will be slow and difficult by hand and the municipality should consider the use of a TLB in this regard. Backfilling of graves will also be challenging with the *in situ* clayey material which can be blocky and difficult to compact. It is recommended that the topsoil and clay are mixed for backfilling to reduce voids (see **Figures 6 & 7**). Soil that is wet will not be suitable for backfilling and should be replaced with drier imported soil from any available source.

Site drainage is important to prevent ponding of surface water around the graveyard and deep v-channels are recommended throughout. This may also help increase the basal buffer zone between the corpse and the perched water table, and keep the surficial soil horizons in a drained state which will add stability to the grave sidewalls.

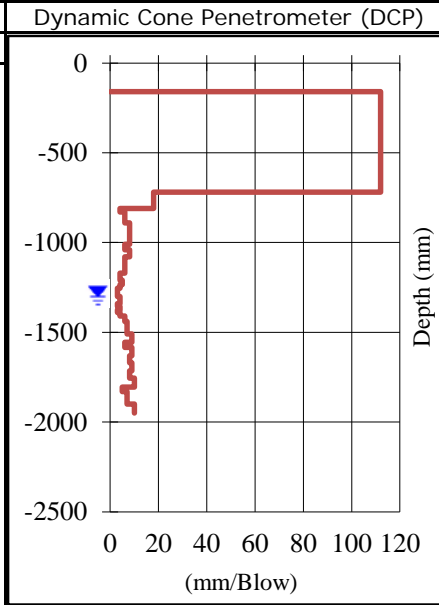
C3	Datum: NGL	Co-ords: 23 Y-030813 X3768718
	Key to symbols: ● Sample taken	▬ Groundwater
(0 to 900)	Moist, dark brown, medium dense, intact, SILTY SAND , transported (Topsoil)	
(900 to 1300)	Very moist to wet, dark red brown, dense, intact, SILTY SANDY GRAVEL , pedogenic (Ferricrete nodules)	
(1300 to 2300)	Moist, dark red orange, stiff to very stiff, fissured, CLAYEY SILTY SANDY CLAY , residual?	
Perched water table @ 1300mm

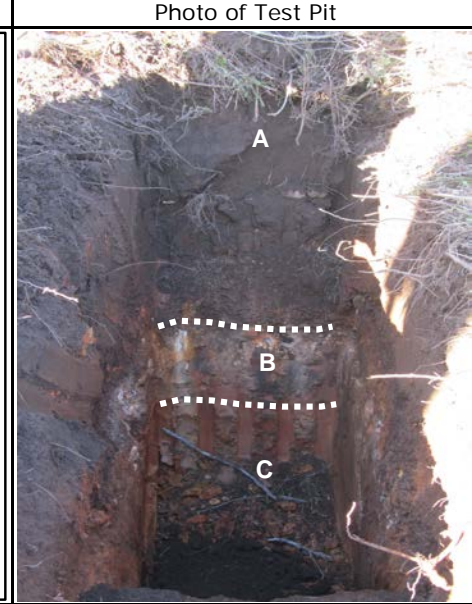
C6	Datum: NGL	Co-ords: 23 Y-031151 X3768425
	Key to symbols: ● Sample taken	📍 Groundwater
(0 to 600)	Moist, dark brown, loose, intact, SILTY SAND , transported (Topsoil)	
(600 to 900)	Moist, dark red brown, dense, intact, SANDY SILTY GRAVEL & minor cobbles , pedogenic/transported (Ferricrete nodules)	
(900 to 1800)	Moist, dark red orange, very stiff, fissured/shattered/slickensided, SANDY SILTY CLAY , residual? Foundation Indicator	
TP stopped due to slow progress
