ENVIRONMENTAL AUDIT REPORT

GLENVILLAGE COUNTRY ESTATE AND ASSOCIATED INFRASTRUCTURE ON PORTION 52 OF FARM 195 KRAAIBOSCH, GEORGE

PREPARED FOR: Bluerain Property Group Pty Ltd
PREPARED BY: Eco Route Environmental Practitioners
DEPARTMENT REF: 16/3/1/1/D2/19-0025/12
AUTHOR: Joclyn Marshall (2022/5006) & Justin Britton (Cand. 2023/6648)
DATE: 2024/08/26
SUBMITTED TO: DEA&DP, George Municipality, Sharples Environmental Services cc (SES), Glen Haven Country Estate (Pty) Ltd., and BA Developments (Pty) Ltd.

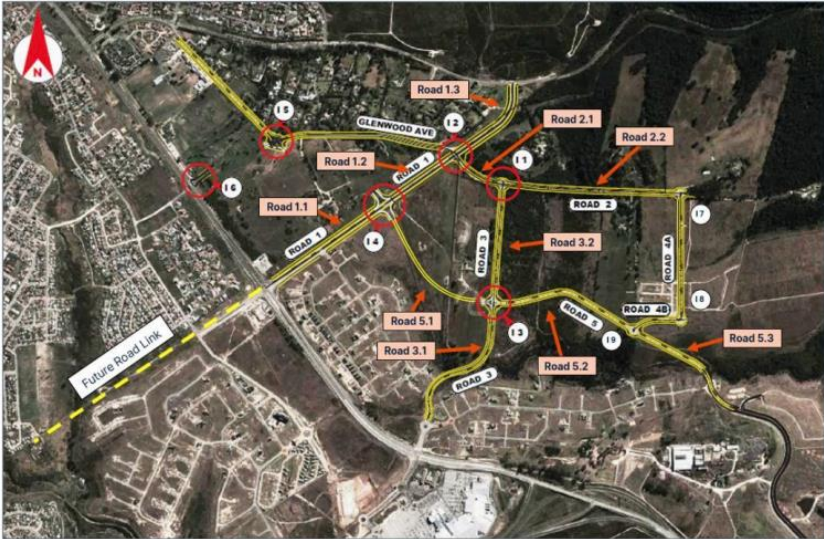
15	The Public Open Space in the southwest of the property should be rehabilitated to as near as natural as possible.				<p>Not Monitorable</p> <p>This has not commenced yet.</p>
16	The proposed development must include a minimum of 2.2ha of Private Open Space (or similar zoning) in the southern part of the property, as indicated in the April 2013 revised layout: Alternative 3.		0		<p>Non-Compliance (major)</p> <p>It was observed that vegetation clearance has occurred along the western boundary to make way for a future road, as indicated in the Kraaibosch Roads Master Plan. Specifically, the road is identified as Road 5.1 in the SMEC update report, as illustrated in the image below.</p>

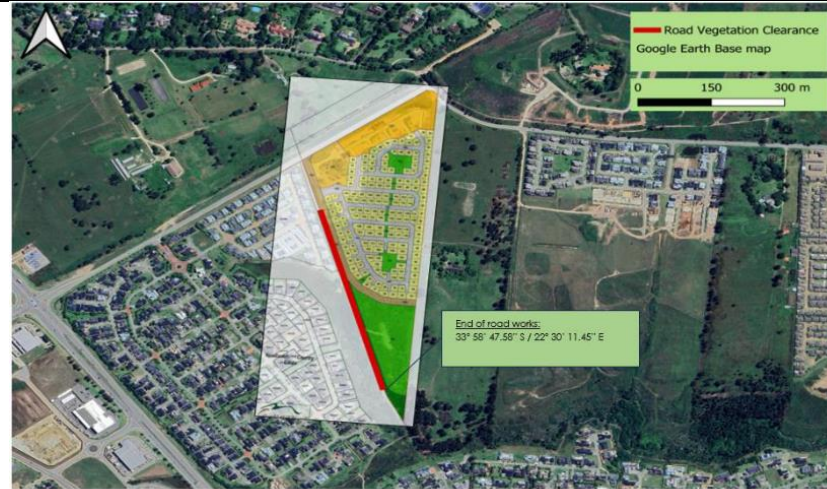
<p>The current owners have cleared vegetation beyond the designated servitude road waypoint as per the approved SDP. The extent of this clearance reduces the open space size below 2.2 ha (illustrated by the red line in the provided image below).</p>

Clearance of vegetation designated to the construction of a road.

This non-compliance has a major impact on the surrounding environment as it reduced the requested open space area below the required recommendations.

Recommendation: It is recommended that the road be removed to the point that reflects the correct alignment as per the approved SDP, and rehabilitated. The servitude road should be surveyed to mark on the ground the exact position/alignment.
17	<p>The draft Environmental Management Programme ("EMP") submitted as part of the application for environmental authorisation is hereby approved on condition that the following amendments are made to the EMP and must be implemented.</p> <p>17.1. Incorporate all the conditions given in this Environmental Authorisation</p> <p>17.2. Be included in all contract documentation for all phases of the development</p> <p>17.3. Describe the level and type of competency required of the Environmental Control Officer ("ECO"), or Environmental Site Agent where applicable.</p> <p>17.4 Determine the frequency of site visits.</p> <p>17.5. Meet the requirements outlined in Section 24N (2) & 3 of the National Environmental management Act, 1998 (Act no 07 of 1998, as amended) ("NEMA") and Regulation 34 of</p>	0 . 5			<p>Partial Compliance</p> <p>The final EMPr (GEO162/21) has been updated to include the conditions specified in the EA. It cannot be determined whether the EMP is included in all contract documentation for all phases of the development, otherwise all other conditions have been met.</p>

9. It is recommended that the road on the western boundary be removed to the point that reflects the correct alignment as per the approved SDP, and rehabilitated. The servitude road should be surveyed to mark on the ground the exact position/alignment.

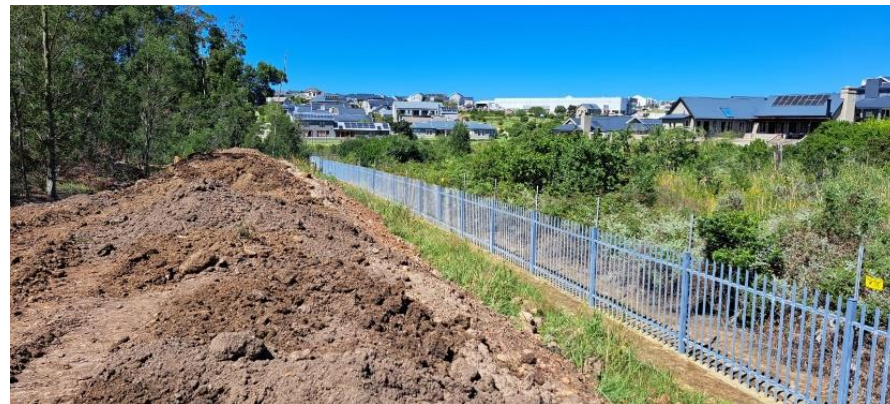
As the new owners were convinced of the road alignment, additional fill material, assumed to be retained from the current development phases, was used to build up and stabilise the road.

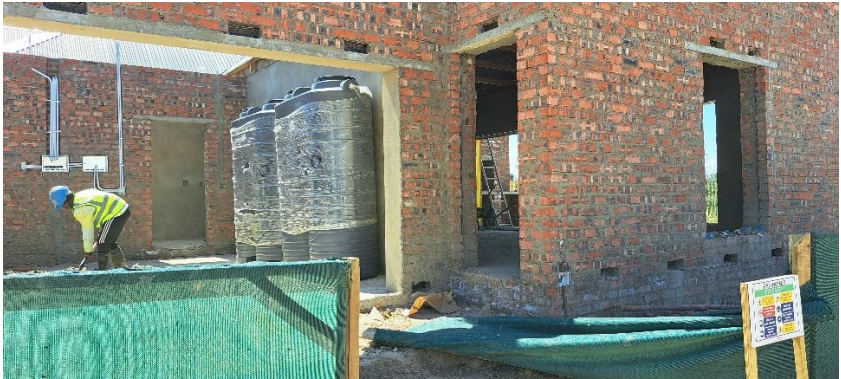
Rainwater tanks were observed by the Auditor on site and noted in the November 2023 Environmental Monitoring Report by SES.

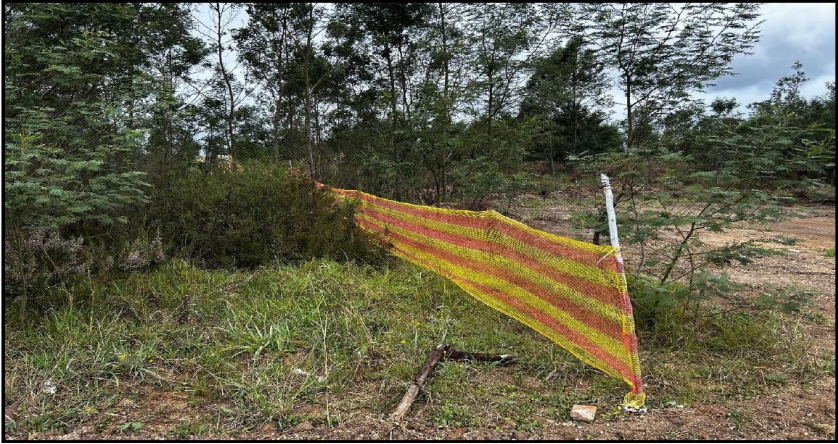
Recommendation: The pedestrian and /or cycle path must be incorporated into the landscape plan.
	The exact positioning of potential pedestrian / cycle routes must be determined on site with input from the ECO, Engineer, George Municipality, and adjacent landowners.				Not Monitorable This has not commenced. The route will be determined when the road is constructed. Recommendation: The route must be determined with input from the ECO, Engineer, George Municipality and adjacent landowners. The pedestrian and /or cycle path must be incorporated into the landscape plan.
	The areas of private and public open space across the southern portion of the property (excluding the proposed clubhouse and bowling greens) must be protected and rehabilitated as far as possible.	0.5			Partial Compliance A boundary fence has been erected with shadecloth on the southern side of the construction activities to demarcate the no-go area. Removal of alien vegetation has commenced.

According to the November and December 2023 EMR, no-go areas are still to be demarcated for the new area (Phase 3 &4) to be developed (Appendix 4). Please also see Condition 16 of the EA for non-compliance in terms of protecting no-go areas.

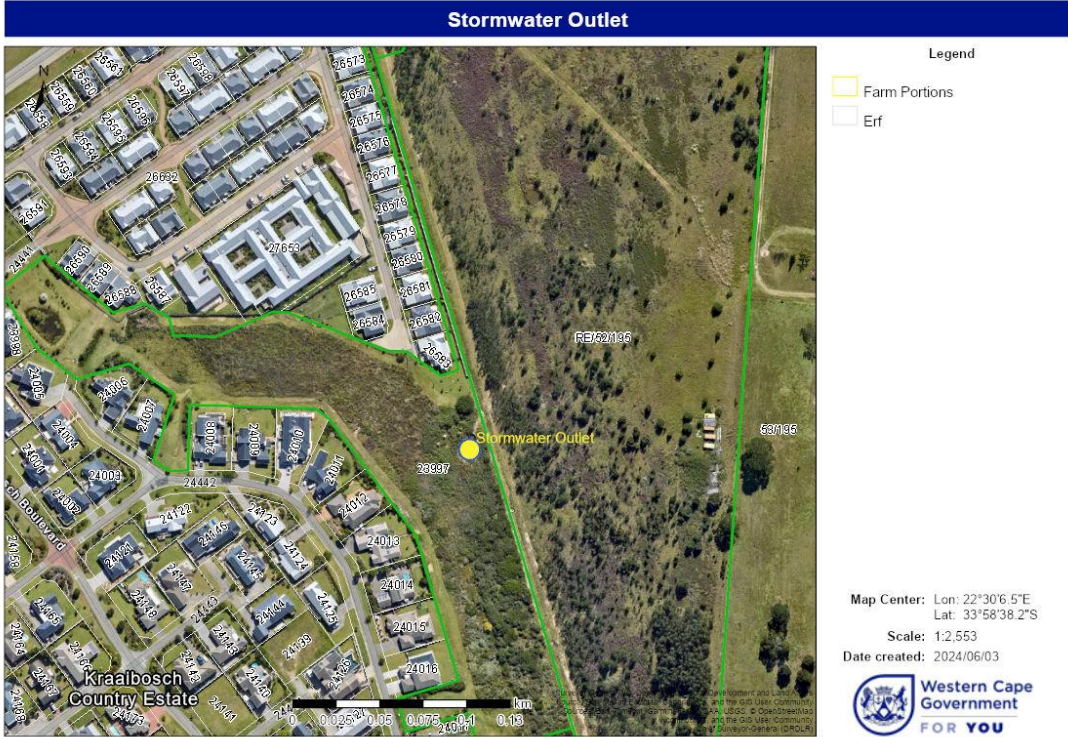
The requirements and duties are stipulated in the EMP.			
5.5 Erosion control and stormwater management	Any formal stormwater infrastructure must ensure that discharge points must be contained within the property boundaries of Portion 52/195 and are designed in such a way as to negate erosion.		0	<p>Non-Compliance</p> <p>As per the stormwater layout plan, the stormwater outlet is positioned on erf 23977 and within 32m of the off-site drainage line to the west of the property. From Google Earth imagery it appears to have been constructed between May and June 2017 following the installation of the stormwater pipeline along the western boundary.</p>

<p>Information from Cobus Louw Pr. Eng. - Originally a stormwater outlet on the border between erven 195/52 and 23997 exist on the Northern side. This outlet was on erf 23997 side of the fence. The developer of erf 23997 placed a berm on their side of the fence forcing the</p>

<p>water towards erf 195/52. The stormwater under dispute was partially generated from erf 23997, 195/52 and the greater George Municipal area. An agreement was reached as per attached letter (Appendix 13), that a new stormwater pipe will be installed in the public road reserve to handle the stormwater. This decision was beneficial to all parties involved, George Municipality, owner of erf 195/52 and 23997. The cost was distributed between the owner of erf 195/52 (32%) and George Municipality 68%), with the owner of erf 23997 contributing their share through a capital payment to the municipality. The stormwater outlet was established on erf 23997 as per the agreement, and the installation of the pipe occurred through a tender process, overseen by Hilland during their tenure as Environmental Control Officer (ECO).</p> <p>Recommendation: The stormwater structure is built outside the boundary of erf 195/52, and therefore remains a non-compliance. However, as it benefits both erf 23997, erf 195/52, and the George Municipality, it is recommended that the EMPr be amended to incorporate the position of the stormwater outlet.</p>

10. The stormwater outlet structure is built outside the boundary of erf 195/52, and therefore remains a non-compliance. However, as it benefits both erf 23997, erf 195/52, and the George Municipality, it is recommended that the EMPr be amended to incorporate the position of the stormwater outlet.

5.5	Any formal stormwater infrastructure must ensure that discharge points must be contained within the property boundaries of Portion 52/195 and are designed in such a way as to negate erosion.	The stormwater structure is built outside the boundary of erf 195/52, and therefore remains a non-compliance. However, as it benefits both erf 23997, erf 195/52, and the George Municipality, it is recommended that the EMPr be amended to incorporate the position of the stormwater outlet.

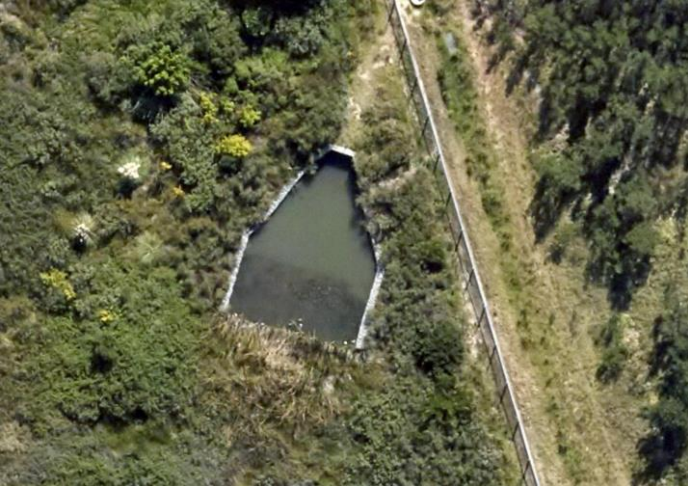
<p>The stormwater outlets should contain suitable energy dissipating structures designed to reduce water energy, dispersing the water rather than concentrating it.</p>	1			<p>Full Compliance</p> <p>The stormwater outlet functions as a retention pond whereby collected stormwater drained from the stormwater system of the estates is allowed to dissipate into the drainage line area without causing erosion.</p>

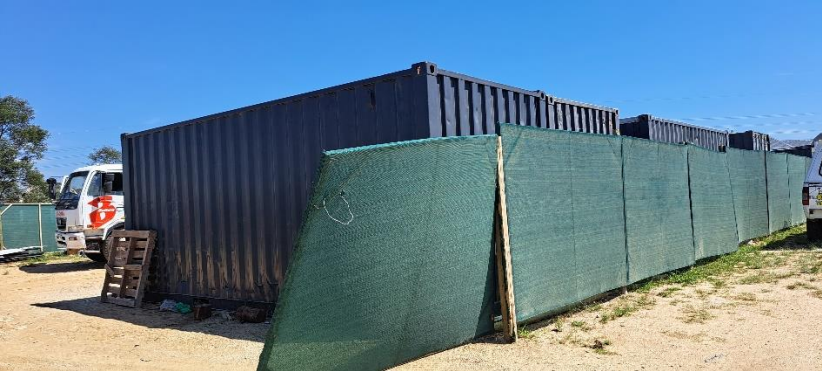
excess dust. No potable water may be used for damping haul roads.				
5.16 Establishment of contractors site camp	The Contractors Site Camp must be established in consultation with the ECO. The site camp may not be erected on any areas considered sensitive and no indigenous vegetation may be removed, damaged or disturbed without consent from the ECO.	1			<p>Full Compliance</p> <p>The site camp is established and fenced off with shade cloth.</p>

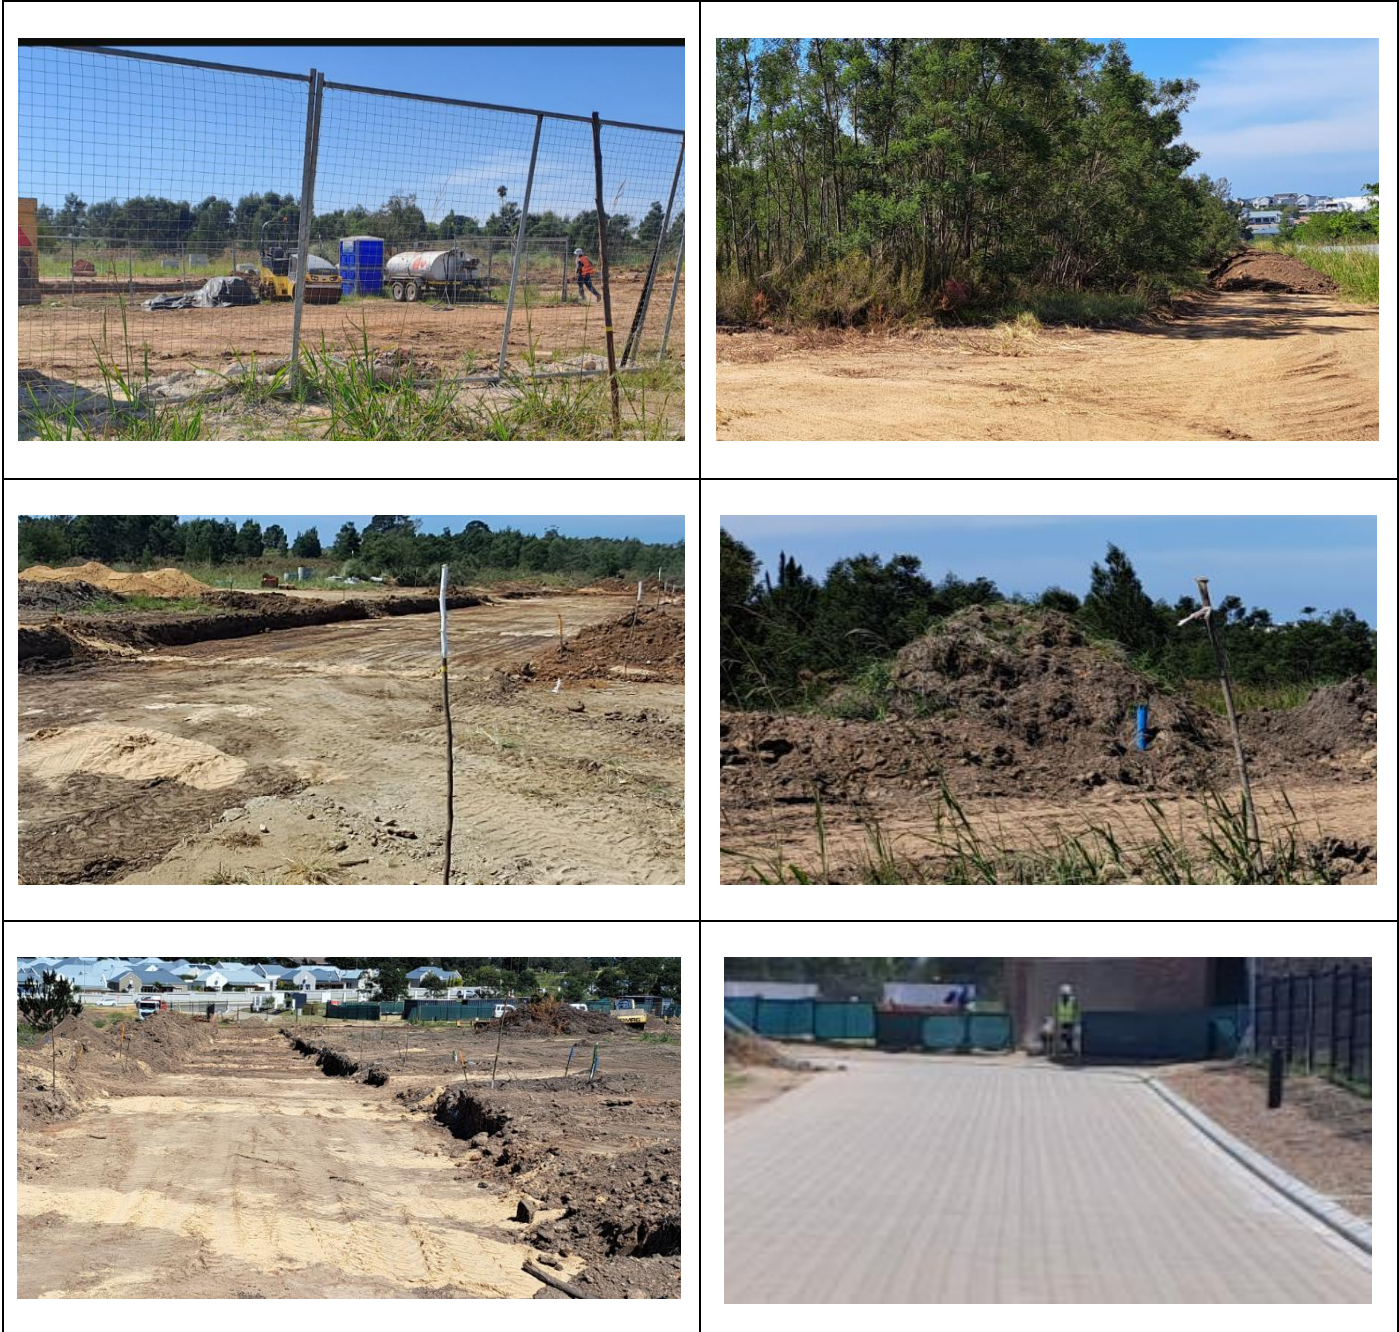
6. PHOTOGRAPHIC RECORD (2024/02/13)

The EMPr has been deemed effective and has been successfully implemented despite changes in ownership and the initial absence of an ECO. However, a shortcoming was identified when a stormwater structure was constructed outside the boundary of Erf 195/52, resulting in non-compliance with condition 5.5 of the EMPr. Since this structure benefits both Erf 23997, Erf 195/52, and the George Municipality, it is recommended that the EMPr be amended to incorporate the position of the stormwater outlet. This amendment would resolve the identified non-compliance.
