Proposed Residential and Tourism Development on Portion 59/216 Uitzigt Farm, Knysna, Western Cape.

Aquatic Biodiversity Site Sensitivity Verification and Impact Assessment.

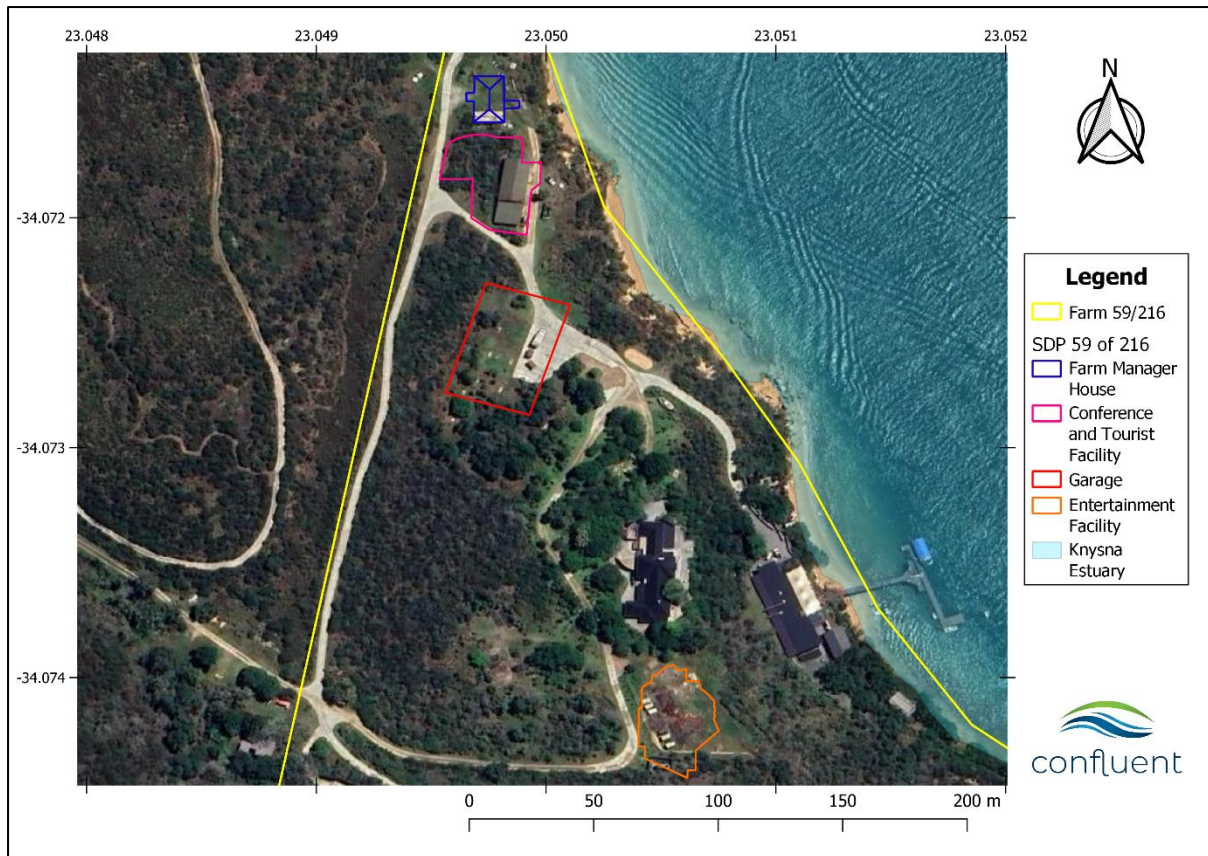
The mixed developments are to take place at the northern point of Farm 59 of 216. A large garage building is proposed on an existing concrete parking area. A conference and tourist facilities are proposed 26.5 m north of the garage building in an area where an existing shed/workshop stands. A manager cottage is proposed 7.5 m north of the conference and tourist facility in an area where two shipping containers are standing. Lastly, an entertainment facility is also proposed 23.6 m south of the existing house (Figure 3).

Figure 3: Farm 59 of 216 with Proposed development layouts.

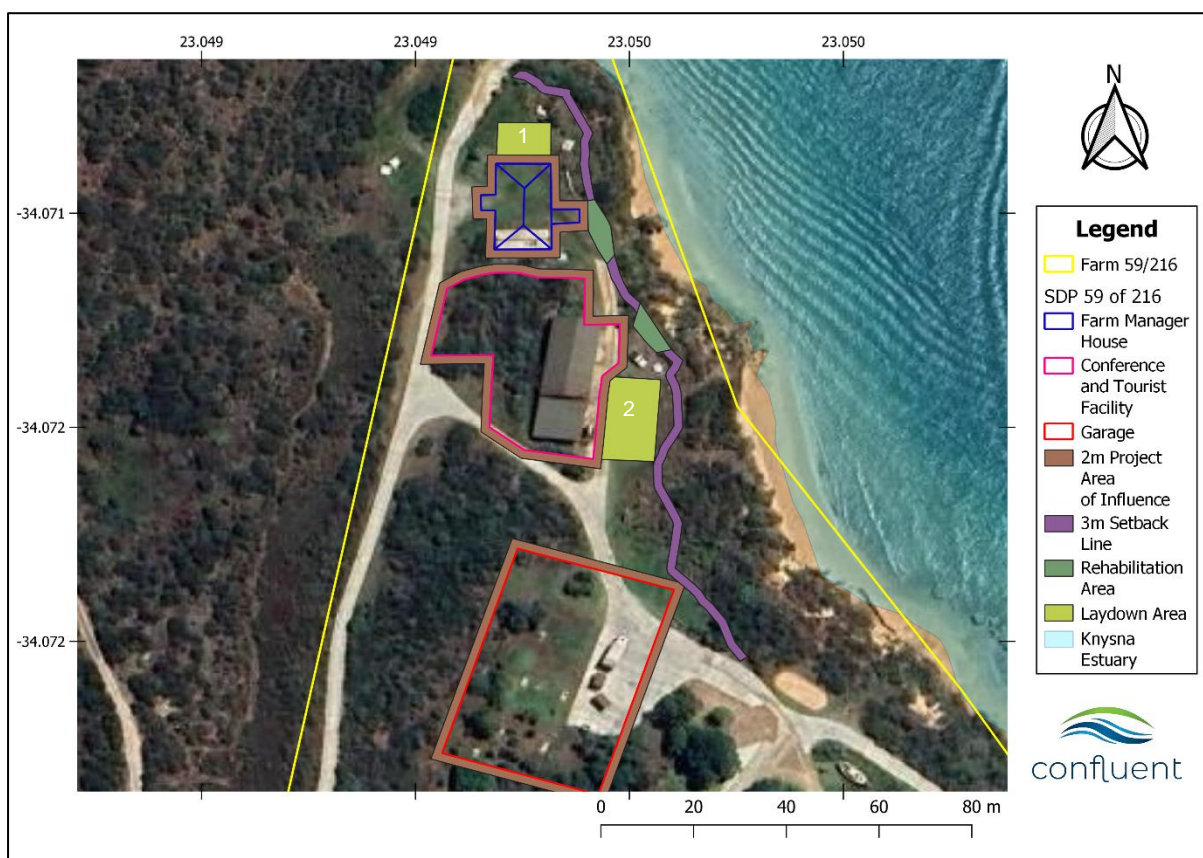
To minimise the impact of the proposed development on the cliff a 3 m setback line has been established from the cliff edge (Figure 22).

Figure 22: Proposed development in relation to laydown areas and sensitive features.

- Establish a 3 m setback line from the edge of the cliff for 160 m from the edge of the road in the north till 21.5 m past the corner of the proposed garage (as indicated on the map below; Figure 22).
- Rehabilitate two areas of lawn within the 3 m setback line with indigenous vegetation of the area by ceasing mowing the lawn and clearing sections for planting (one plant per 1m²). Species can include but are not limited to species listed in Table 3 below.
- Replace the pavement with permeable paving at the northern section of the road that leads down to the estuary. From the estuary for approximately 42 m towards the south.
- Install gutters and rainwater harvesting tanks associated with the workshop/store in the northern corner of the property.

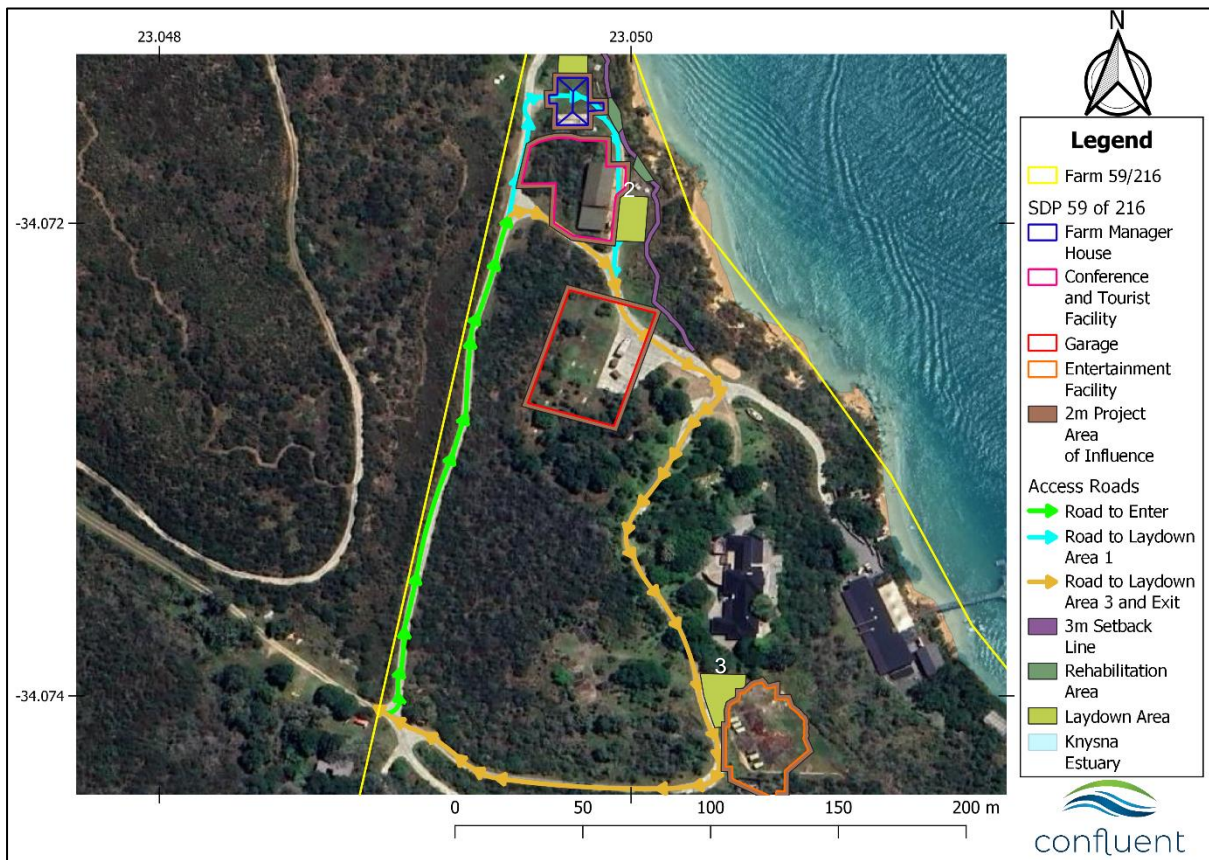
Figure 23: Proposed developments in relation to access roads and Laydown areas.

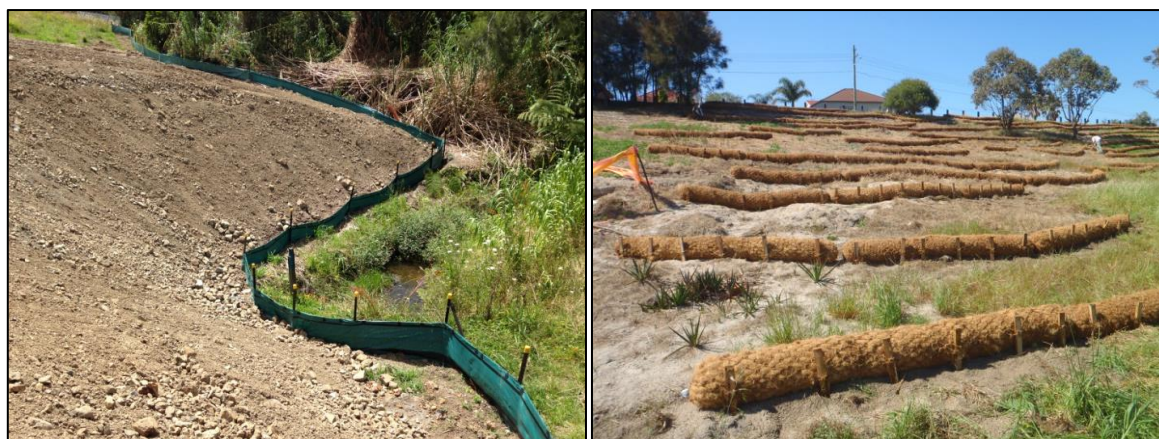
Figure 24: Examples of silt fences (left) and coir logs (right) used to trap sediment mobilised from steep slopes.
