APPENDIX C: SPECIALIST STUDIES - DBAR – ERF 7614

Specialist Compliance Statement for Erf 7614, called Lelieskloof in the Knysna Local Municipality.

Terrestrial Biodiversity & Terrestrial Plant Species Report

Terrestrial Animal Species Specialist Assessment:
Site Sensitivity Verification Report and Compliance Statement

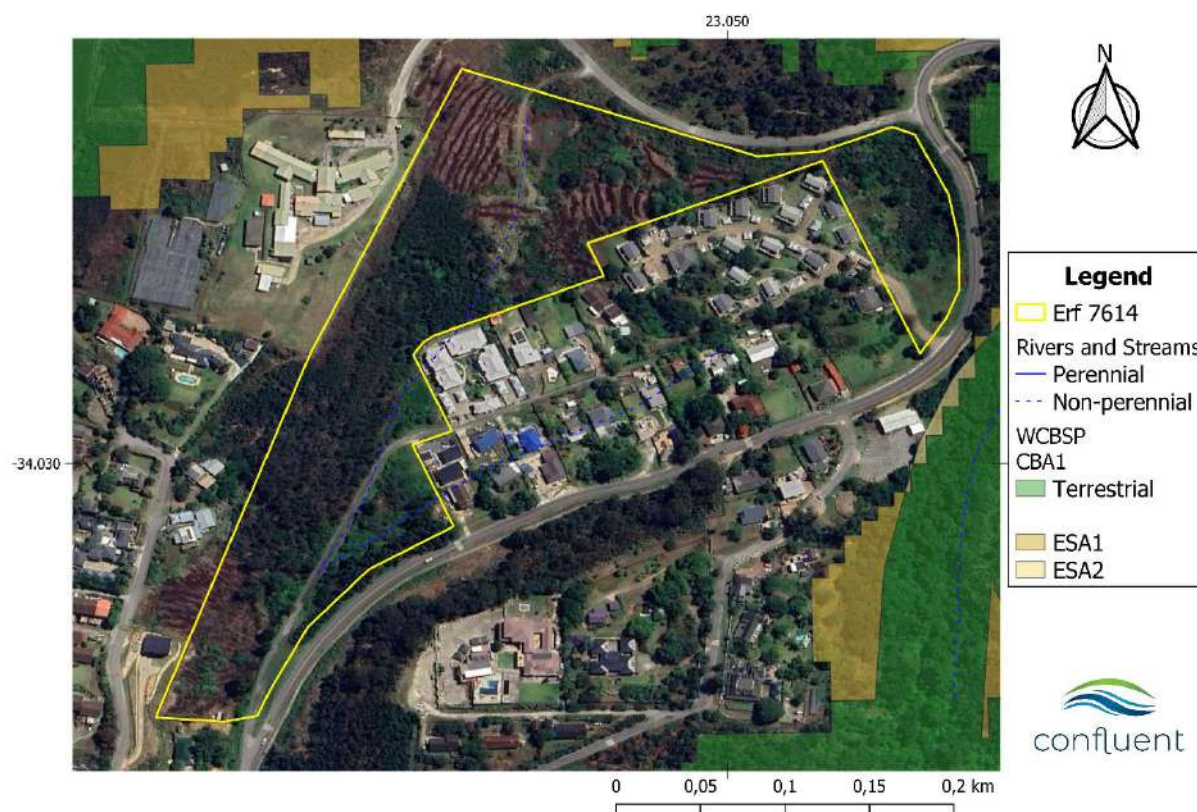
Figure 6: The mapped Western Cape Biodiversity Spatial Plan (WC BSP) categories that have been mapped for Erf 7614.

The Biodiversity Spatial Plan for the Western Cape (WC BSP) does not include Erf 7614. Nearby, however terrestrial critical biodiversity areas (CBA1) and ecological support areas (ESA 1 & 2) are mapped (Fig. 6). Despite not being mapped on the BSP plan, the site does form part of a wider connected open landscape, albeit being heavily transformed.

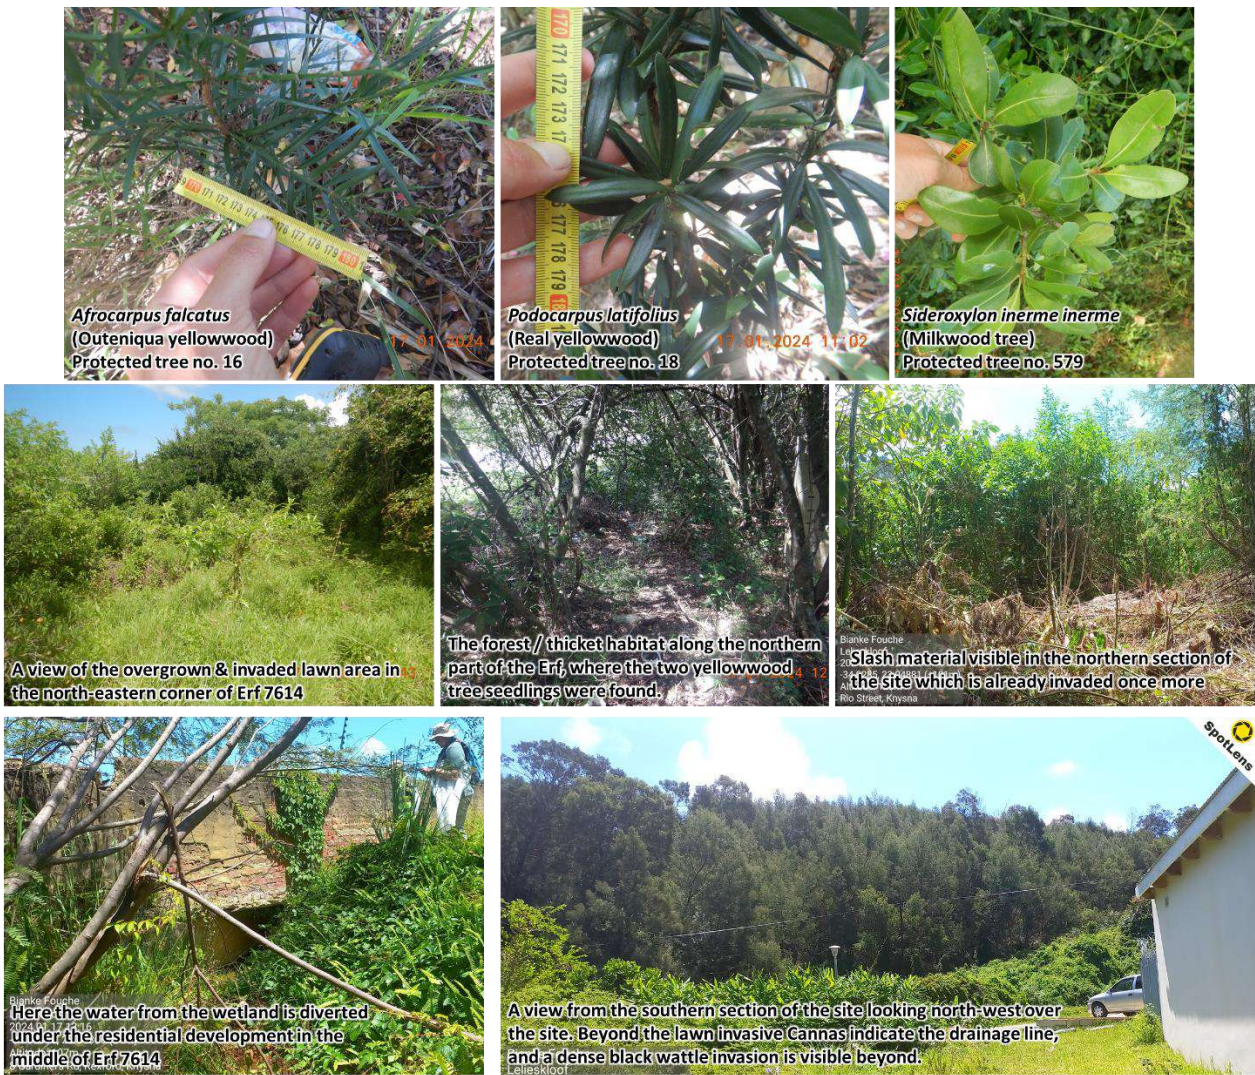
Figure 9: An image illustrating the two yellowwood seedlings, large milkwood tree that were found on the site, and other landscape photos showing the state of the vegetation on Erf 7614.

Two protected yellowwood seedlings were found on the site (*Podocarpus latifolius* and *Afrocarpus falcatus*). Although protected, neither of these species are threatened as per the SANBI Red List. No other Red Listed plant SCC were observed or are expected to occur on the site. If an appropriate forestry license is obtained for the yellowwood seedlings, and they are retained somewhere on Erf 7614, then the development will not negatively affect the plant species on the site. The site is also very heavily invaded, and the habitats transformed. The plant species theme has a **Low** sensitivity.

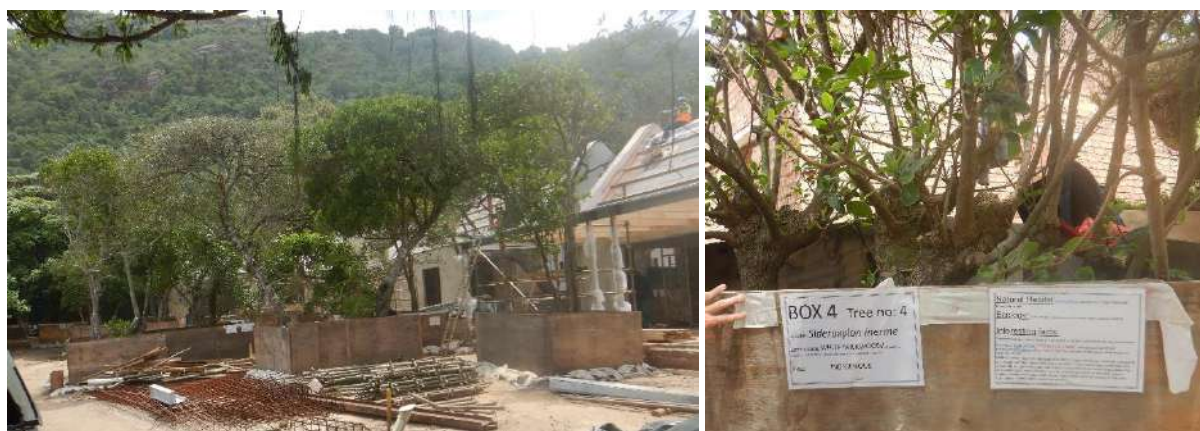
Figure 10: An example of a construction site with protected and other indigenous trees marked and sectioned off from the rest of the construction site. Each tree and box was marked, and interesting facts about the species and its ecology was provided on the construction site.

6. If a forestry license is obtained, then the yellowwood seedlings within the development footprint must be relocated elsewhere on Erf 7614, where they will have a reasonable likelihood of survival and chance to mature. The large Milkwood tree on the site must be avoided entirely, so that the development may only occur around the tree (see Fig. 10).

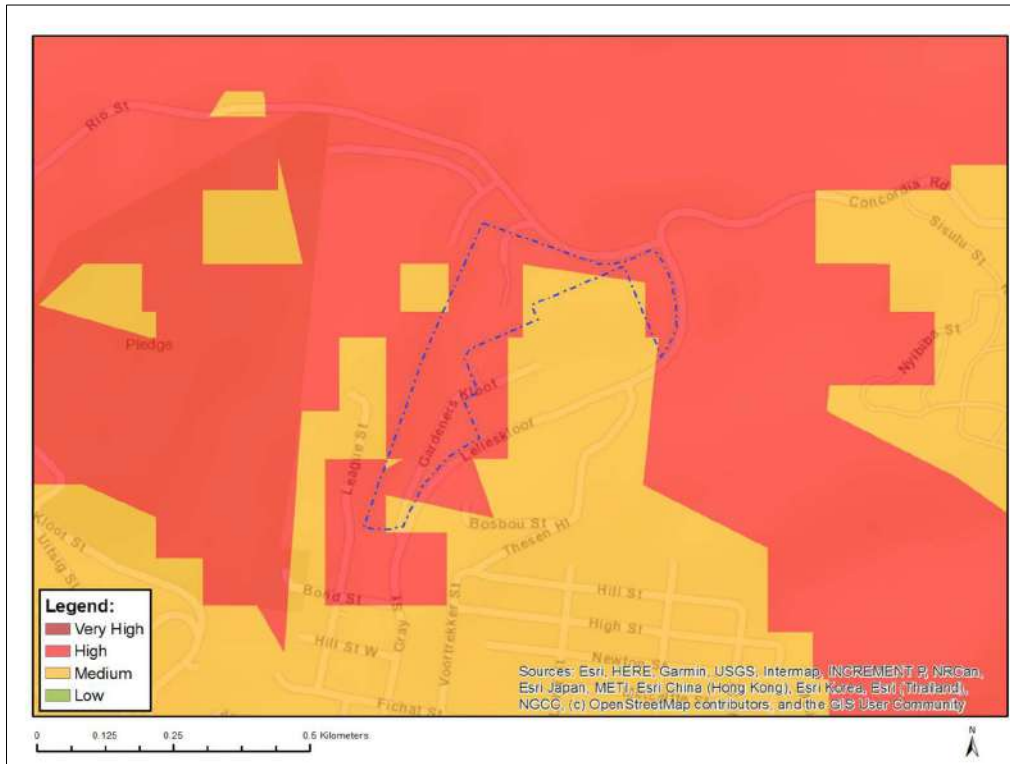
Figure 4. DFFE Online Screening Tool outcome for terrestrial animal species theme. The property boundary for Erf 7614 is indicated by the blue dashed line.

The Department of Forestry, Fisheries and the Environment (DFFE) Screening Tool revealed a HIGH sensitivity for the terrestrial animal species theme across the majority of Erf 7614 as well as a few small areas highlighted as MEDIUM sensitivity (Figure 4), with several animal Species of Conservation Concern (SCC) potentially present (Table 1).

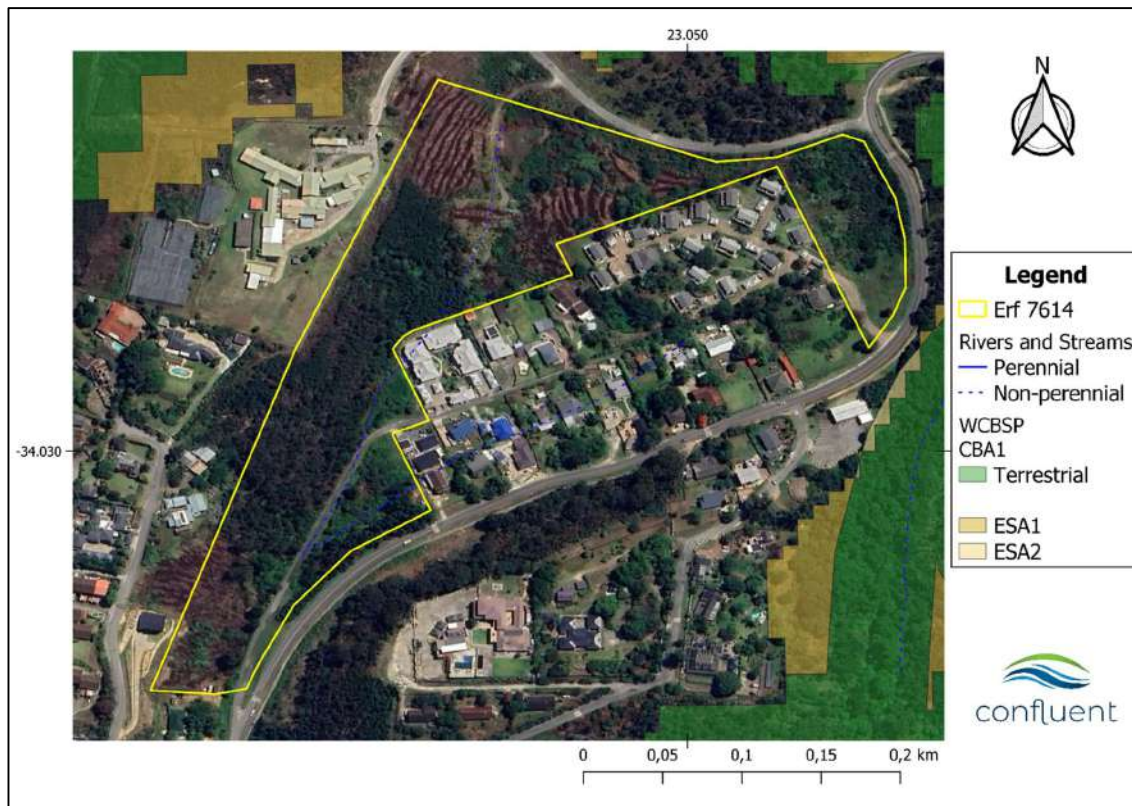
Figure 7. Site map of Erf 7614 with layers for rivers, streams and wetlands (NWM5), and the Western Cape Biodiversity Spatial Plan’s (WCBSP) Critical Biodiversity Areas (CBA1) and Ecological Support Areas (ESA1,2).

Additional mapping layers were applied to Erf 7614 to include wetlands (NWM5) and the Western Cape Biodiversity Spatial Plan’s (CapeNature 2017) Critical Biodiversity Areas (CBAs) and Ecological Support Areas (ESAs) (Figure 7, Table 2). The property itself does not contain any mapped areas of concern, however, the surrounding areas are identified as CBA1, ESA1 and ESA2 due to an overlap with mapping layers for Garden Route Shale Fynbos (Endangered), Indigenous Forest Type, Rondevlei Sandplain Fynbos (Vlok variant - Critically Endangered), South Outeniqua Sandstone Fynbos (Vulnerable), Water source protection - Knysna, and Watercourse protection - South Eastern Coastal Belt.

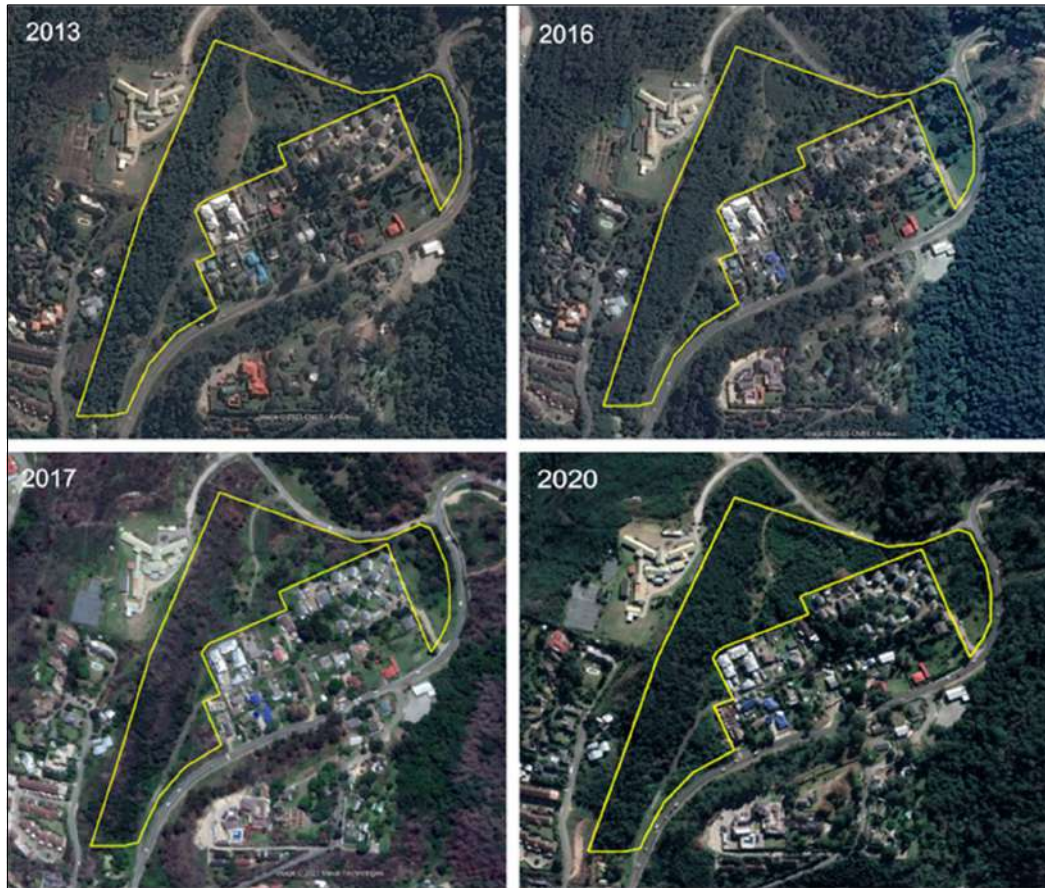
Figure 9. Historical images of Erf 7614 showing notable changes from 2013 to 2020 (CD:NGI & Google Earth imagery).

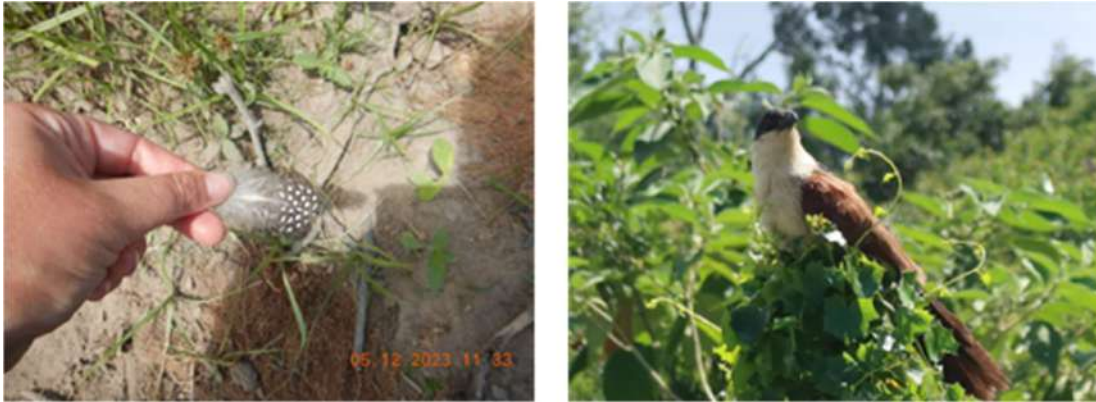
Figure 12. Evidence of Helmeted Guineafowl (*Numida meleagris*) and a Burchell's Coucal (*Centropus burchellii*) seen on Erf 7614.

No SCC were found on site and there was little suitable habitat for any of the SCC given the general lack of indigenous vegetation and dense stands of alien plant invasions (*A. mearnsii* and other alien species). A total of 25 bird species were encountered during the site visit (See Appendix 1, Figure 12).

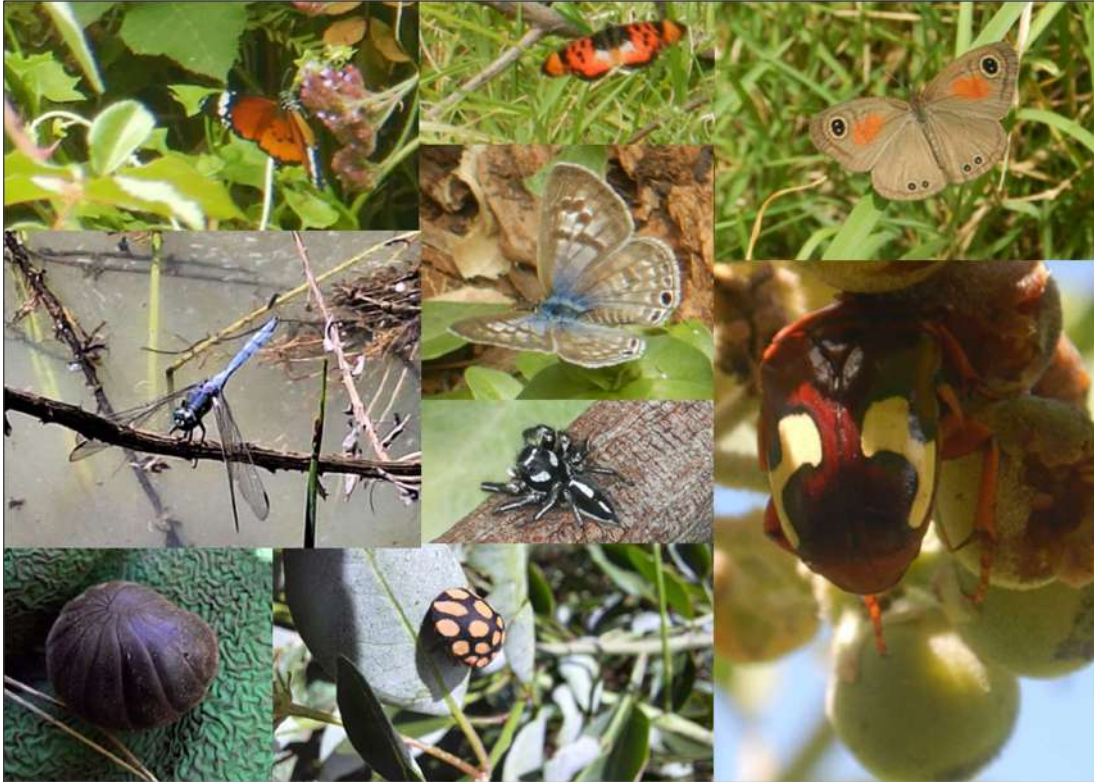
Figure 14. Invertebrates photographed on Erf 7614 during the site inspection.

No SCC were found during the site inspection. The habitat is highly modified and does not represent suitable habitat for the Yellow-winged Agile Grasshopper or the butterfly SCC which largely rely on fynbos habitat. Additionally, no larval food/host plant species were found on site during the Botanical Specialist Assessment (B. Fouche, Confluent Environmental). Invertebrates from 13 Families were photographed and identified from the site (Figure 14, see also Appendix 3).

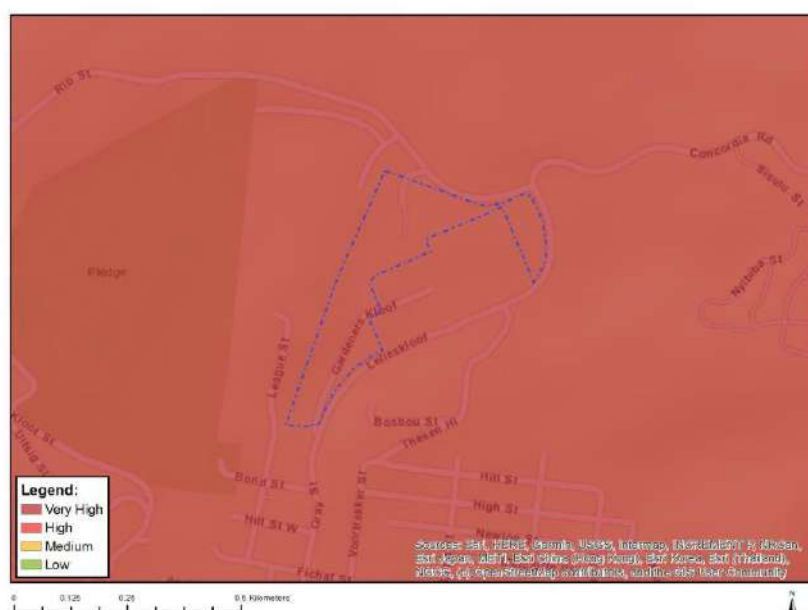
Figure 4. Results of the DFFE Screening Tool which indicate Very High Sensitivity of the Aquatic Biodiversity theme for Erf 7614.

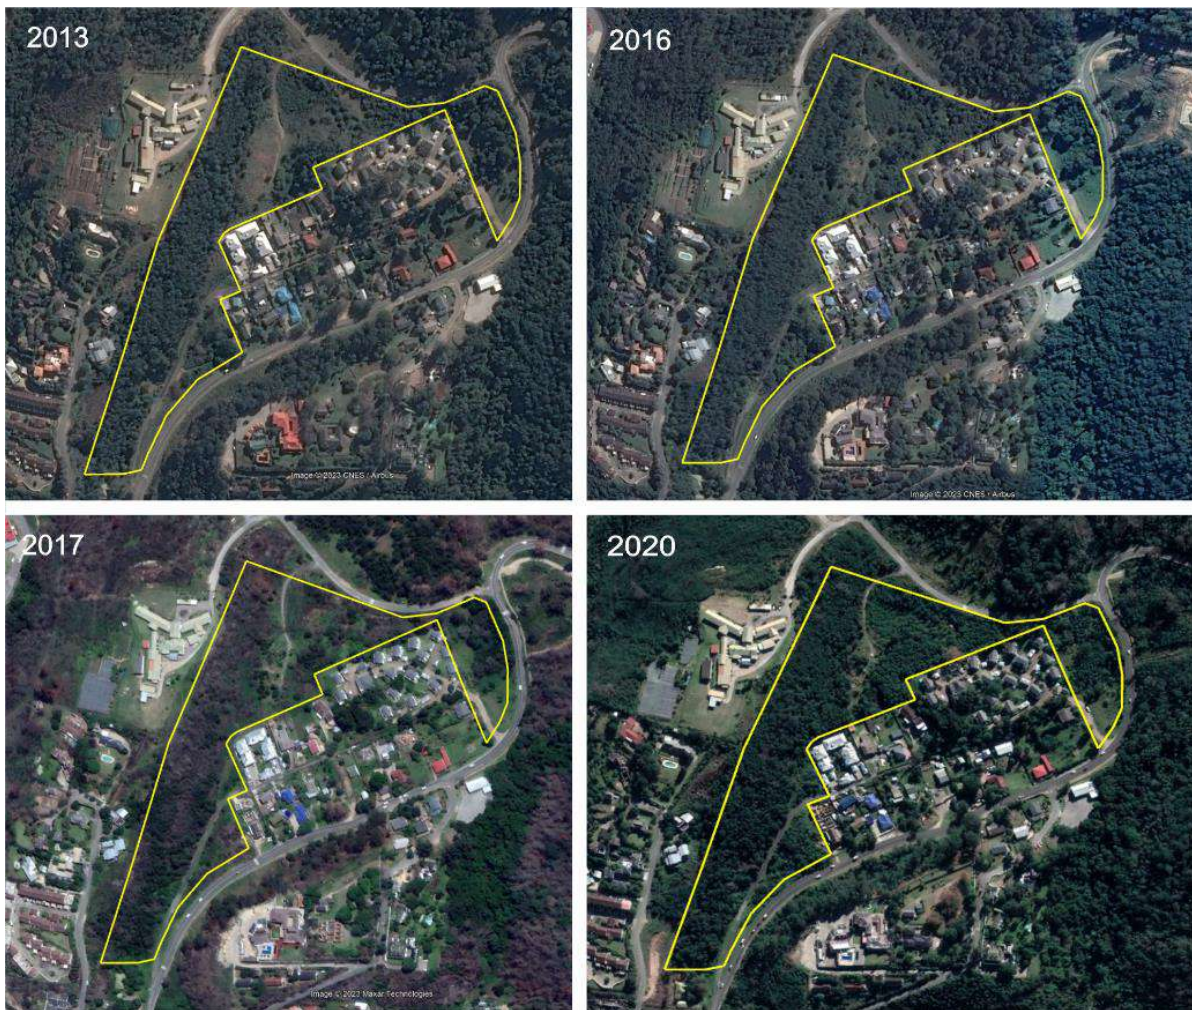
Figure 11: Historical photos showing Erf 7614 through notable changes between 2013 and 2020 (Google Earth imagery).

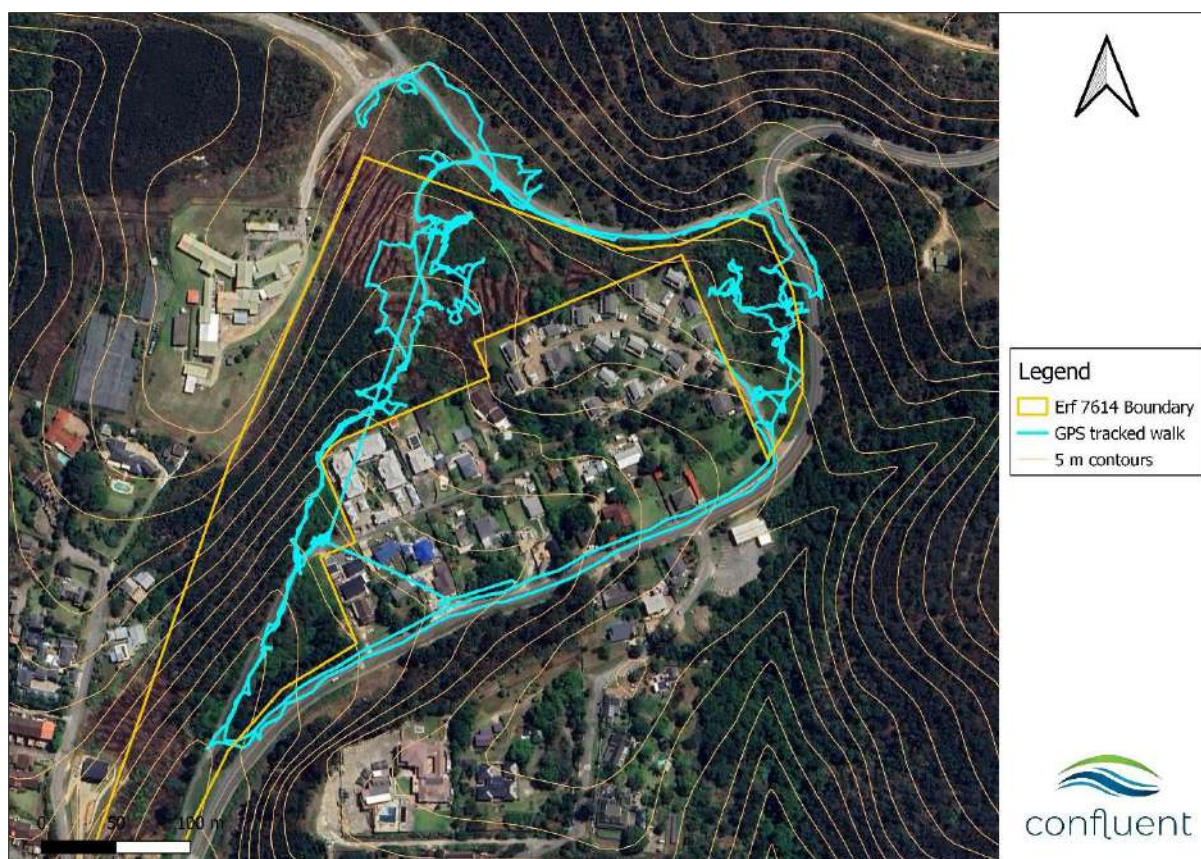
Figure 12. GPS track walked at Erf 7614 over two days of fieldwork in December 2023 and January 2024.

The site was visited twice in December and January 2023. A GPS was carried throughout to track the site meander and ensure adequate coverage of the development area (Figure 12). Weather during both site visits was clear, hot and dry with moderate to low rainfall received in the weeks prior. In addition to the site itself a few adjacent areas upslope of the site were included to assess the presence / absence of wetland habitat that could be related to aquatic features observed within the property.

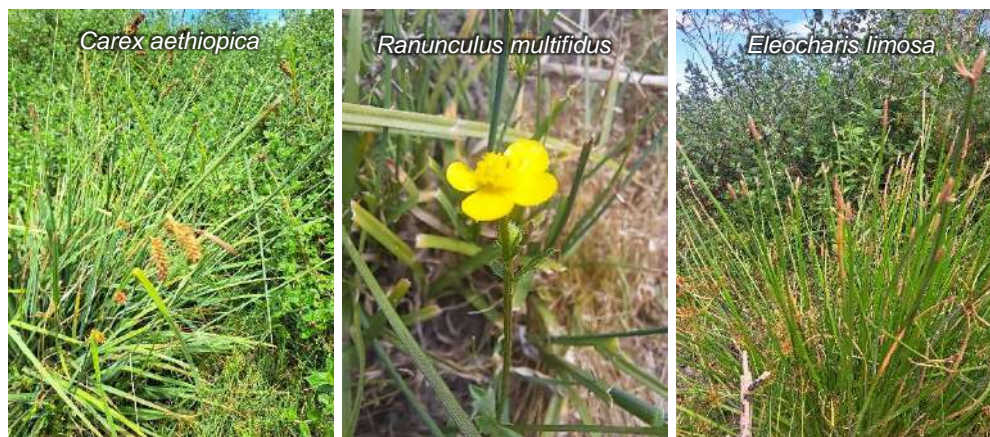
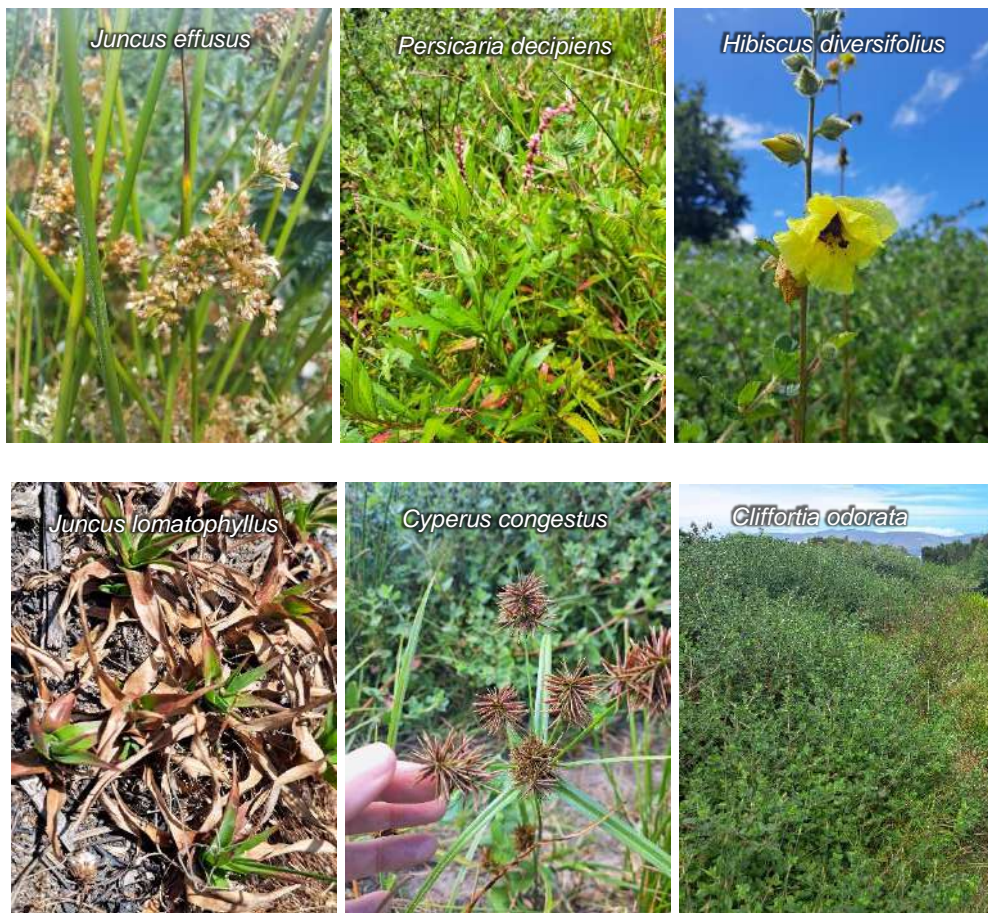
Figure 14. Wetland plant species identified from the unchanneled valley bottom wetland in the central areas of the site.

Wetland plants on the site were typical seasonal wetland species from the region, and the diversity indicates a natural wetland feature (Figure 14). The wetland is dominated by a dense canopy of *Cliffortia ororata* which shelters a wide diversity of wetland plants beneath it. An area of *C. odorata* had been cleared in the wetland, revealing a wide variety of wetland plants below. Wetland plants were also observed across the road above the site where *Phragmites australis* and *Typha capensis* reeds were also observed among other wetland plants.

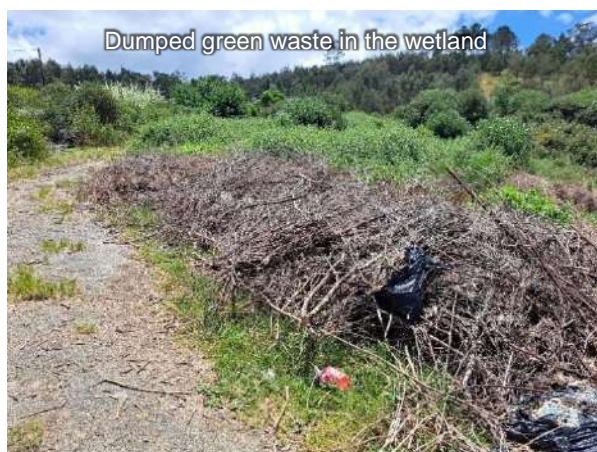
Figure 19. Photos of the wetland and drainage lines indicating impacts affecting the Present Ecological State of the wetland.

area of the wetland. Downstream of the housing complex the water exits the piped culvert into a channel approximately 1.5m deep which flows parallel to the road. The most natural area of the wetland is located in the upper portion of the property where vegetation within the wetland is all indigenous and fairly diverse (Figure 14). In adjacent areas of the wetland are dense patches of alien vegetation dominated by black wattles (*Acacia mearnsii*; Figure 19). In the drainage lines below the housing complex alien vegetation includes exotic garden plants and invasive species such as sword fern (*Nephrolepis cordifolia*) and cannas (*Canna indica*). Dumping in the form of cut alien plants, garden waste, and household refuse has occurred at various points of the wetland and drainage lines (Figure 19).

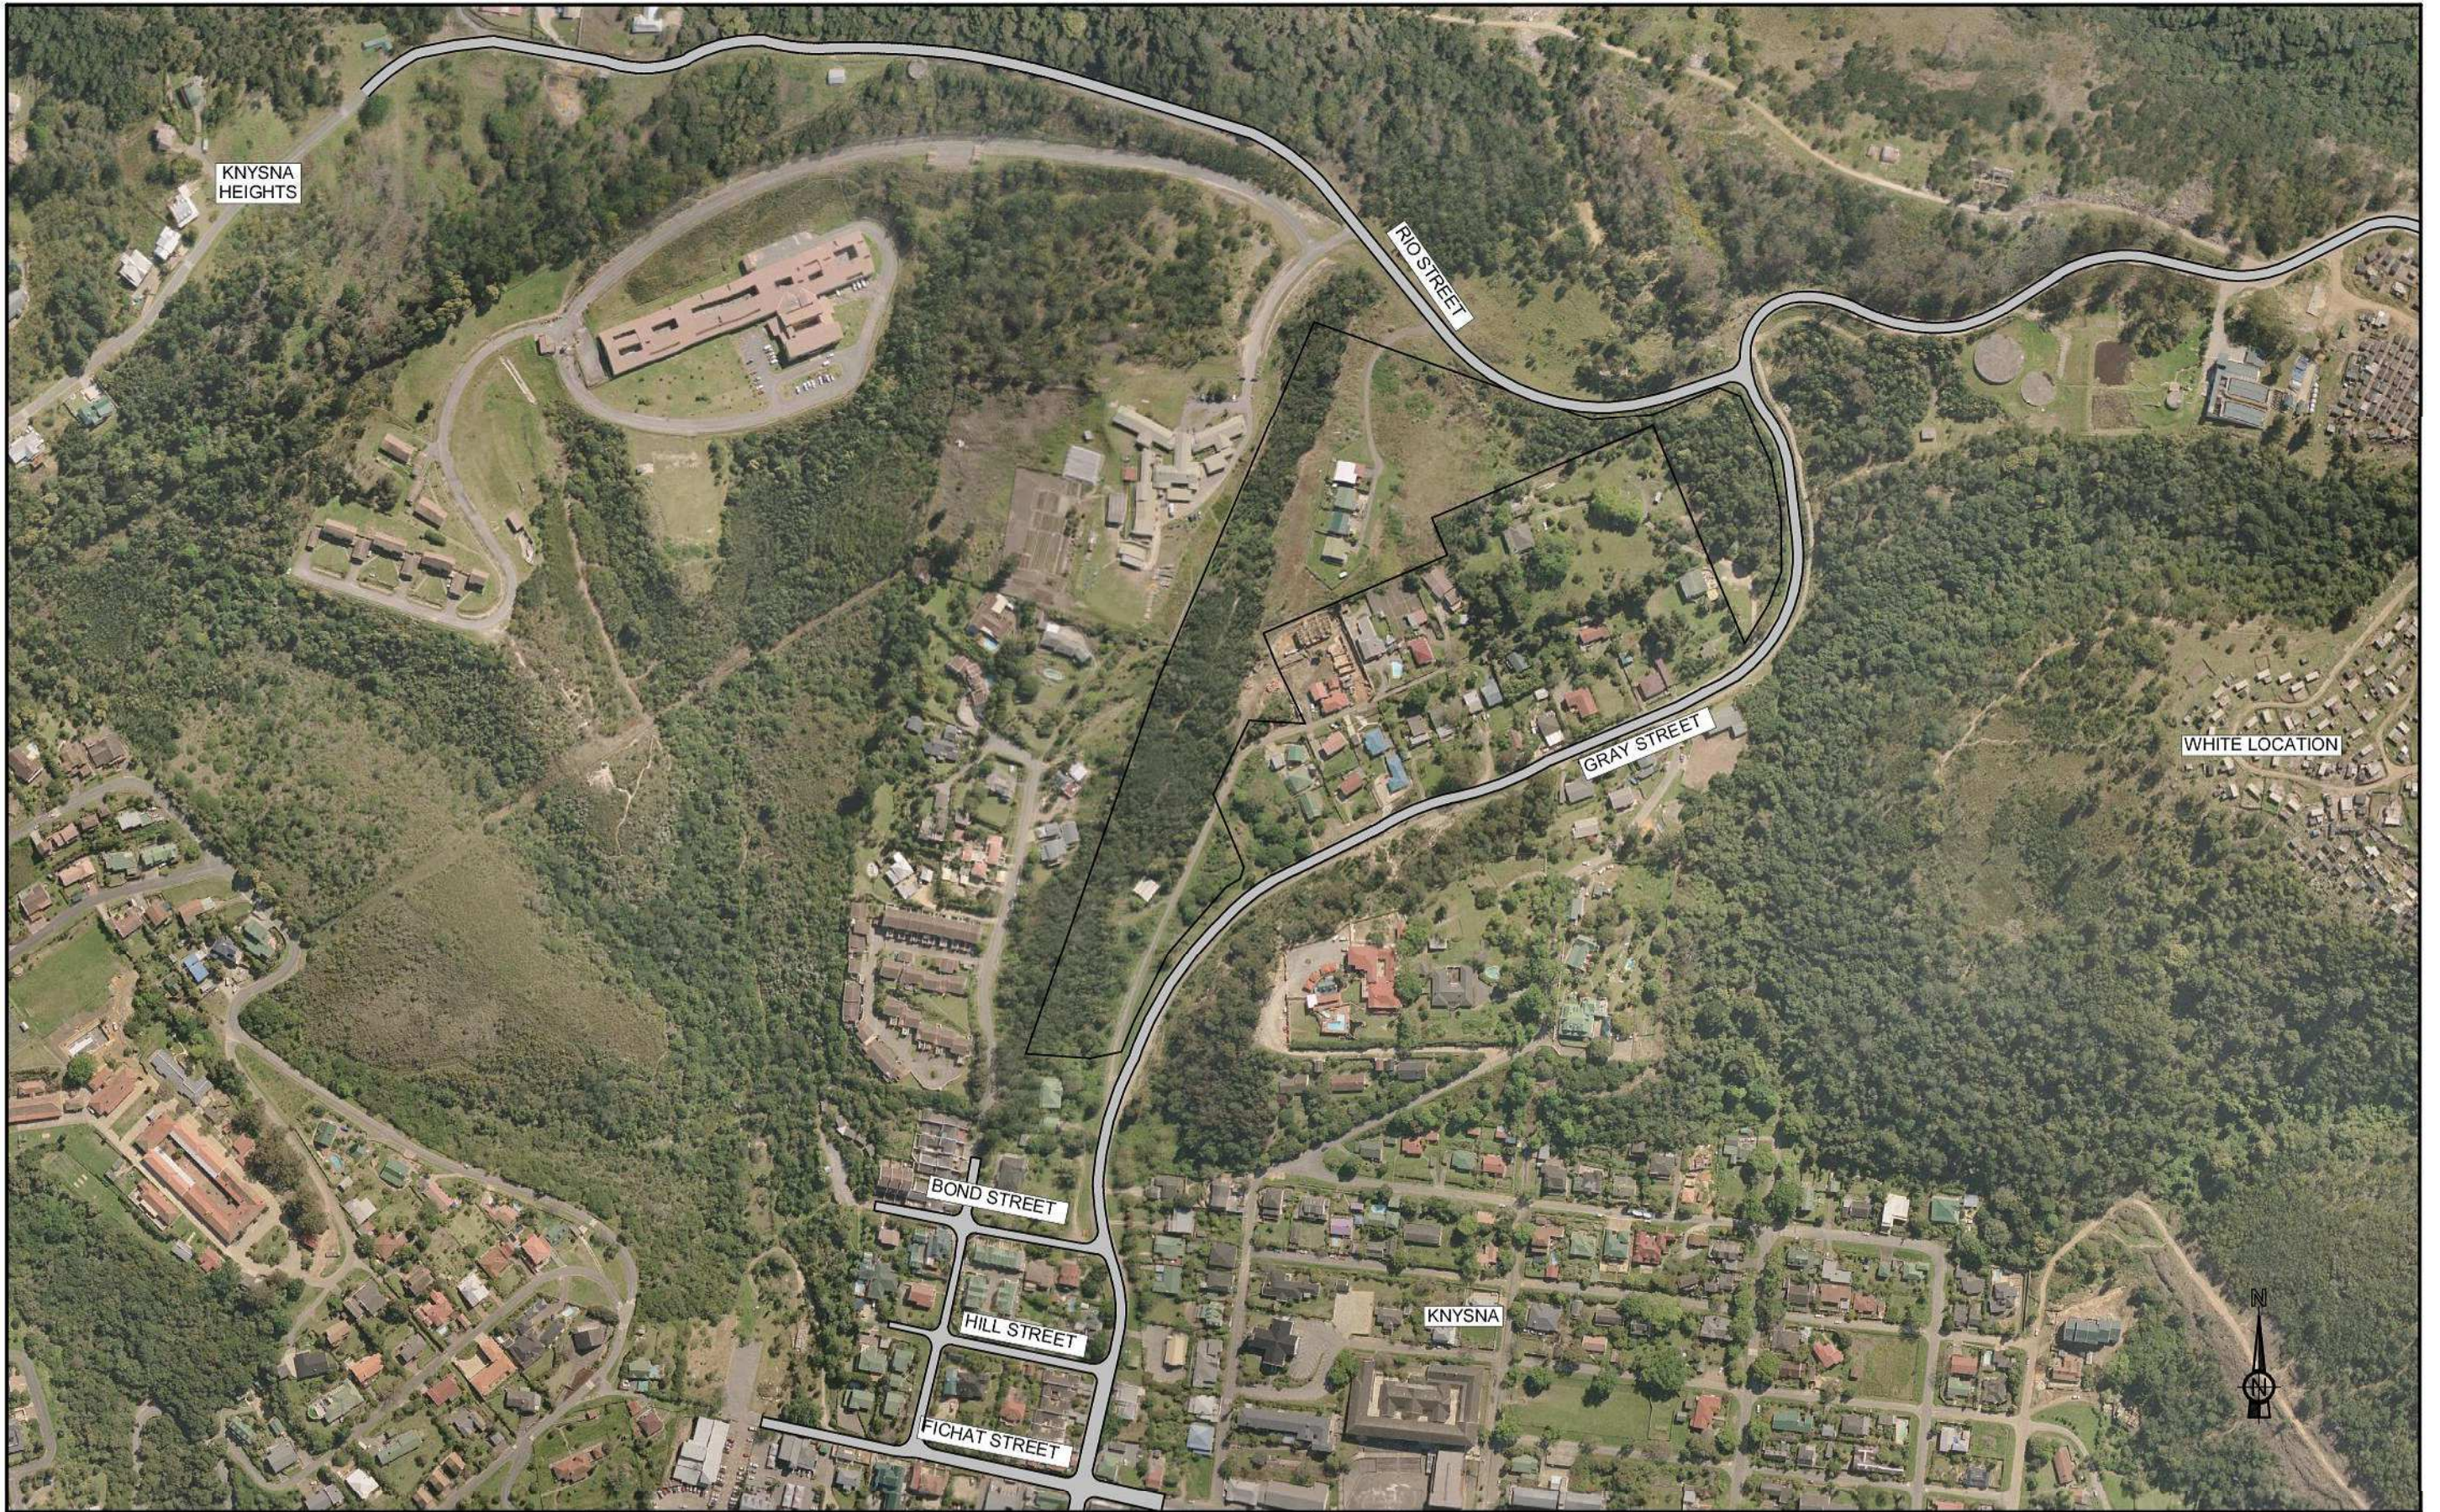
UTSHINTSHO / AMENDMENTS		UMLINGANISELO SCALE	UMLINGANISELO WOMZOBO OHLISWEYO SCALE ON REDUCED DRAWING	UMENZI DESIGN	CH	ENGINEERING ADVICE AND SERVICES associated with ULWAZI 73 Hugh Road, Walmer P.O. Box 12987 Hummwood Port Elizabeth 6013 tel/fax: (041) 581 2421	IVUNYELWE APPROVED	IVUNYELWE APPROVED	IPROJETHI / PROJECT	INAME LESIVUMELWANO CONTRACT NO.
IVUNYELWE APPROVED	IVUNYELWE APPROVED	UMLINGANISELO SCALE	UMLINGANISELO WOMZOBO OHLISWEYO SCALE ON REDUCED DRAWING	UMZONI DRAWN	CP		ININELI/ENG.	UMENZELWA / CLIENT		
UMHLA / DATE	UMHLA / DATE	UMLINGANISELO SCALE	UMLINGANISELO WOMZOBO OHLISWEYO SCALE ON REDUCED DRAWING	IVUNYELWE APPROVED	CH		UMENZELWA / CLIENT	UMZONIKHCAZA / DWG DESCRIPTION	1088-P-05	
		UMLINGANISELO SCALE	UMLINGANISELO WOMZOBO OHLISWEYO SCALE ON REDUCED DRAWING	UMHLA / DATE	JAN 2014		UMHLA / DATE	EXISTING ROADS - FIGURE 5
