# GEOTECHNICAL REPORT

## PROPOSED NEW RESIDENTIAL DEVELOPMENT ON PORTION 91 OF MATJIESFONTIEN 304, KEURBOOMSTRAND, PLETTENBERG BAY

8 March 2023 (Rev 0)

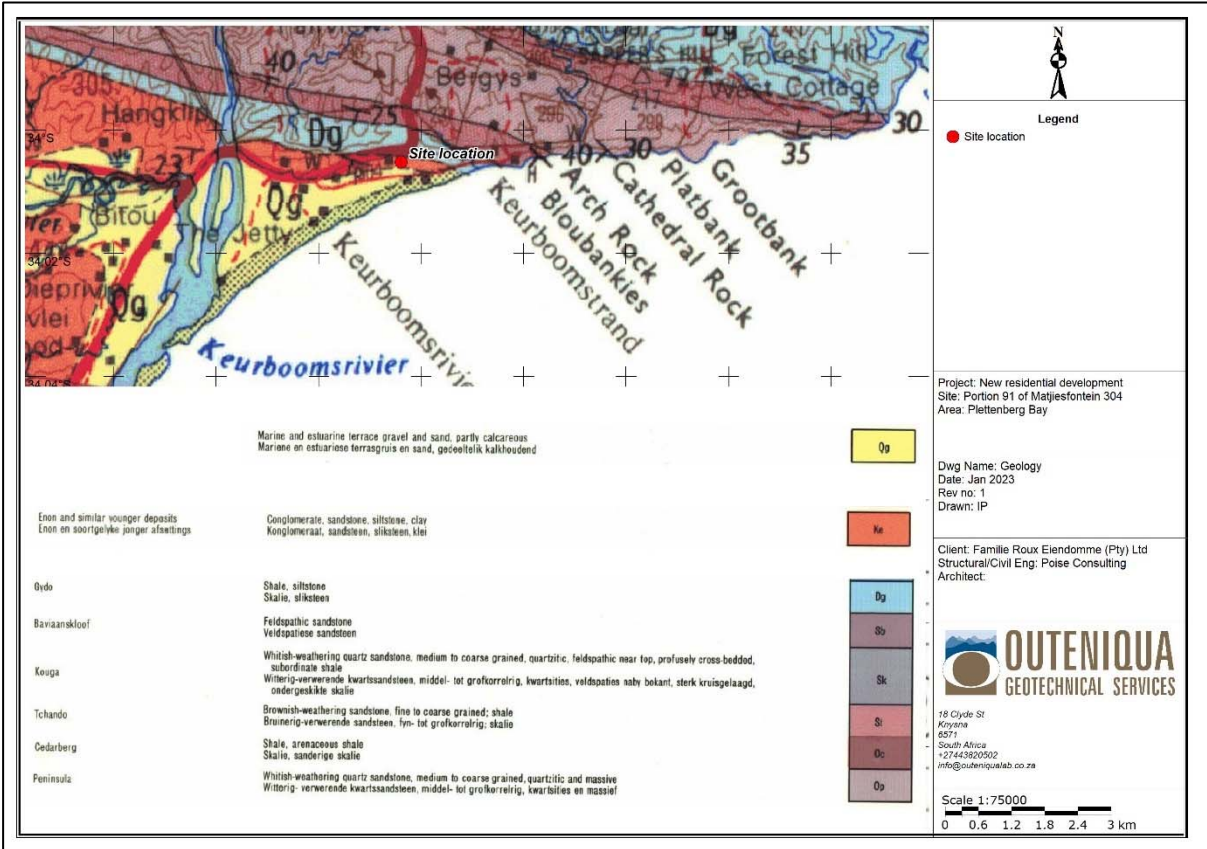
Figure 5: Geological map of site

The official geological mapping of the area indicated that the lower/southern portion of the site was underlain by estuarine/alluvial sand deposits of Quaternary age (yellow on map in **Figure 5**) which overlie sandstone and conglomerate of the Enon Formation (red/orange on map) of the Uitenhage Group on the northern slopes. The Enon Formation then overlies shale of the Gydo Formation and sandstone and shale of Baviaanskloof Formation which outcrop along the Keurboomstrand road to the east of the site. No major geological faults were mapped in the vicinity of the site and the risk of seismic activity was low. The geology was generally considered macro stable for development purposes with due consideration paid to local geotechnical constraints.

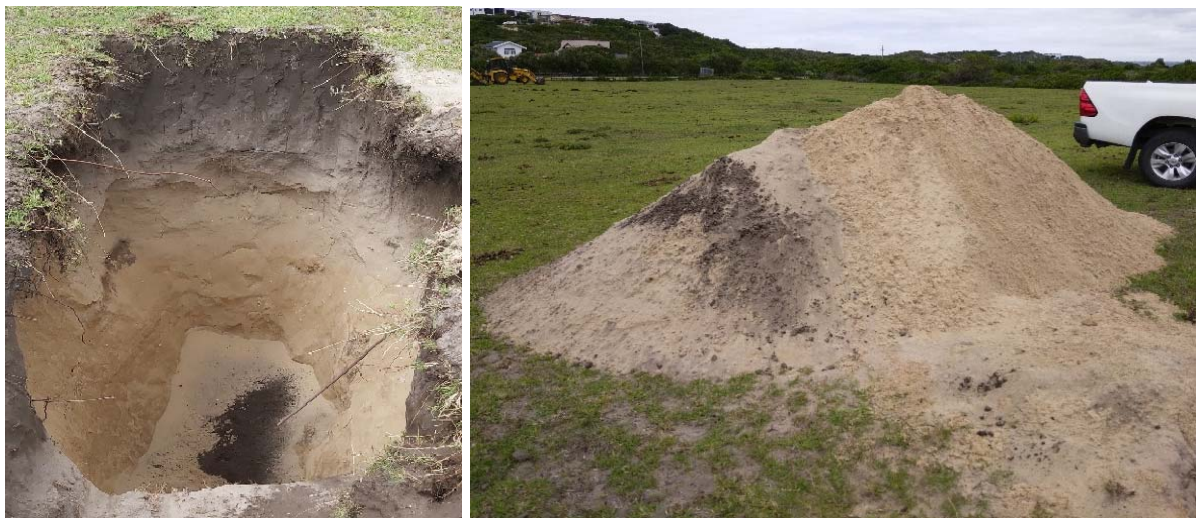
Figure 6: Typical sandy soil types encountered in test pits

The soil profile was broadly consistent across the site, and dominated by estuarine sandy soil (see **Figure 6**). The profile broadly included a sporadic upper horizon of imported fill soil (disturbed or dumped soil), underlain by an insitu topsoil horizon, consisting of silty sand, roots and organic humus, which was underlain by unconsolidated to semi consolidated sand with scattered marine shell fragments. At TP5, a pedogenic calcrete hardpan layer (very soft rock) was encountered just below the topsoil horizon (see **Figure 7**). The calcrete was highly to completely weathered in places to a sandy gravel, angular cobbles and/or small boulders. A summary of the soil profiles was provided in **Table 1**.

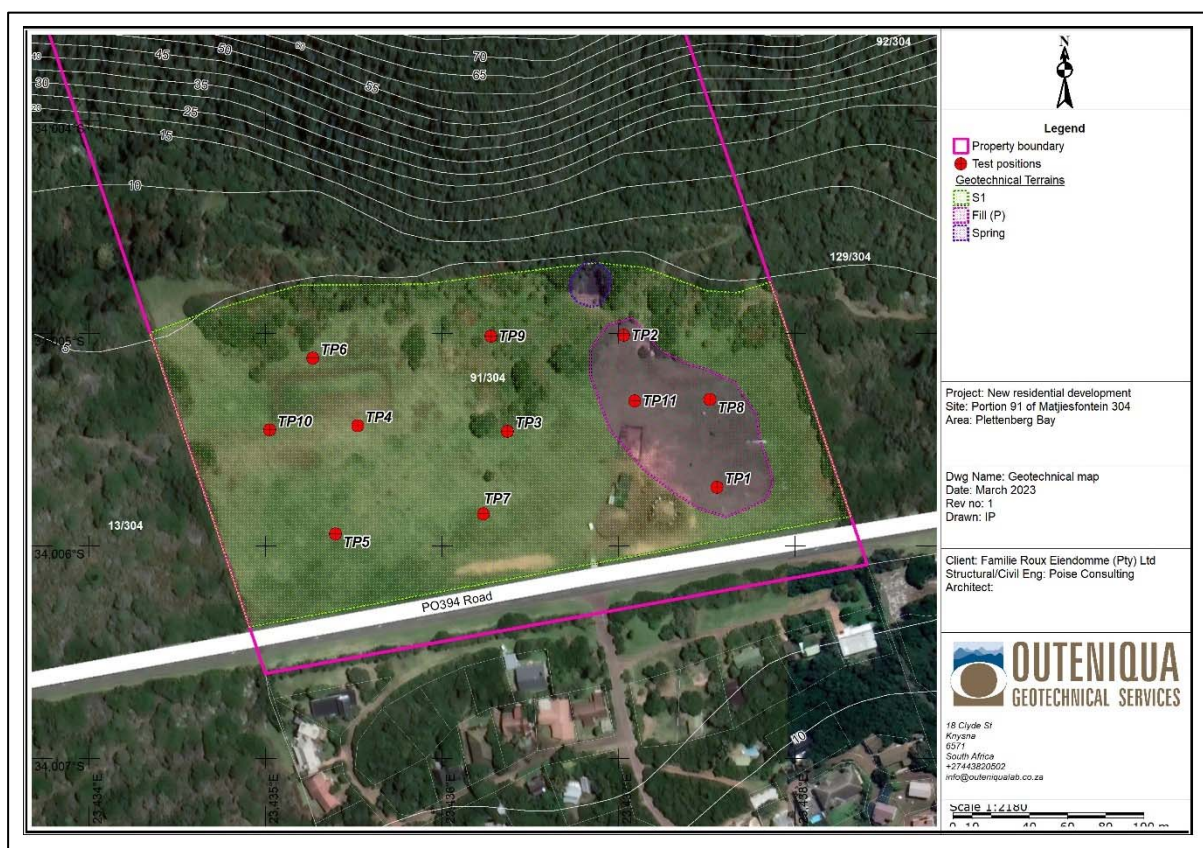
Figure 8: Geotechnical map

The site was mapped according to the site class designations provided in SANS10400-H (refer to **Table 5**). Due to the broadly consistent conditions observed in the investigation, the majority of the proposed development footprint area was mapped as a single geotechnical terrain with the site class designation of **S1** (potentially compressible sandy soils). Minor superficial deposits of uncontrolled fill (**P**) were also mapped as indicated in **Figure 8**.

Observations made during the site investigations and analysis of test results indicated that the natural soils at normal shallow levels (0.5-1m) was dominated by potentially compressible fine sand. The soil would require improvement (compaction) to safely support type 1 residential structures on conventional shallow spread foundations with typical bearing pressures of up to 150kPa. Beyond this maximum typical load, the depth of improvement or type of foundation would require further consideration.

Other geotechnical constraints which could affect earthworks or foundations, such as uncontrolled fill, surface water bodies and ground water were also identified. Earthworks and foundation design recommendations were provided in **Chapter 6**.

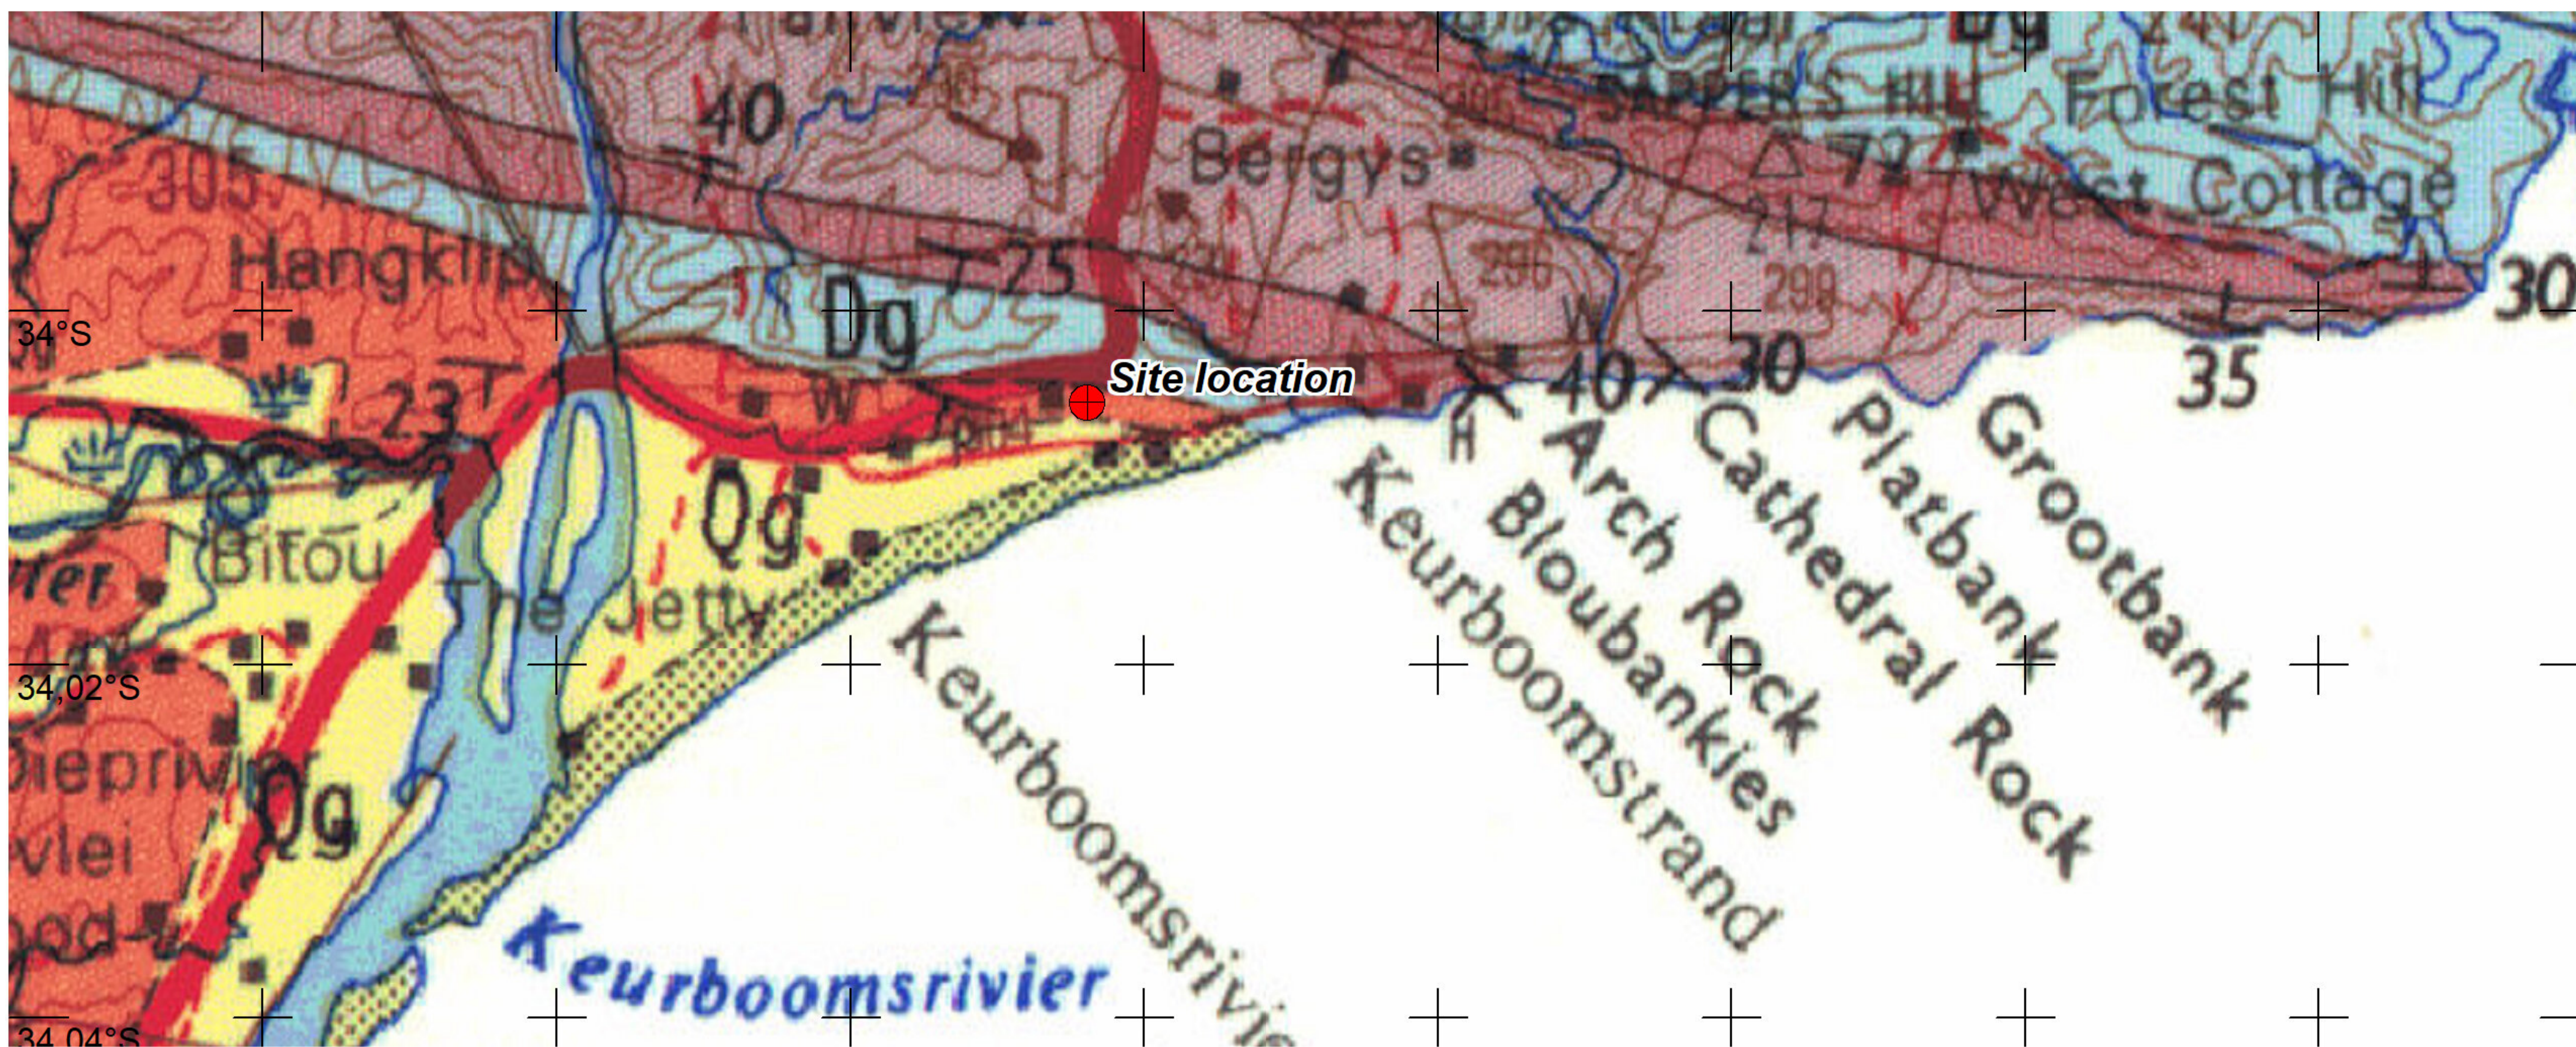
**Legend**

● Site location

Enon and similar younger deposits  
 Enon en soortgelyke jonger afsettings

Conglomerate, sandstone, siltstone, clay  
 Konglomeraat, sandsteen, sliiksteen, klei

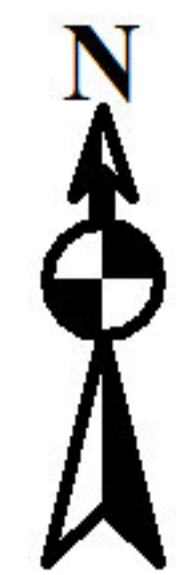
Dwg Name: Geotechnical map  
 Date: March 2023  
 Rev no: 1  
 Drawn: IP

Steep slopes > 1:4 not recommended for development

**Legend**

- Property boundary
- Test positions
- Geotechnical Terrains
- S1
- Fill (P)
- Spring

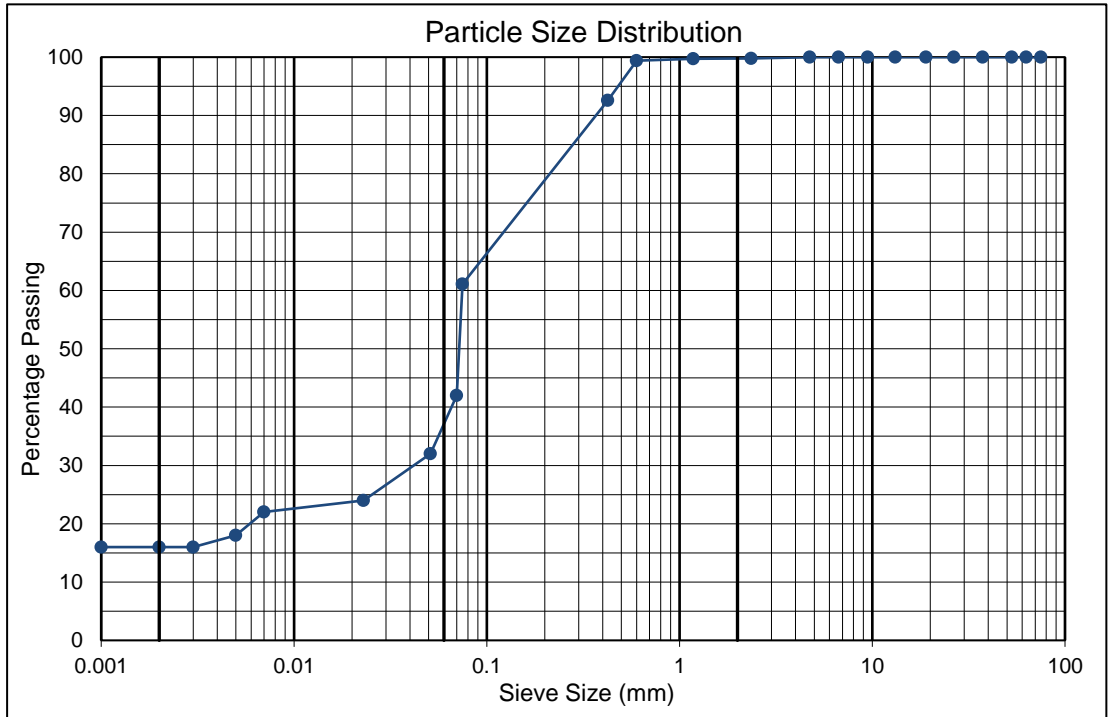
## TEST REPORT FOUNDATION INDICATOR - (ASTM Method D422)

75.0mm	100
63.0mm	100
53.0mm	100
37.5mm	100
26.5mm	100
19mm	100
13.2mm	100
9.5mm	100
6.7mm	100
4.75mm	100
2.36mm	100
1.18mm	100
0.6mm	99
0.425mm	93
0.075mm	61
0.07mm	42
0.051mm	32
0.023mm	24
0.007mm	22
0.005mm	18
0.003mm	16
0.002mm	16
0.001mm	16

% Clay	16
% Silt	21
% Sand	63
% Gravel	0

Unified Soil Classification	ML
AASHTO Soil Classification	A-4

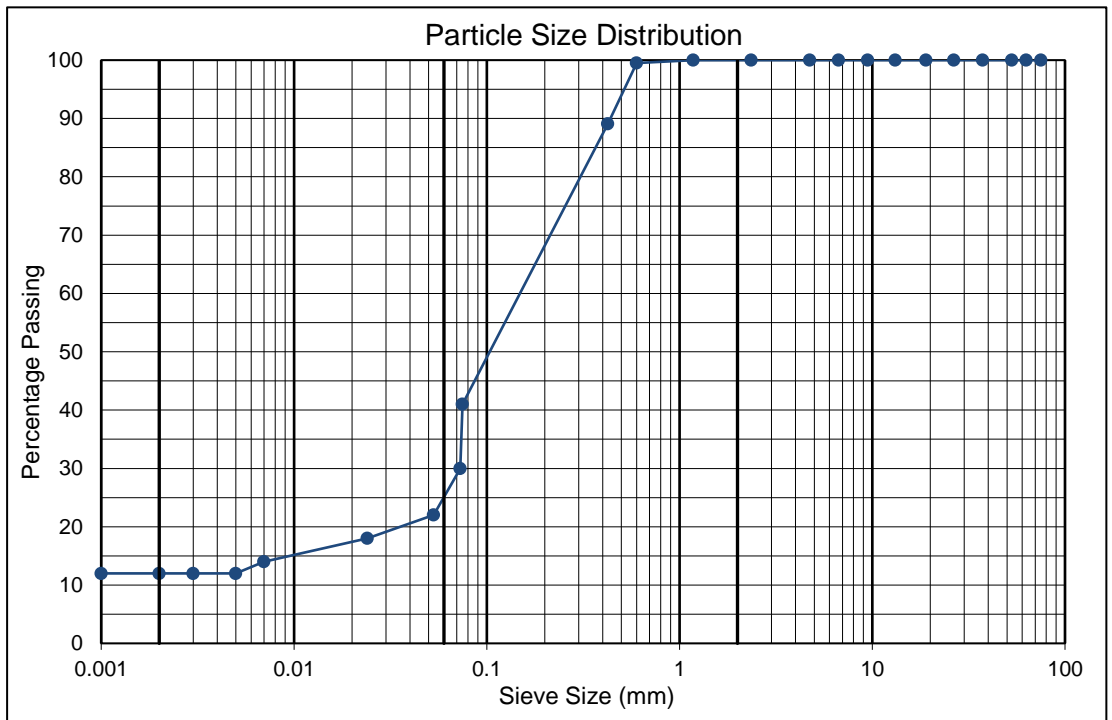
## TEST REPORT FOUNDATION INDICATOR - (ASTM Method D422)

75.0mm	100
63.0mm	100
53.0mm	100
37.5mm	100
26.5mm	100
19mm	100
13.2mm	100
9.5mm	100
6.7mm	100
4.75mm	100
2.36mm	100
1.18mm	100
0.6mm	100
0.425mm	89
0.075mm	41
0.073mm	30
0.053mm	22
0.024mm	18
0.007mm	14
0.005mm	12
0.003mm	12
0.002mm	12
0.001mm	12

% Clay	12
% Silt	13
% Sand	75
% Gravel	0

Unified Soil Classification	SM
AASHTO Soil Classification	A-4

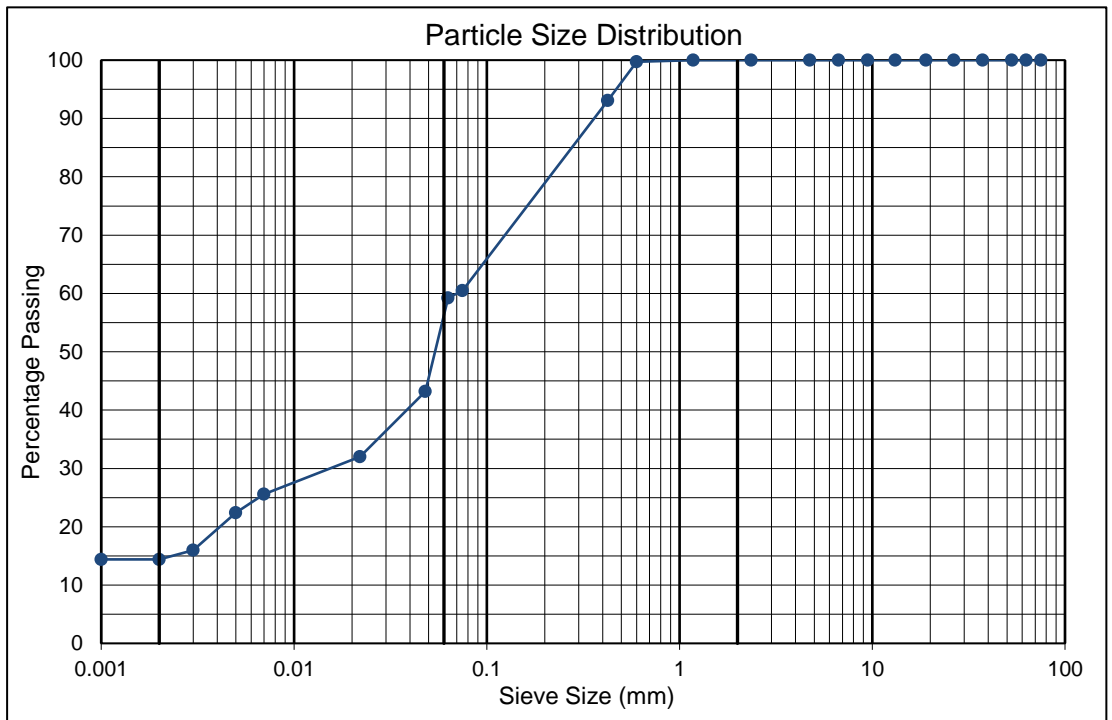
## TEST REPORT FOUNDATION INDICATOR - (ASTM Method D422)

75.0mm	100
63.0mm	100
53.0mm	100
37.5mm	100
26.5mm	100
19mm	100
13.2mm	100
9.5mm	100
6.7mm	100
4.75mm	100
2.36mm	100
1.18mm	100
0.6mm	100
0.425mm	93
0.075mm	61
0.063mm	59
0.048mm	43
0.022mm	32
0.007mm	26
0.005mm	22
0.003mm	16
0.002mm	14
0.001mm	14

% Clay	14
% Silt	42
% Sand	44
% Gravel	0

Unified Soil Classification	ML
AASHTO Soil Classification	A-4

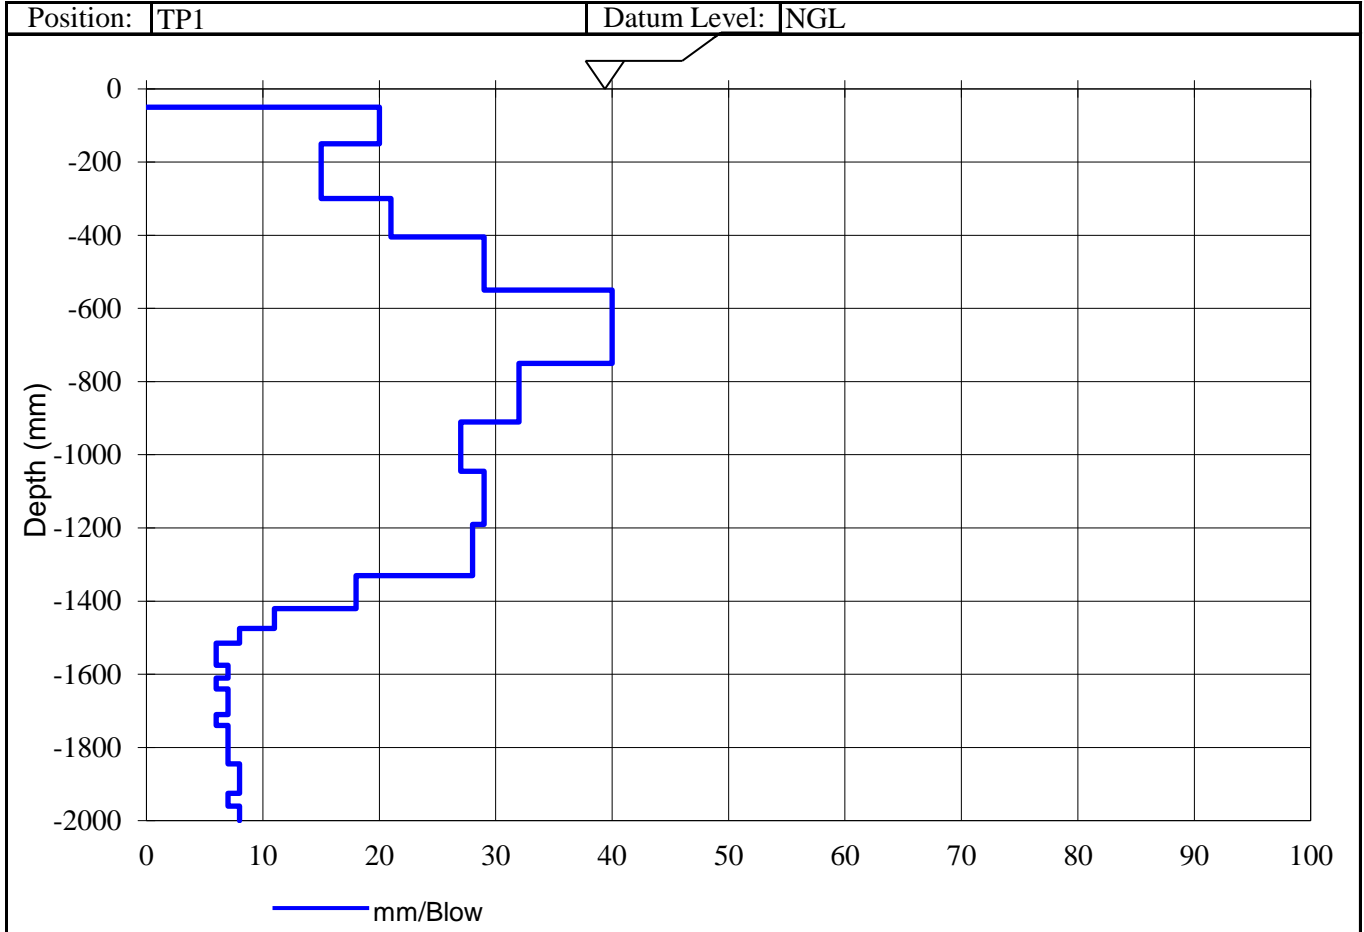
### Dynamic Cone Penetrometer (DCP) - (TMH 6 Method ST6)

In situ penetration tests (DCP) indicated significant variation in the consistency of the soil in the upper 0.7m of the profile, but consistently dense conditions below this level.
