Rock Hounds (pty)Ltd

Scope: Preliminary Geomatic and Geotechnical investigation to determine dune stability and morphology over time

Location: Sedgefield area, Cola Beach, Garden Route, erf 79/205 Ruygte Vally

Report: RH160524

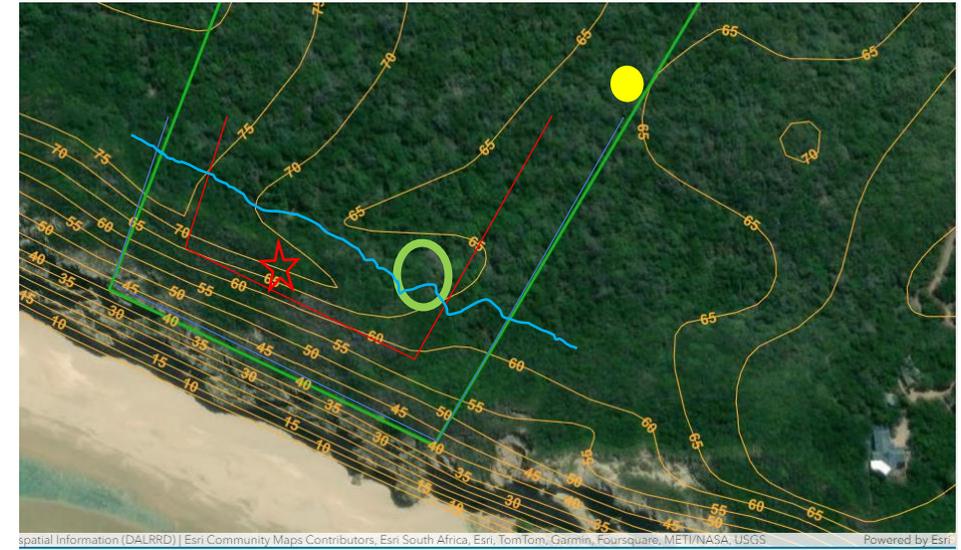
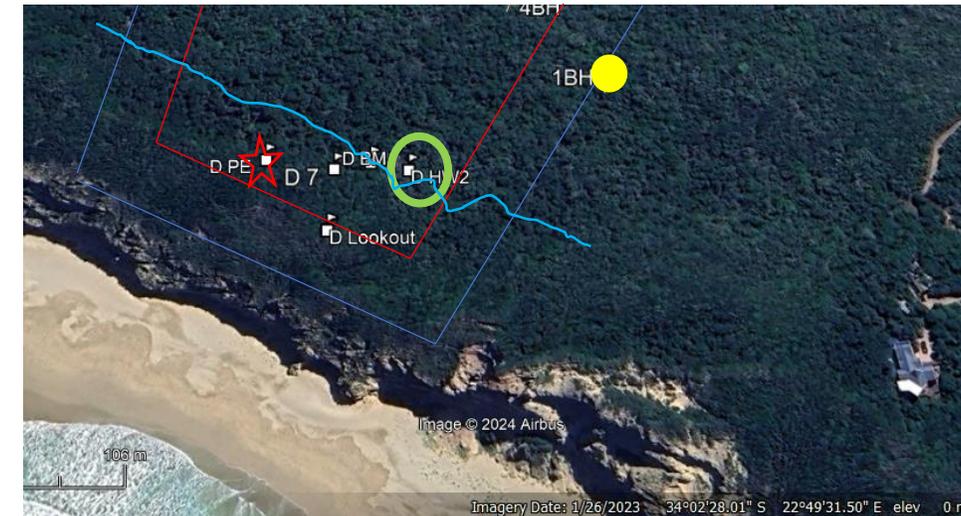
Overlays of proposed sites onto satellite image (plain 2D view) - Cape Farm Mapper (top) and Google Earth Pro (bottom)

PE- Western point on path & survey point (75m above sea level); Lookout – Path overlooking sea (76m above sea level); D7 – Position of deep fracture on scan (79m above sea level); Cross – Split in path (77m above sea level); BM – survey point (72m above sea level); HW2 – survey point & Tall trees (70m above sea level)

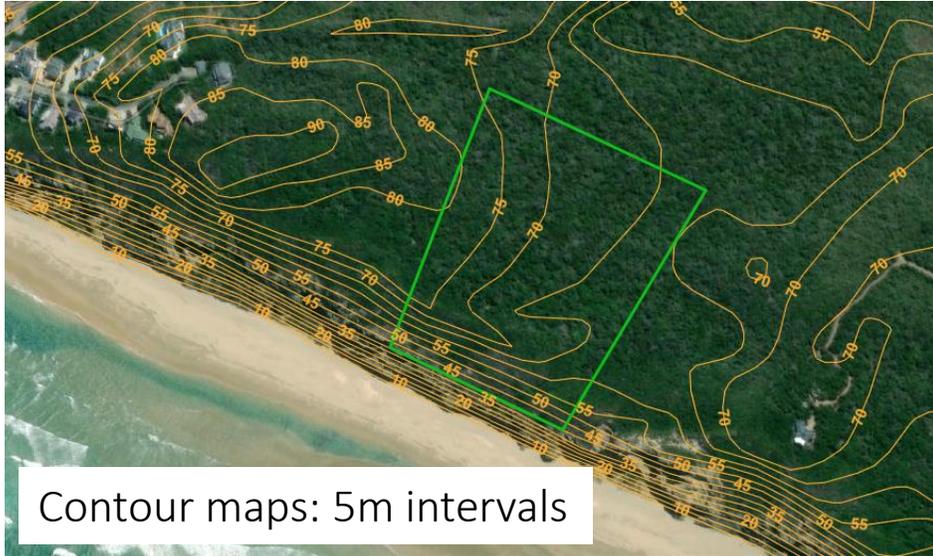
Slope stability: The property is located on low-sloping areas behind the front dune edge, from marker HW2 inland, dipping gently from 0-21% degrees with an easterly dip. The slope changes significantly from marker HW2 towards the coast at 26-70 degrees over a 70m horizontal distance.

- **Slope:** The area is classified as low sloped area in the areas of PE, BM and HW2 inland, covered in tall trees from the 65m contour at 0-21 degrees , with high slope values from the BM area towards the Lookout point and toward the coast, covered in coastal shrubs, from the 75m contour to the sea level, at 26 to 70 degrees over 50m. The area from the lookout to the coastal zone is a high risk area due to the high slope values.

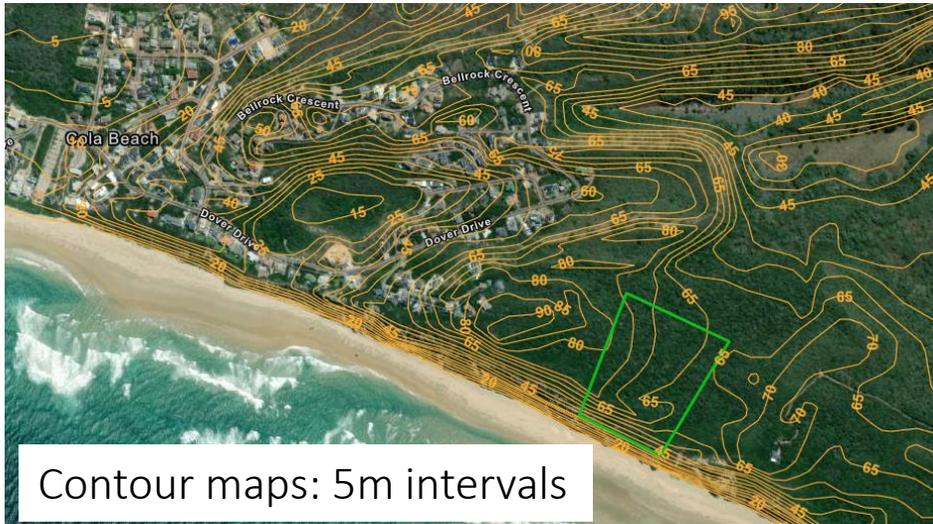
Slope Degrees

- The property lies across the 5m contour map from 75m in the western areas to 40m height on the coastal border.
- Sudden slope changes occur at the coastal border edge from 70m to 40m, across a horizontal distance of 60-70
- Slope changes from 2 degrees in areas BM and HW2 to 32 degrees from Lookout to coastal zone

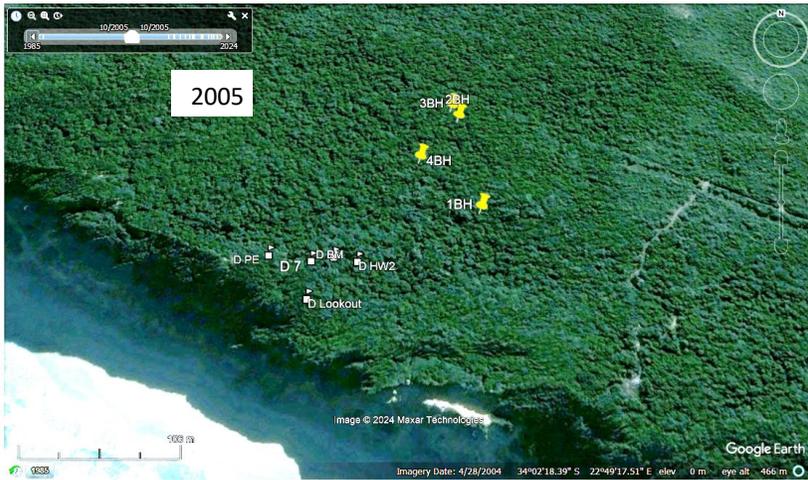
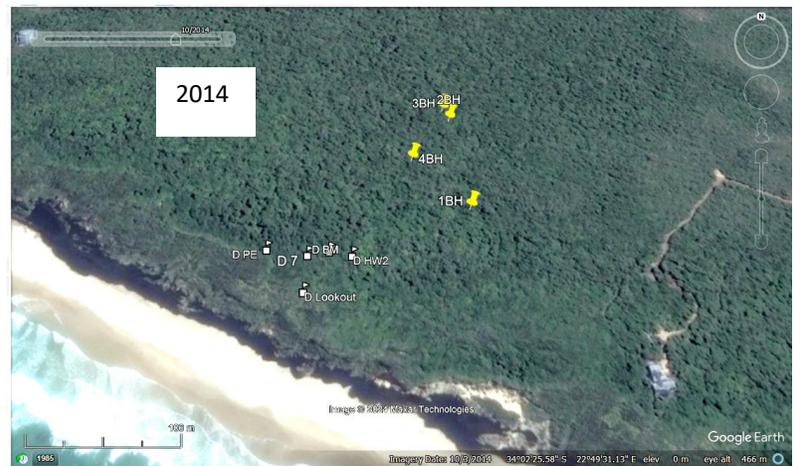
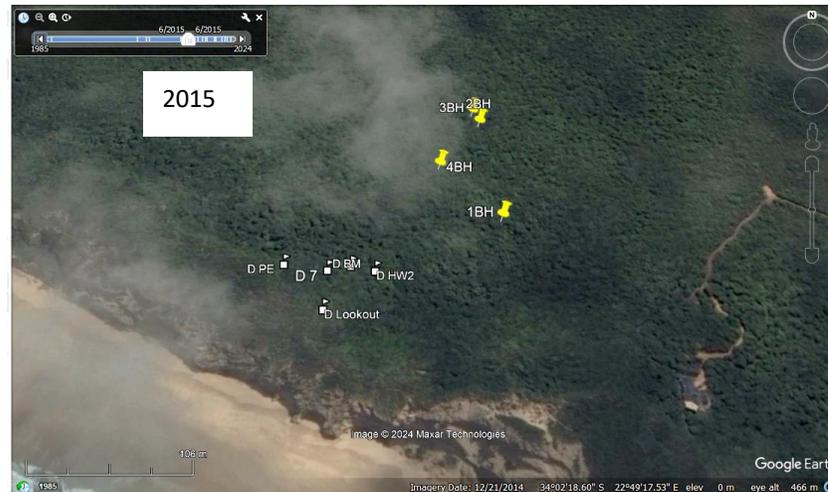
Historical satellite imagery 2005 to 2015: Indicate a significant sea erosion episode in 2013-2014 that caused an overhang in the fossil dune. The soft beach sand were removed by wave action at sea level and created hollows under the dune.

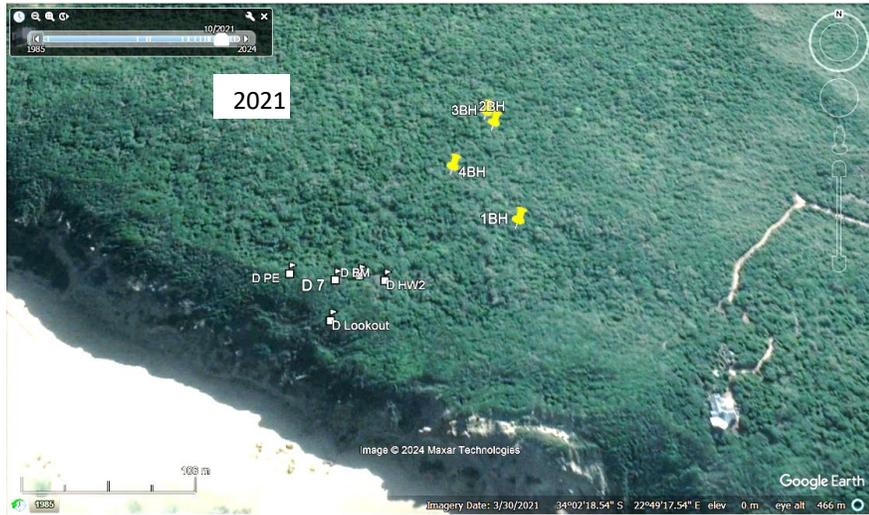
Historical satellite imagery 2021-2024: 2021 to 2022 indicate a significant dune build episode, with sand deposited at sea level at the foot of the fossil dune and a recovery in vegetation on the top of the dune. Wave erosion in 2023 caused an overhang in the fossil dune again. The soft beach sand were removed by wave action and created hollows under the dune. The top of the fossil dune were moderately eroded in 2023 by rainfall, visible as exposed ragged edges on the vegetation edge.

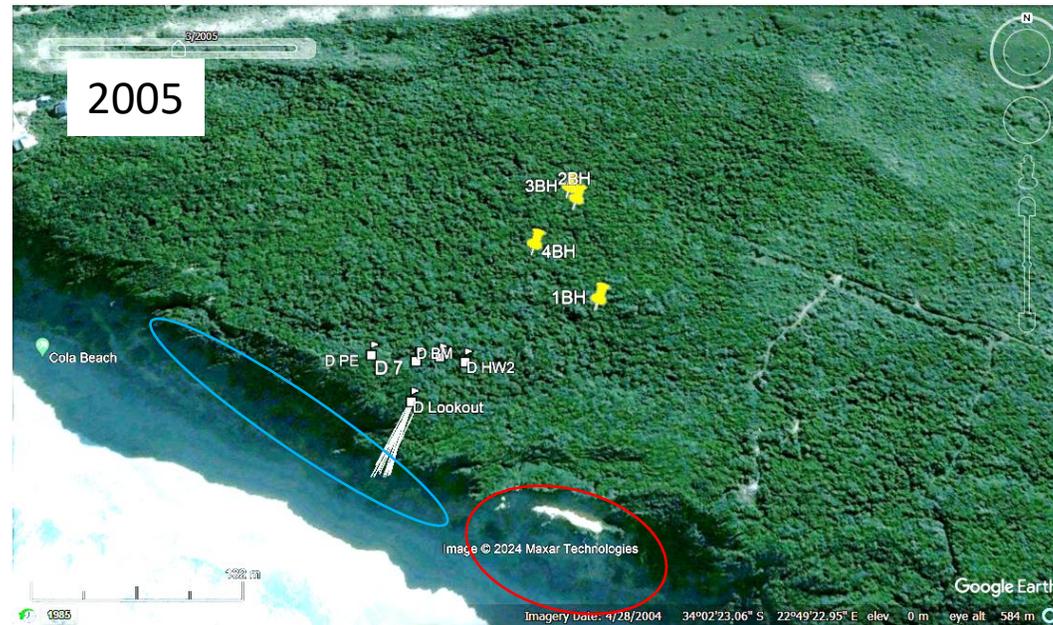
Google Earth Pro measurements: Horizontal distance of the Lookout towards the fossil dune edge

Total retreat 4m-6m +/-2m over 19 years in the 10-25m contour area

- Distances were measured from the Lookout GPS Point towards the top edge of the fossilised dune 10m-25m contour line, at a 90 degree angle to the coast. Measurement error is approximately 2m.

- Measurements are superimposed on both images (white lines)
- The data indicate a absolute horizontal retreat of the fossilised dune from 57m (2005) to 54m (2022), 4m total, or 53m (2013) to 47m (2024), 6m total, over a time span of 19 years. Note that the dune builds and erodes approximately every 5 -6 years. See red datapoints, indicating erosion events.*

- Image observations:* Loose sand covered the fossil dune base, along the high water mark (red circles) in 2005, 2015, and 2022 compared to 2013, 2019 and 2024 where the fossil dune is more exposed and eroded at sea level than in 2005, indicating increased erosion over time and caving in at sea level, creating overhangs, ie geotechnically unstable. Then the dune building cycle repeats and sand is deposited in the hollows again.

- Fossil dune top surfaces has been eroded from the top in the 20-30m contour, due to wind and rainfall (blue circles) in 2024, compared to 2005. This gives the area a more exposed image in 2024, compared to 2005 and makes it more prone to further rain damage

- Measurements satellite images:** The data indicate a absolute horizontal retreat of the fossilised dune from 57m (2005) to 54m (2022), 4m total, or 53m (2013) to 47m (2024), 6m total, over a time span of 19 years. Note that the dune builds and erodes approximately every 5 -6 years. The dune morphology (shape) builds (sediment deposition) and erodes in cycles of approximately every 5 -6 years. Erosion at sea level occurred in 2013, 2019 and 2024. Building (sediment deposition) of the dune occurred in 2005,2015 and 2022 where sand was re-deposited by wave action at sea level. Total observed change is 4-6m inland horizontal movement over 19 years in the 10-25m contour area. The property border is on the 40m contour line, 10m away from the 30m coastal zone contour line. Fossil dune top surfaces between 20-30m contours has been eroded from the top, due to wind and rainfall in 2024, compared to 2005. This gives the area a more exposed image in 2024, compared to 2005. Vegetation has consistently grown from 2005 to 2024 from the 25m contour inland.
