GEOTECHNICAL SOIL TEST REPORT

Client: Mr Beveridge c/o Dave Visser Consulting Engineers

Project: Rem of Ptn 57 Brakkloof 443, Plettenberg Bay

Date of test: 20.09.2024

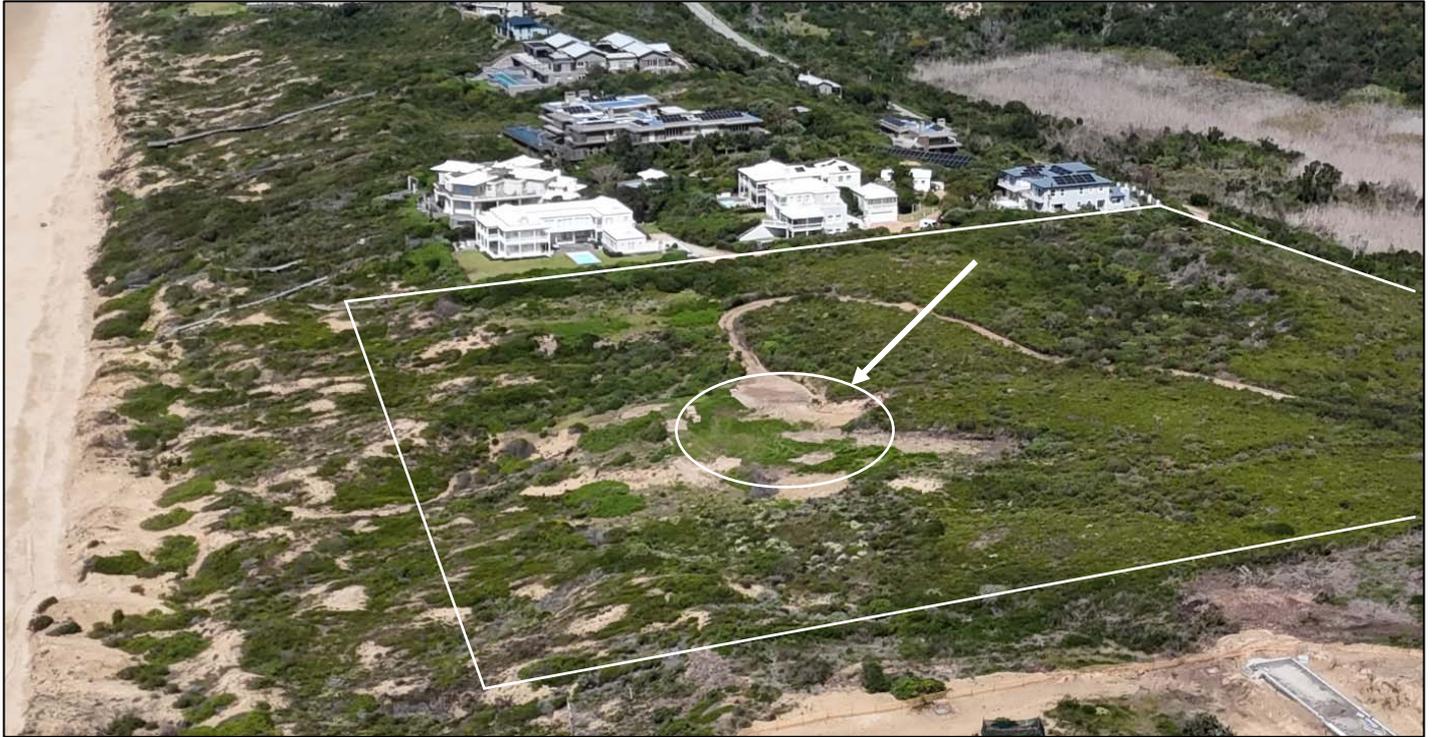
Figure 1: Oblique aerial view of the site and existing platform area, looking southwest

The natural topography of the site was generally characterised as a coastal dune ridge, sloping to the west and east. Robberg beach was located less than 100m to the east of the site. There were no significant natural drainage features or surface water bodies on the site such as streams, marshes or dams, but the ground surface was fairly irregular with several depressions and small hillocks, typical of a dune field. The proposed site for the new house was a fairly level existing platform where

the previous house was built (See Figure 1-2). The surface conditions were moist due to recent rain and loose/sandy but generally stable with no signs of any severe stability problems.

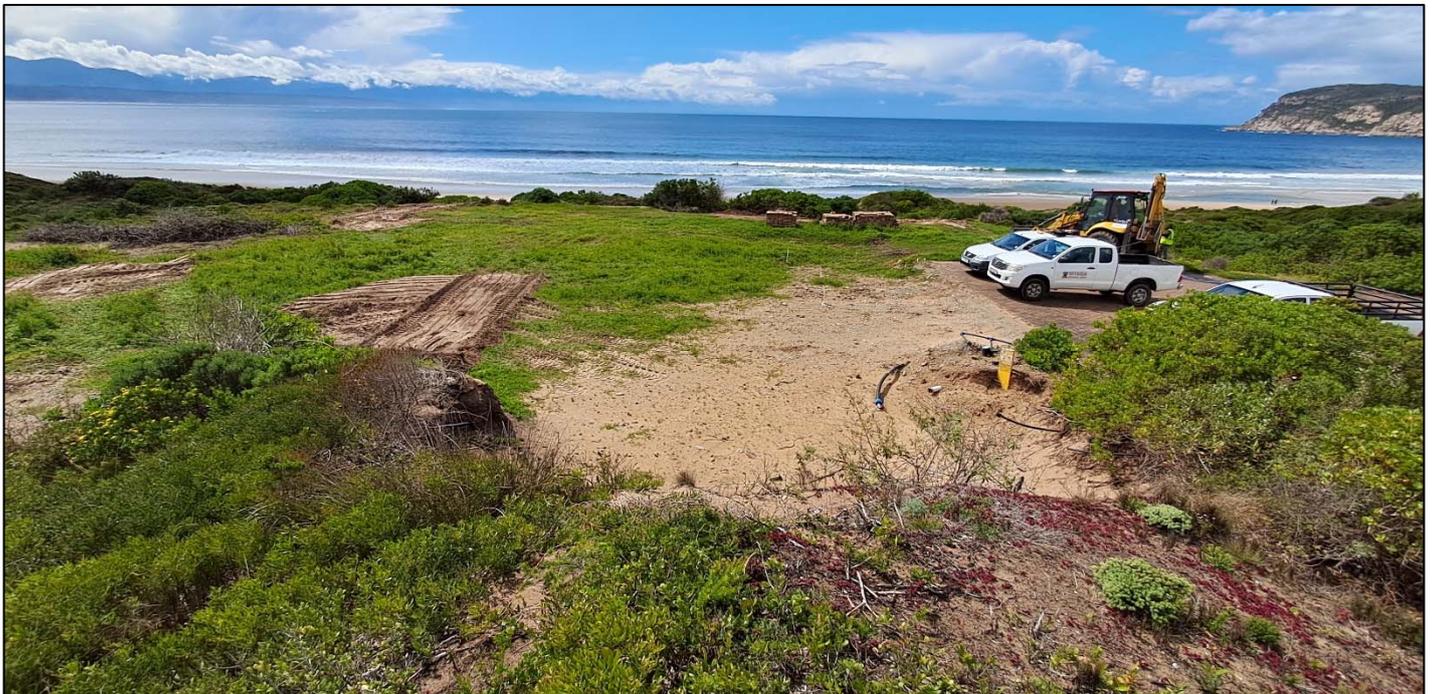
Figure 2: View of the site, looking east towards Robberg Beach

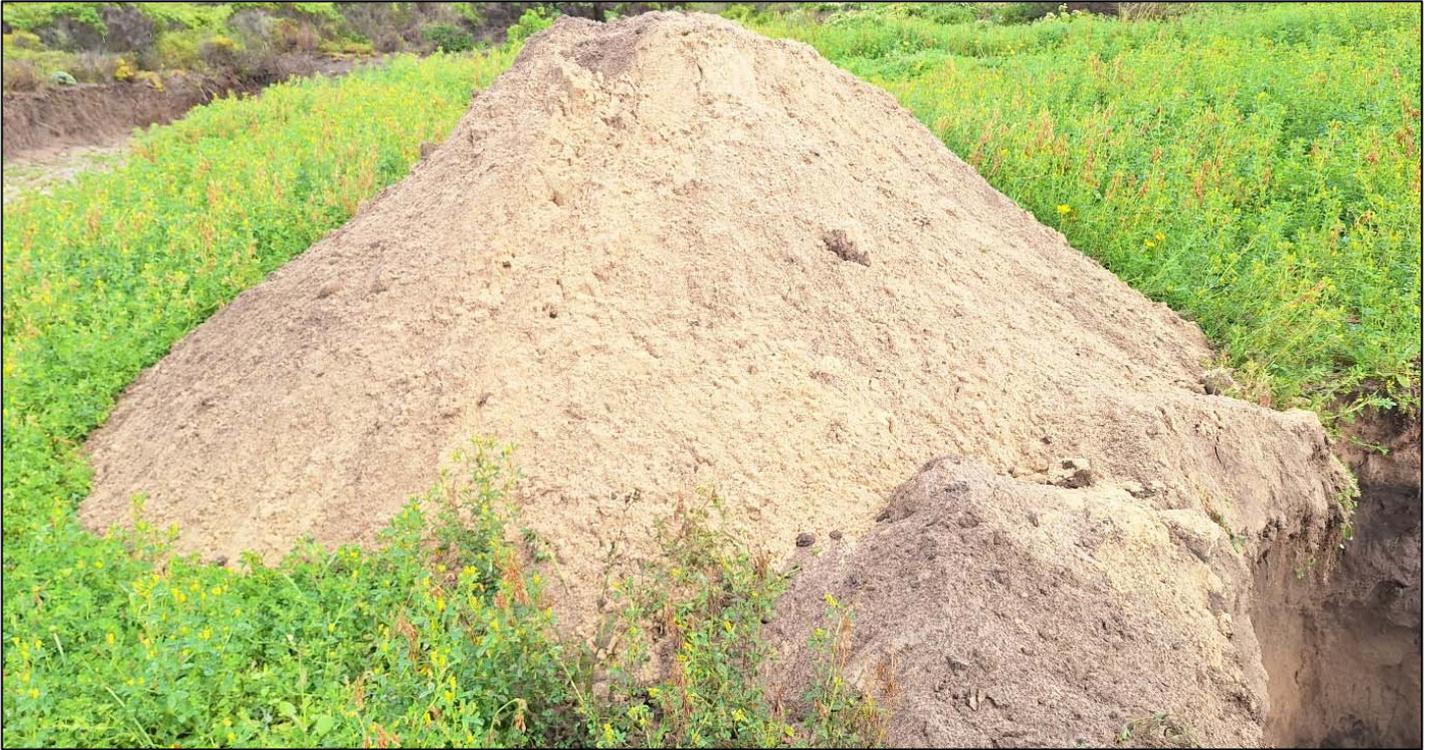
Figure 3: Typical fine grained aeolian sand encountered in test pits

The profile excavated in test pits correlated with the local geology of the area. The natural soil profiles were dominated by fine aeolian (dune) sand (see Figure 3). Uncontrolled fill from the previous house and its demolition were encountered in some of the test pits, consisting of a mixture of rubble, sand and remnant foundation structures (See Figure 4). The underlying bedrock was not exposed on surface or in test pits and was not expected within a depth of at least 10m.

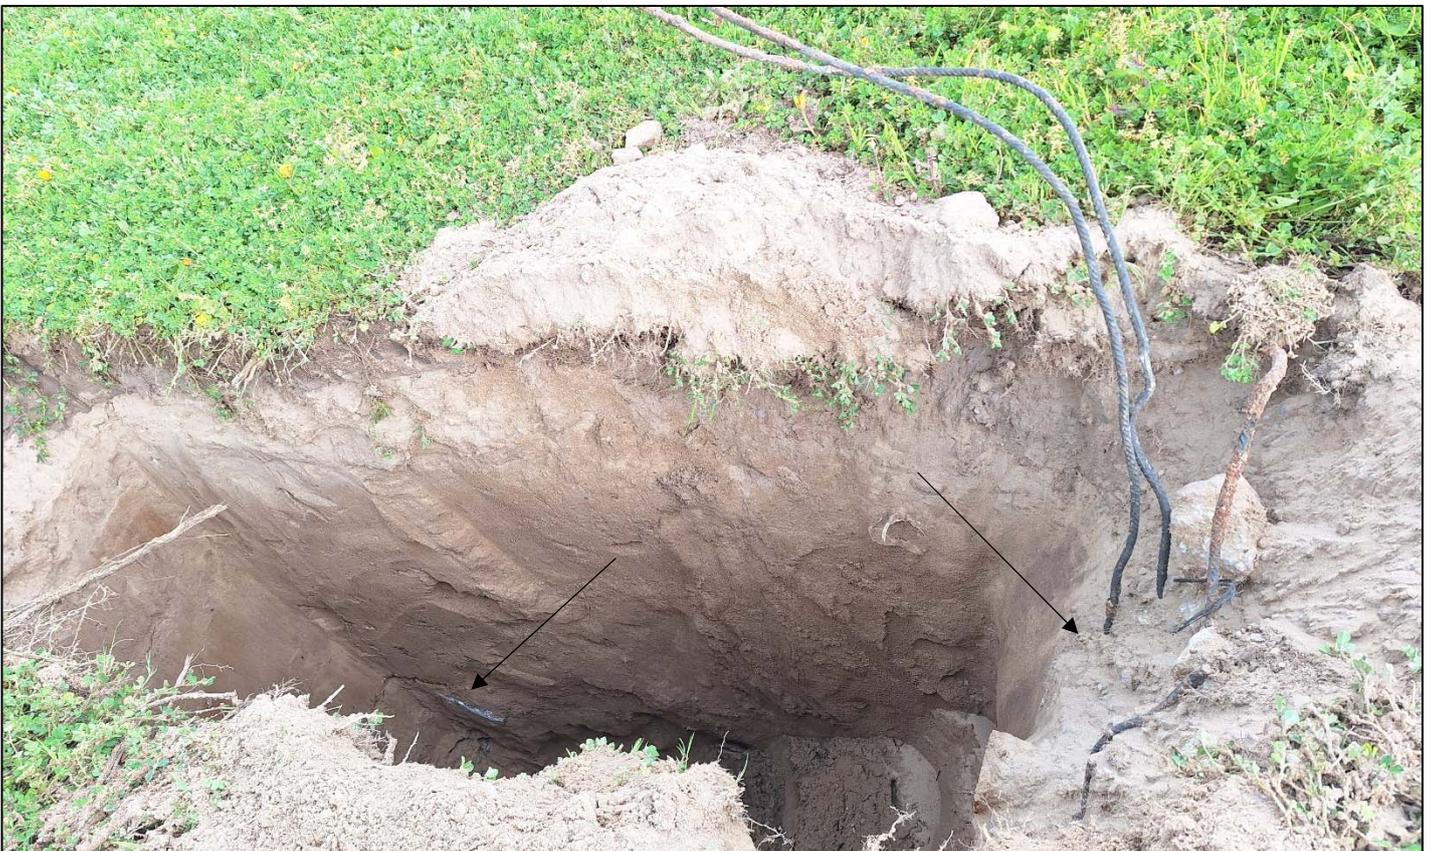
Figure 4: Rubble and remnant foundation structures encountered in some pits

Earthworks: Significant earthworks were expected to remove old remnant foundation structures and establish the various proposed platform levels. All excavations were provisionally classified as "soft" in accordance with SANS1200D and thus excavatable with a TLB or preferably tracked excavator, as some buried foundations may be difficult to excavate with a TLB.

All vegetation and existing uncontrolled fill should be completely stripped from the footprint of the proposed structures and stockpiled for later use or removed to spoil as directed by the engineer. The insut sandy soil could be re-used for bulk fill material on platforms, behind retaining walls and under floors and foundations, provided that any unsuitable rubble, steel rebar, etc is selected out and the required level of compaction is achieved (recommend 95-98% MDD (<25mm/blow of DCP) for load-bearing fill). All soils obtained from excavations on site should first be stockpiled for approval by the engineer before reuse as fill material. Allowance should also be made for importation of some higher quality material (such as G5) for upper layerworks under surface bed floors and under heavily loaded spread foundations, where necessary. Compaction should be properly tested. Deep excavations may be highly unstable at angles greater than 45° and shoring or battering of slopes is recommended in excavations >1m.

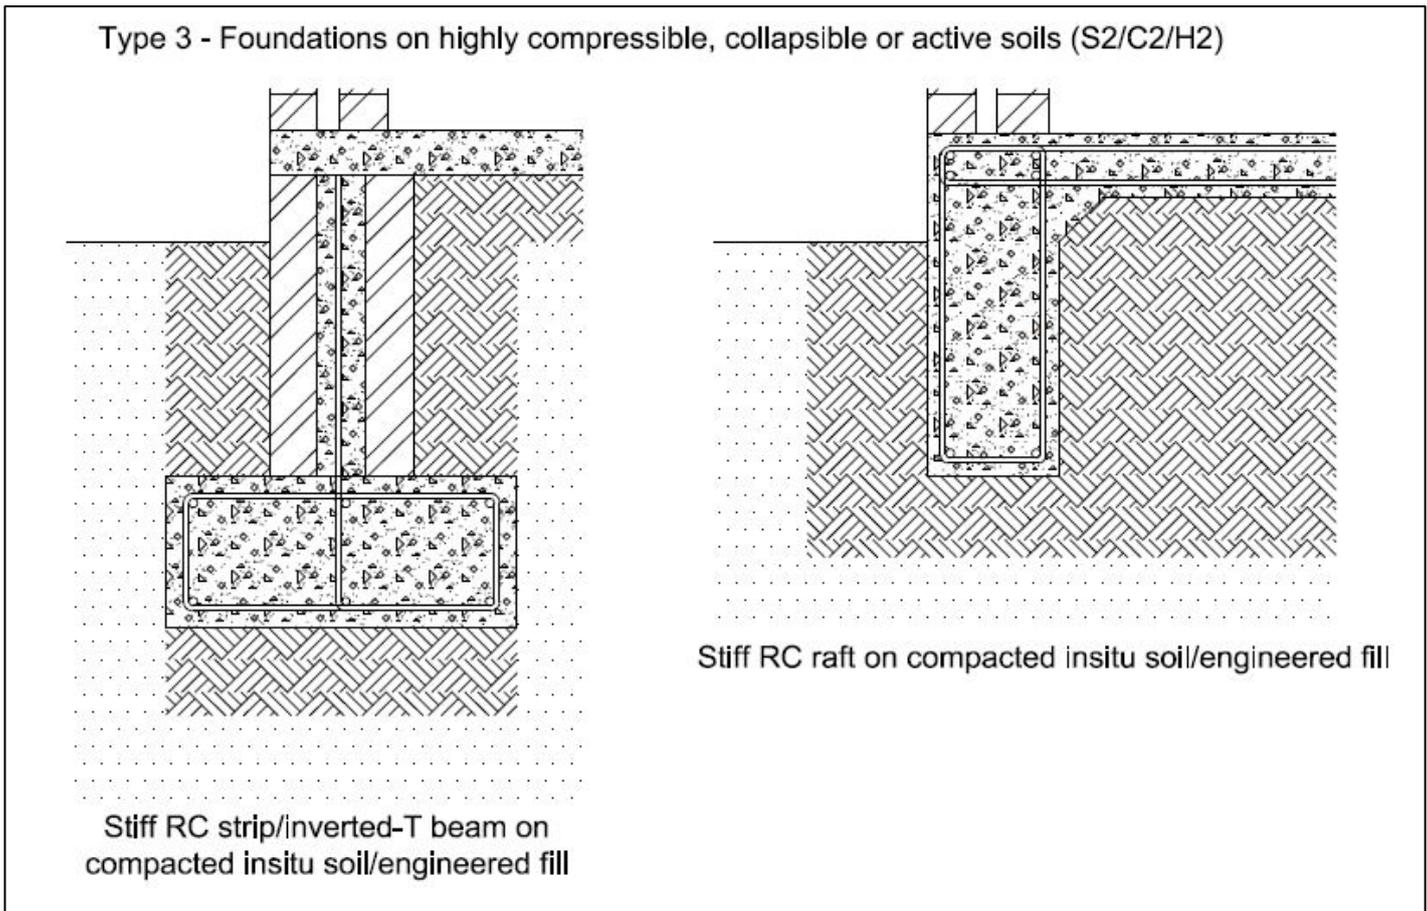
Figure 5: Recommended shallow foundation types

Foundations: Single/double storey masonry structures can be founded on reinforced spread foundations (strips/pads), placed on recompacted insitu soil (i.e. a soil raft). Bearing pressure should be limited to 150kPa. Higher loads may require deep foundations (e.g. piles) or stabilisation of the insitu soil below foundations. The thickness of compacted soil below shallow foundations should be at least 1.5x width of the footing and should be tested with a DCP. The recommended method is to over excavate the trench, wet and compact the base of the excavation and then replace the excavated soil back into the trench in compacted layers not exceeding 0.3m if using a 2t roller or 0.15m for 1t roller or trench compactor. Sand should be well wetted to achieve compaction. The engineer should also inspect excavations to confirm suitable conditions. An RC raft foundation is also a suitable system on an engineered soil raft. Some articulation joints are recommended in large structures to accommodate differential settlement. Furthermore, it is recommended that the eastern edge of the structure is supported on piled foundations to protect against possible future coastal erosion. The recommended pile type is bored or driven piles embedded at least 6-8m below ground level. No water table is expected at this depth.

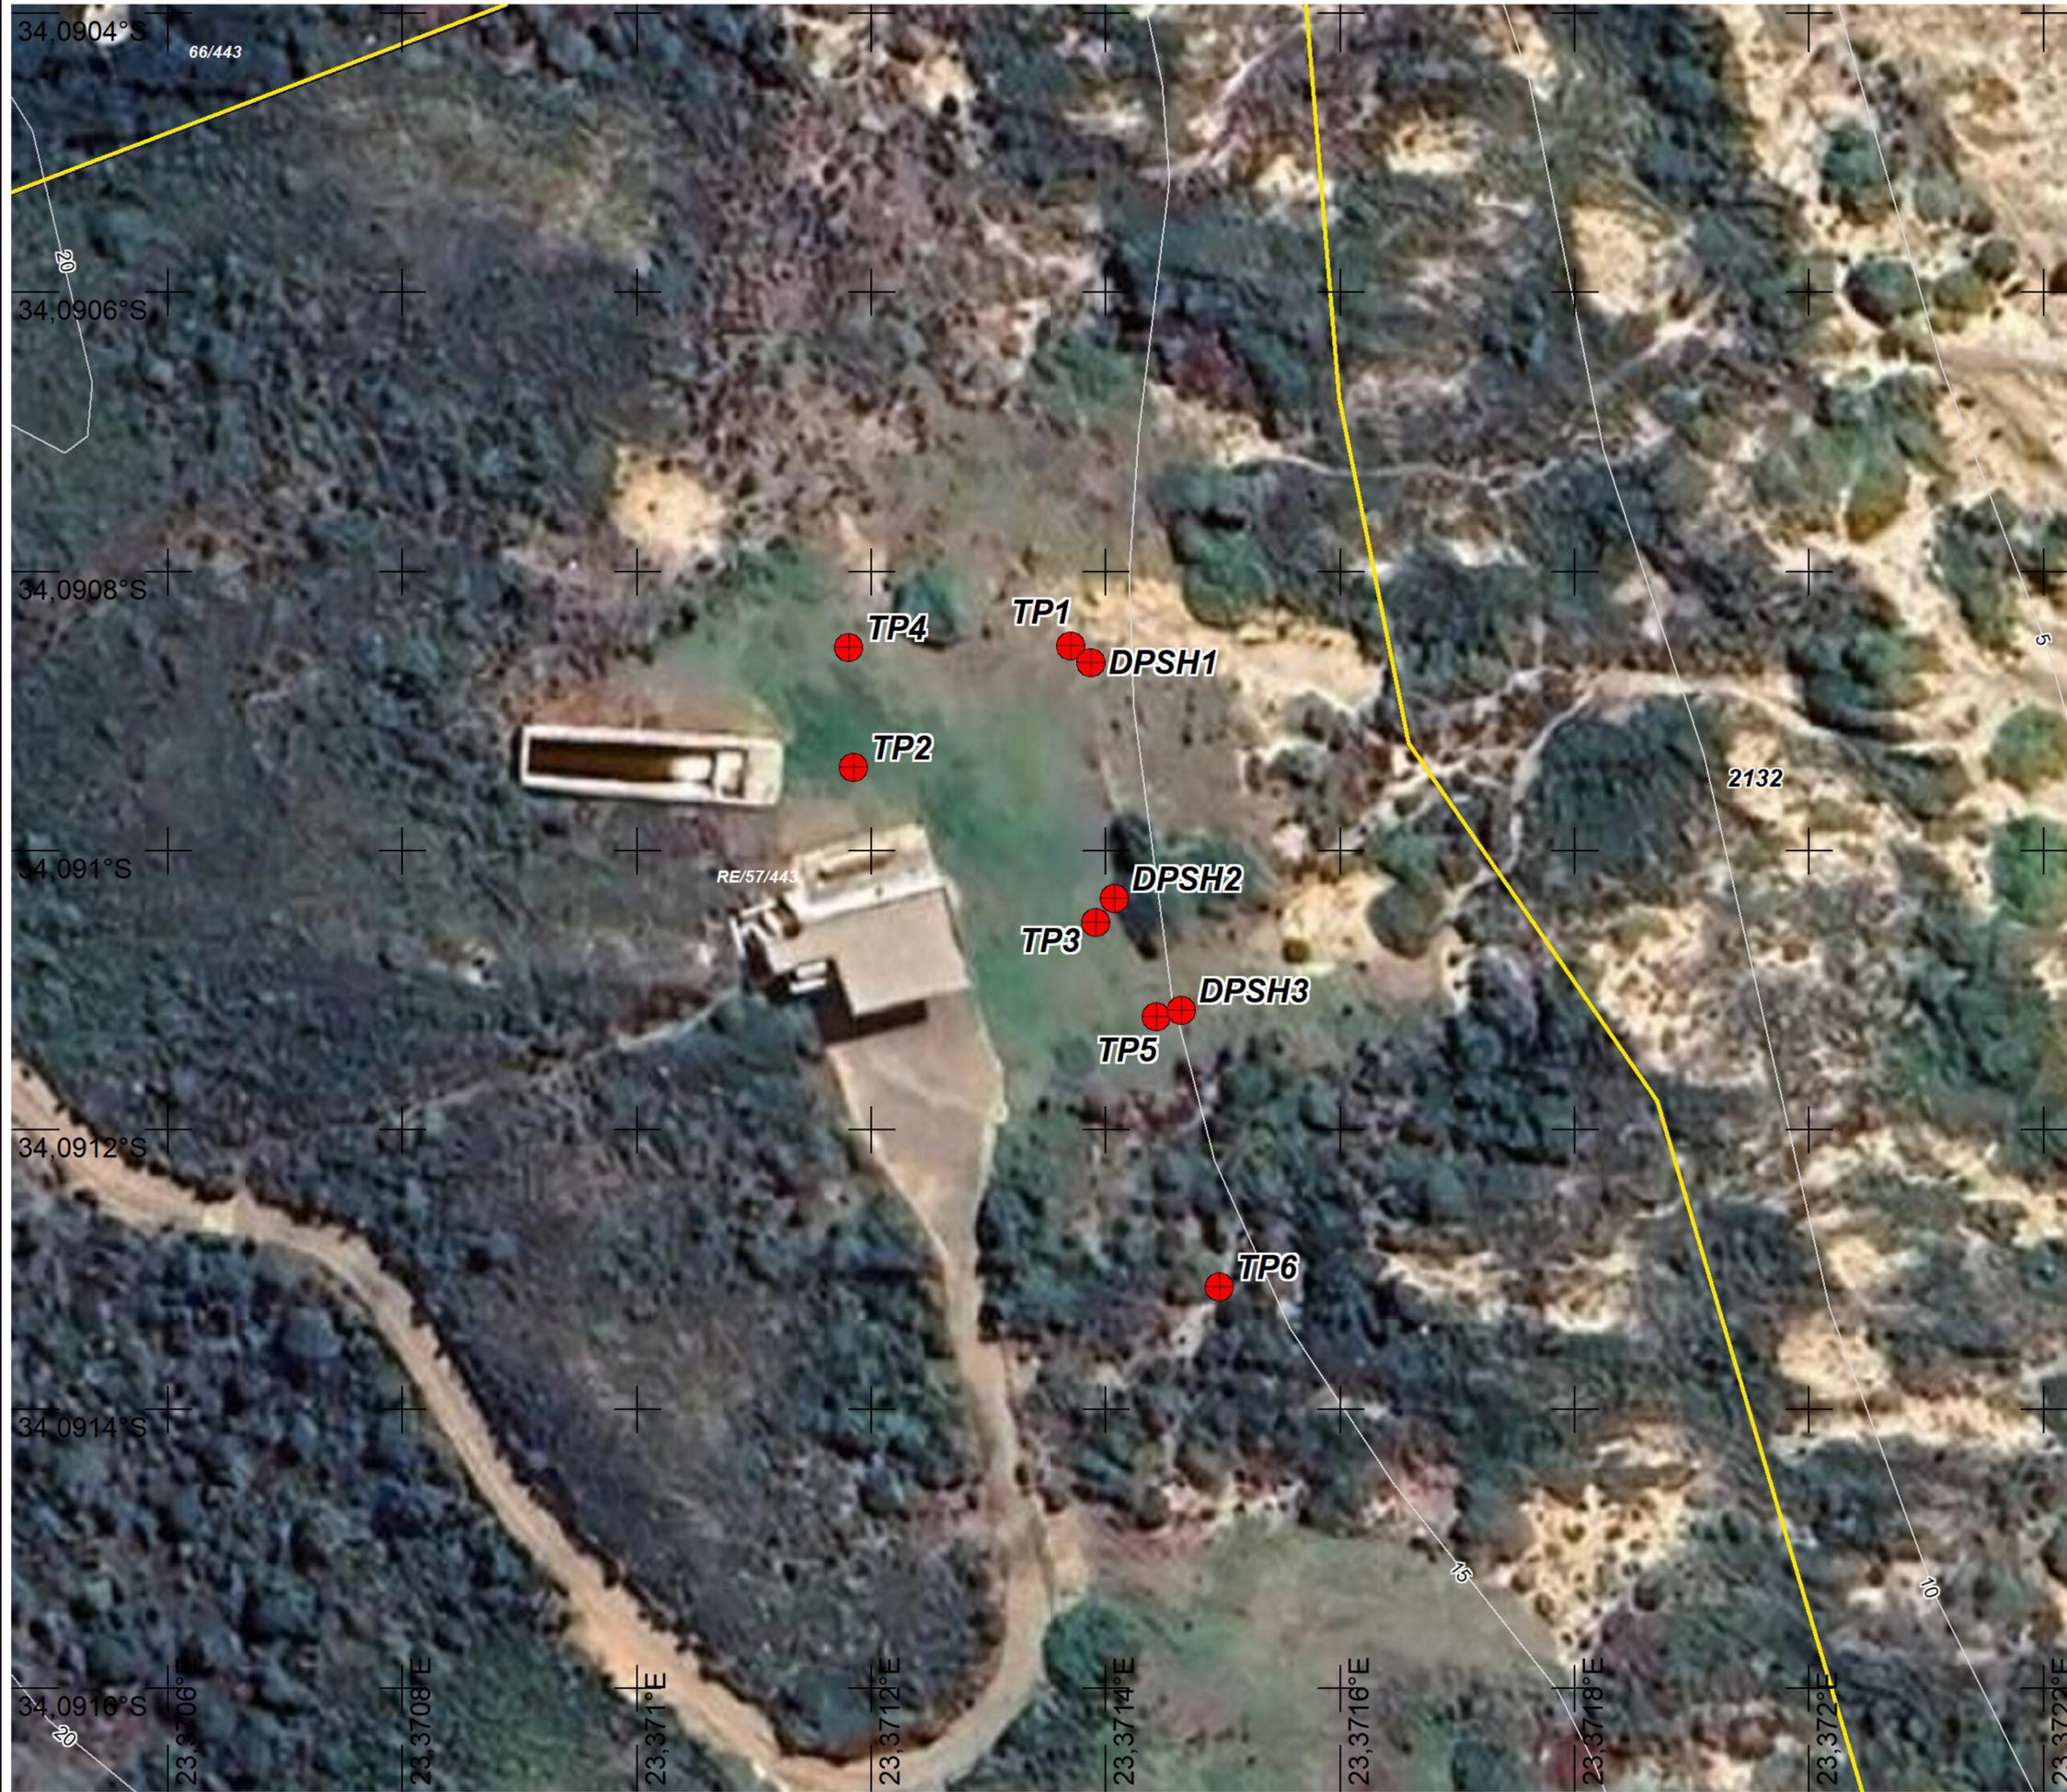
Dwg Name: Geotechnical tests
 Date: Sept 2024
 Rev no: 1
 Drawn: IP

- Site Boundary
- Test Holes
- DPSH Positions

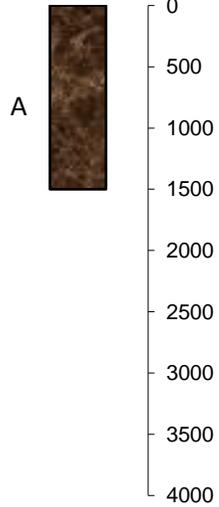
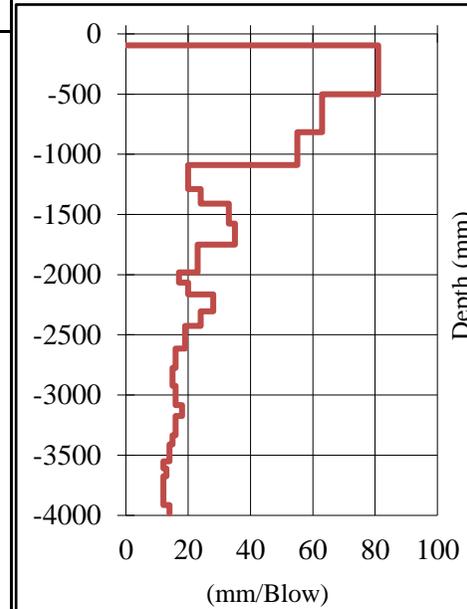
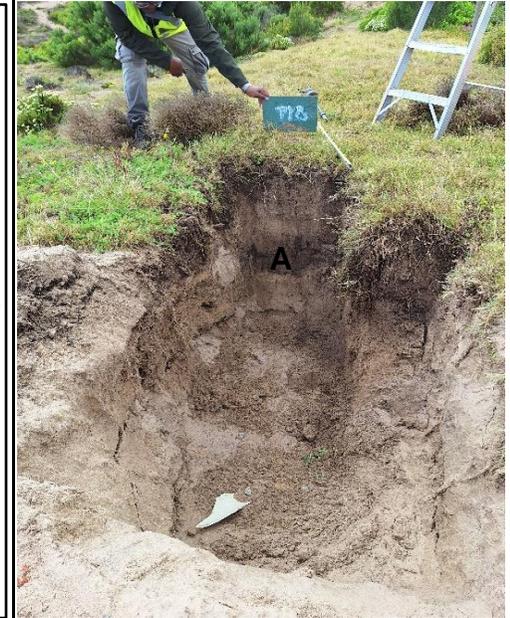
TP 5

(0 to 1500) Moist, dark brown & light yellow, very loose to medium dense, structureless, **slightly silty fine SAND**, imported (old concrete foundations).

Sidewalls highly unstable
TP refused on old foundations @NGL-1.5m
No Water

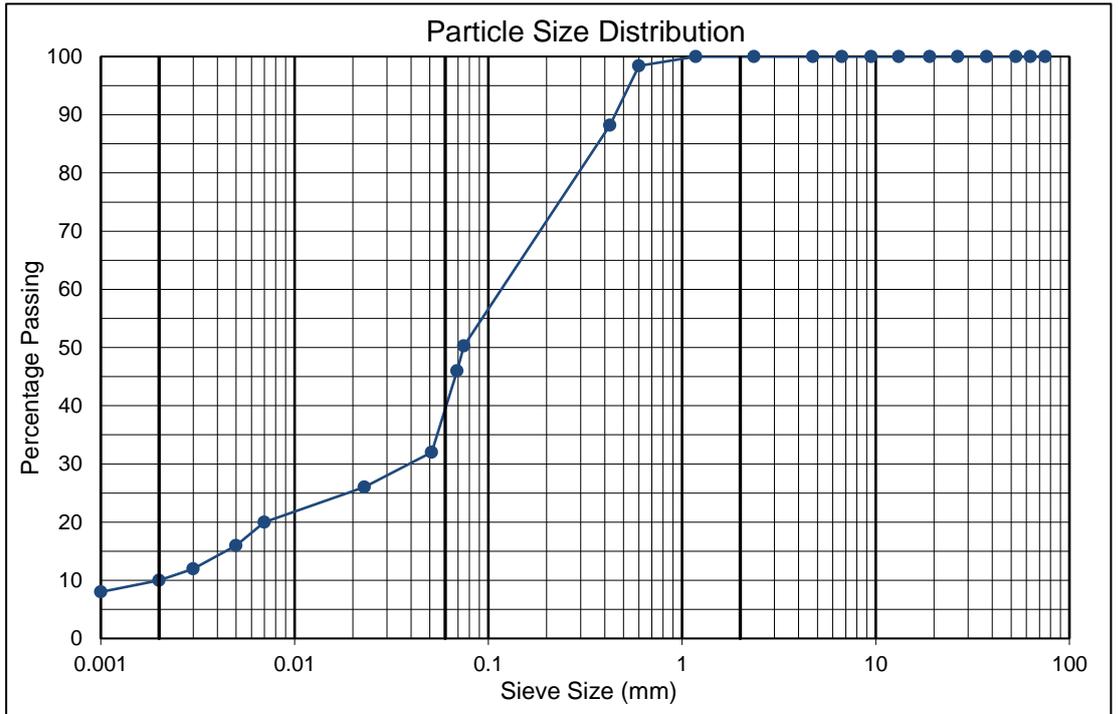
FOUNDATION INDICATOR - (ASTM Method D422)

| Unified Soil Classification | SM |
| AASHTO Soil Classification | A-4 |

The lab results indicated that the insitu soil was dominated by non-plastic, silty fine sand with negligible clay content and zero heave potential. The soil type was classified according to the Unified Soil Classification as SM (sand with >12% fines) and was deemed suitable for use as a general filling material (probably G8 quality).

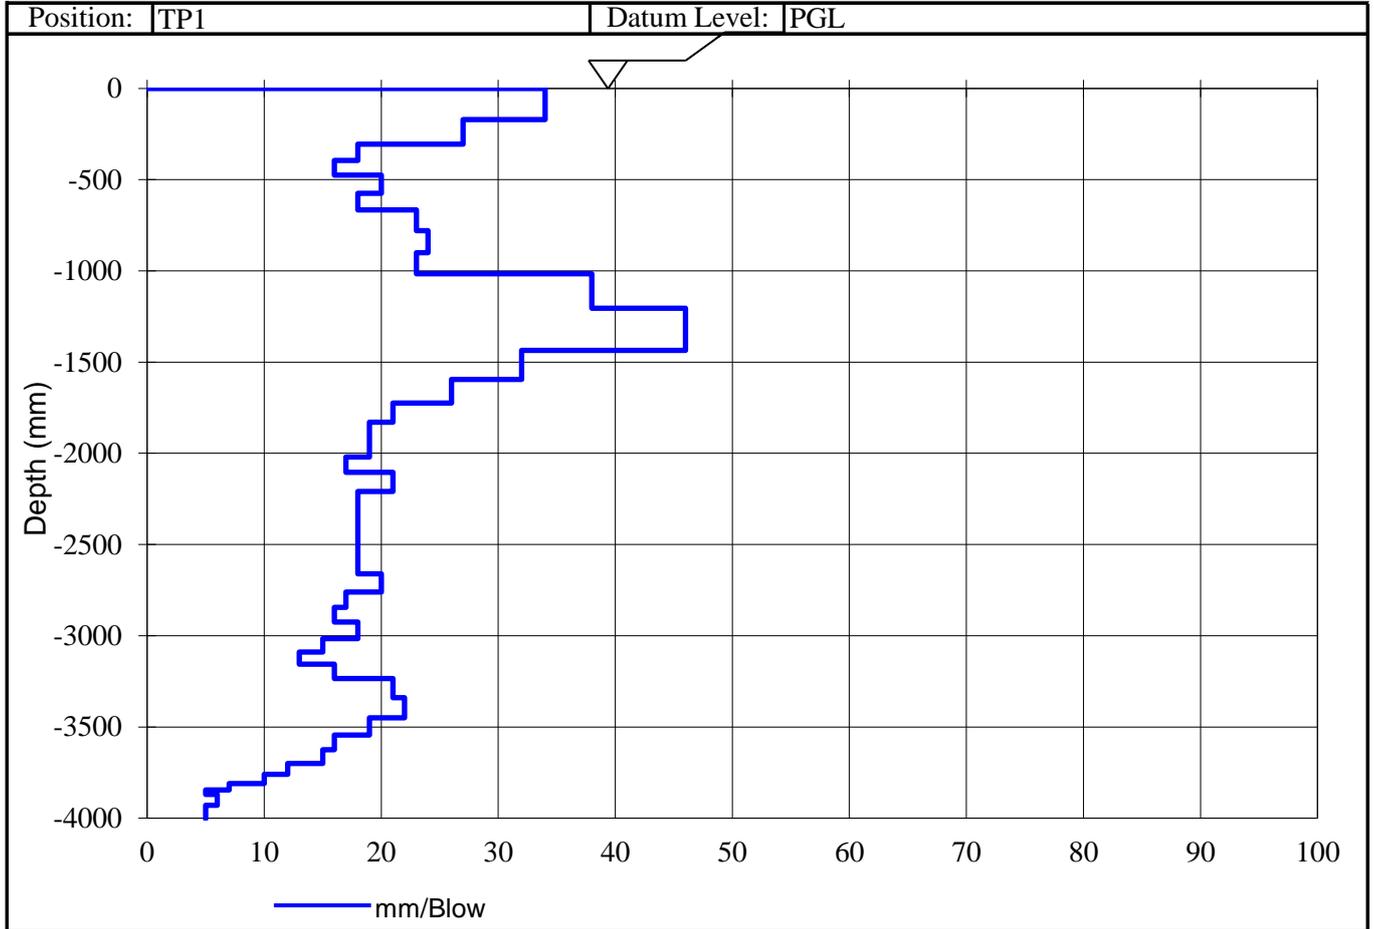
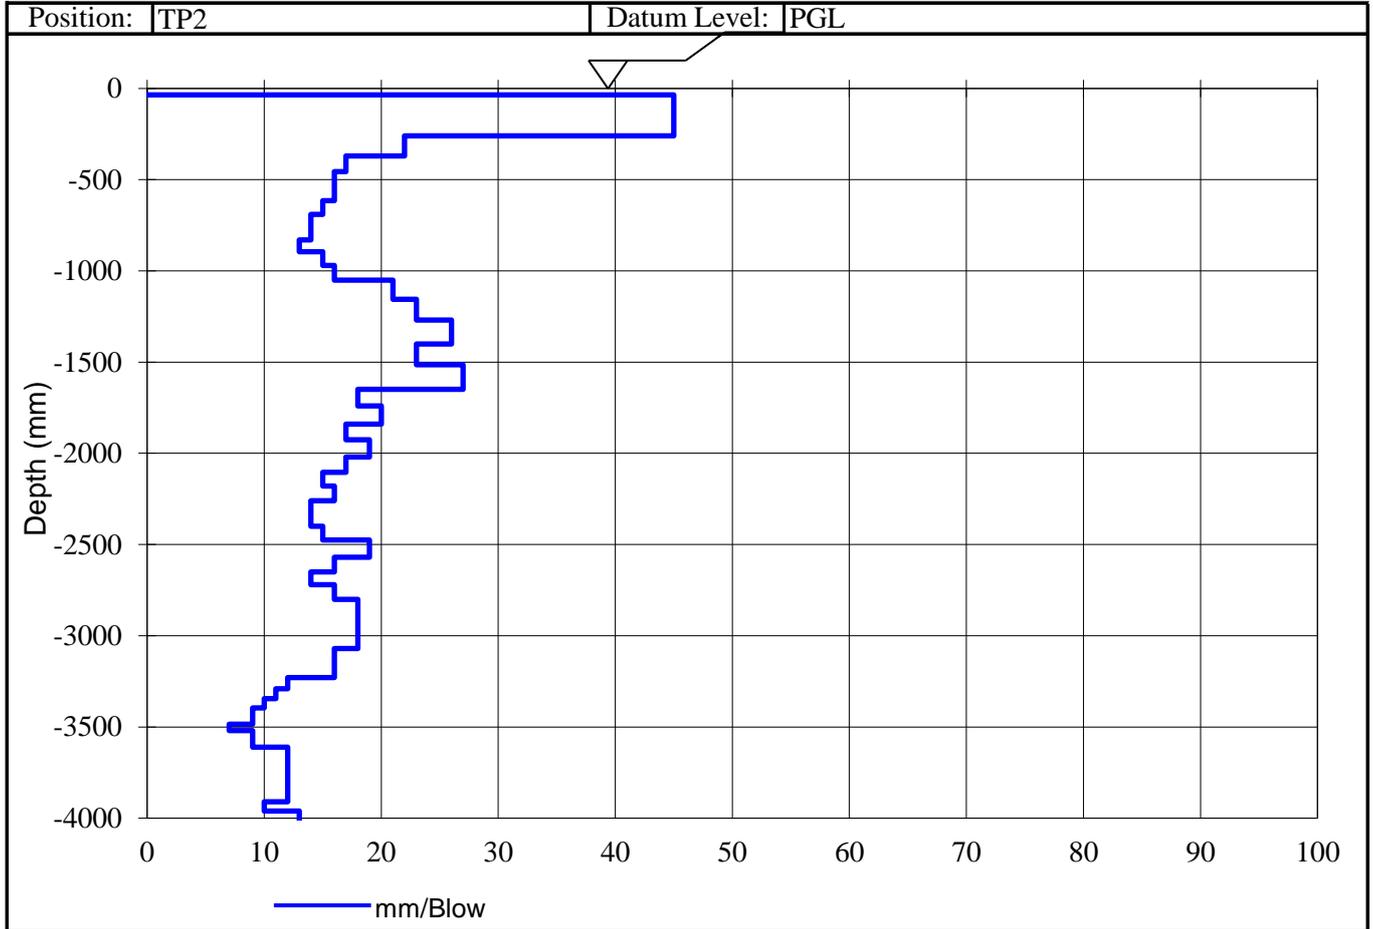
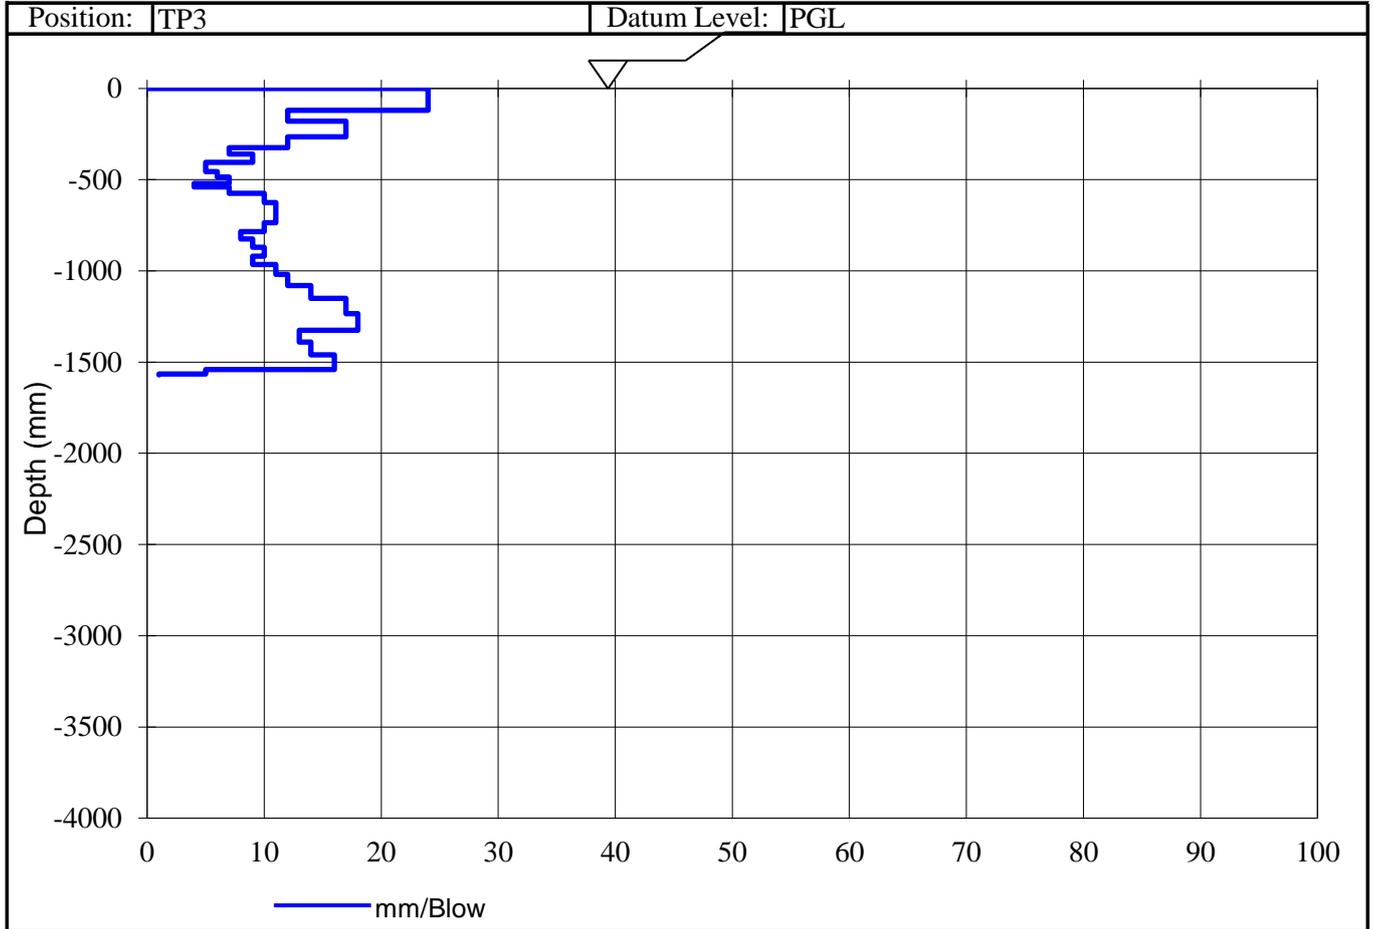
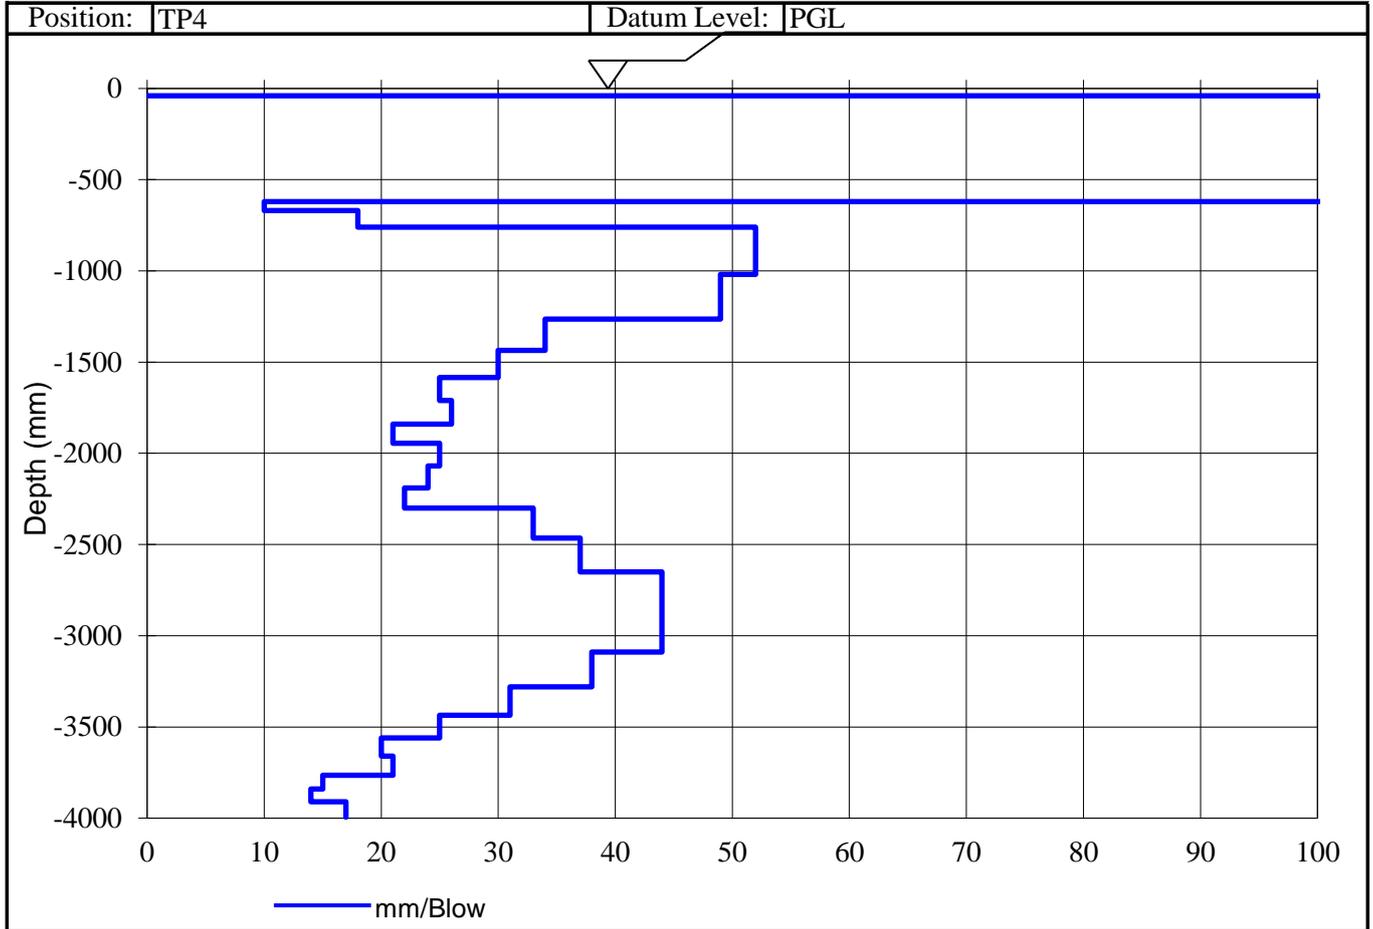
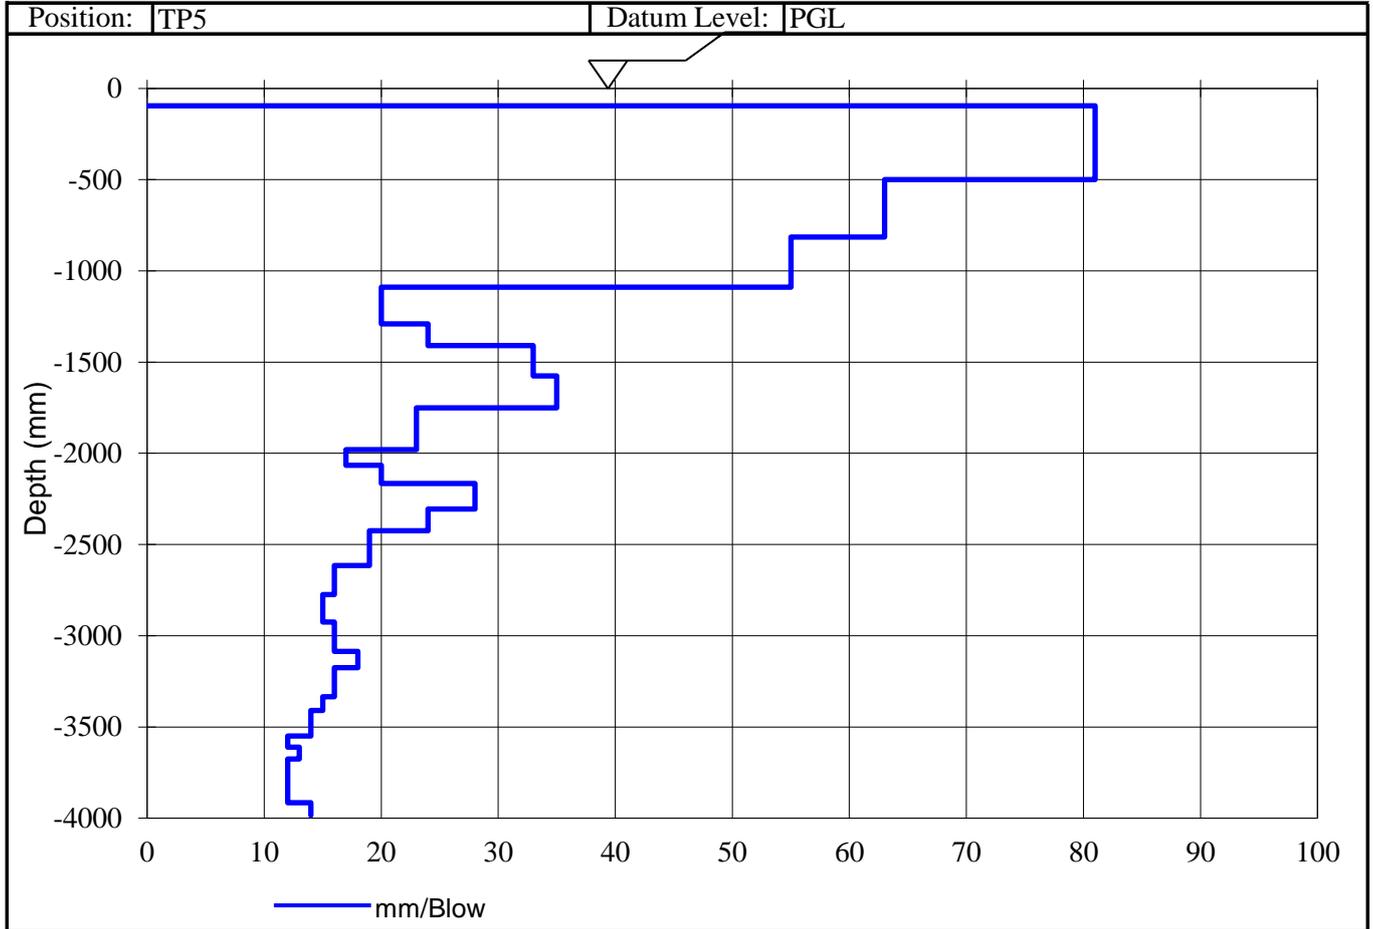
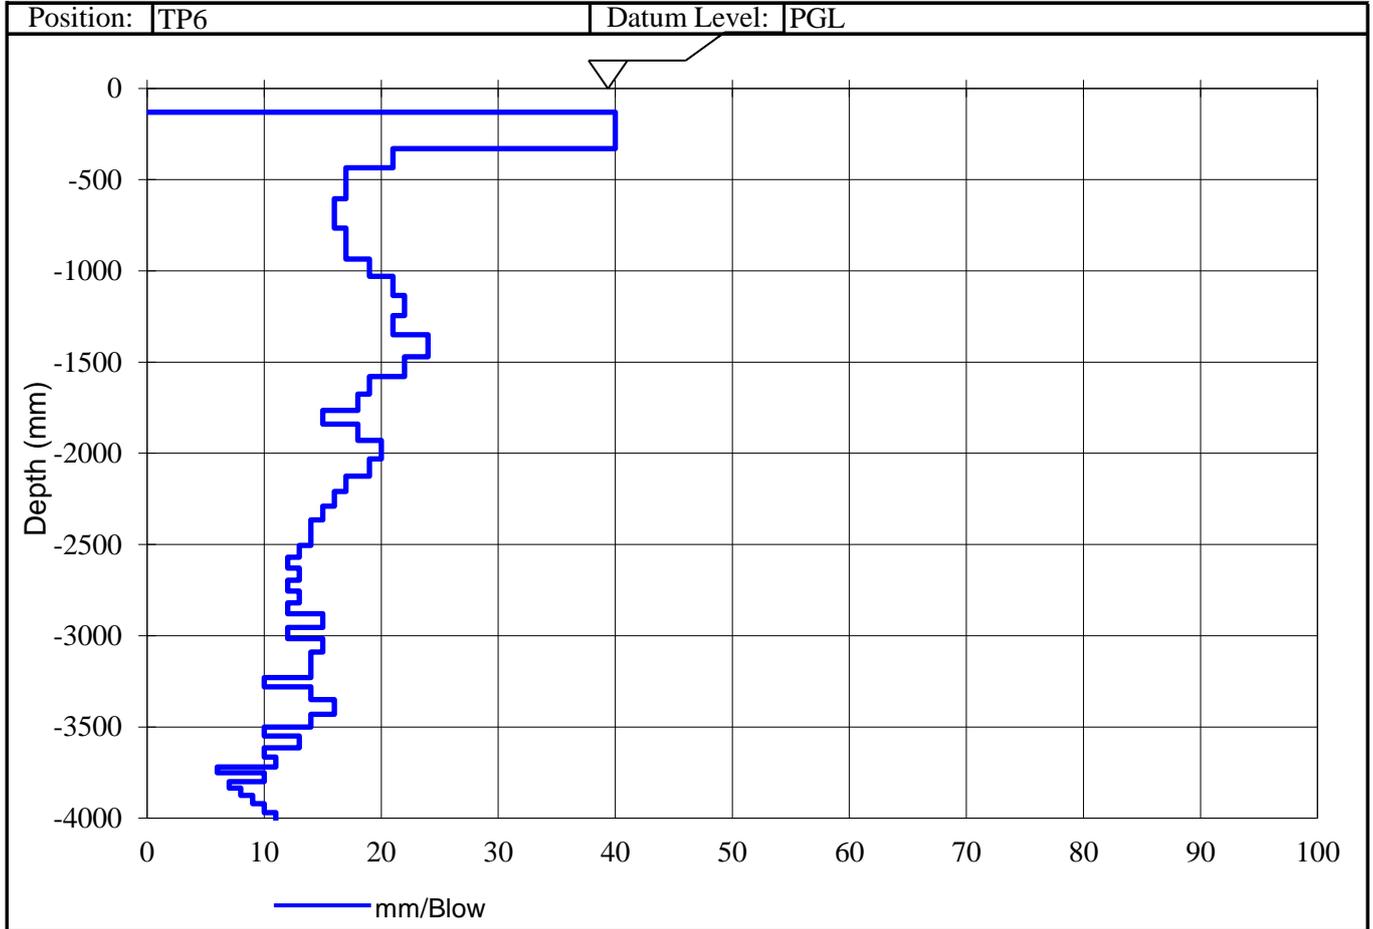
Dynamic Cone Penetrometer (DCP) - (TMH 6 Method ST6)

handheld penetration tests (DCP) conducted through the upper 4m of the profile indicated that the upper 1.5m was very loose, but consistently improving below 2m to medium dense state (see attached results). The following approximated shear strength parameters were derived from DCP tests:

- 0-1500mm: loose, $\phi'=28^\circ$, $c'=0\text{kPa}$, high compressibility.
- 1500-2500mm: medium dense, $\phi'=32^\circ$, $c'=0\text{kPa}$, moderate compressibility.
- 2500-4000mm: dense, $\phi'=34^\circ$, $c'=0\text{kPa}$, low compressibility.

In general, the tests indicated a highly compressible soil within the influence zone of normal shallow foundations, thus requiring modified or improved foundation systems.

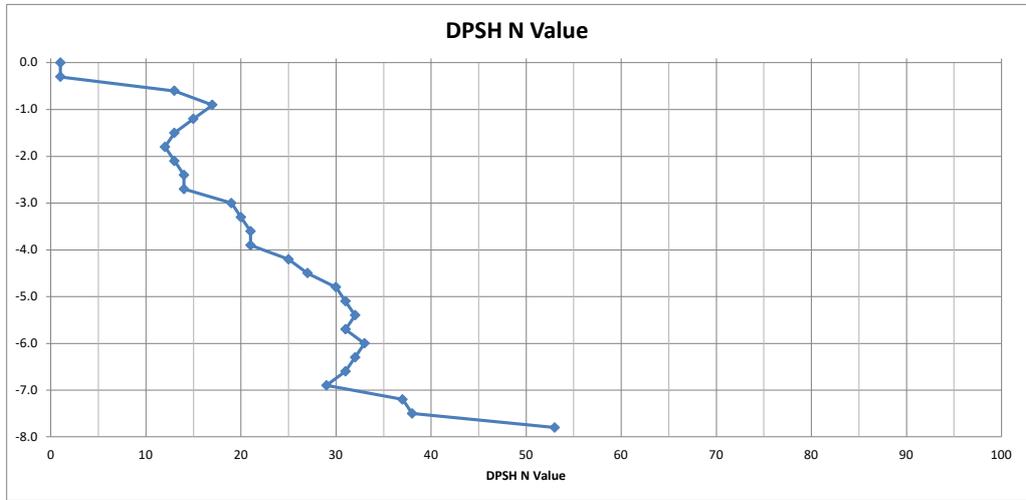
| Position | DPSH1 (TP1) |

- **DPSH1:** Very loose upper 1m (<10 blows/300mm), improving to a medium dense state (10-20 blows/300mm) to a depth of 3.5m and then dense below this depth (>20 blows/300mm).
- **DPSH2:** The test indicated a very dense upper 2.5m possibly due to obstruction from buried old concrete foundations, underlain by a generally medium dense layer to 7.5m and becoming very dense beyond this depth.
- **DPSH3:** The test indicated a variable consistency (medium to dense) in the upper 4.5m, but consistently dense below this depth.

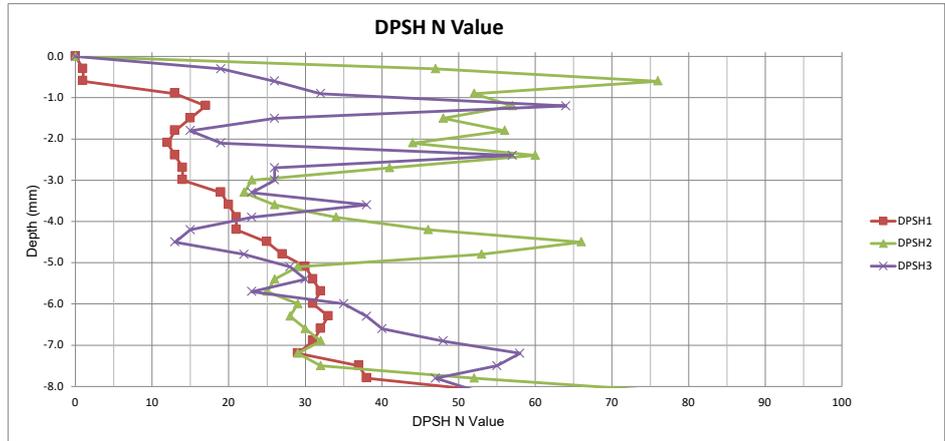
| Position | DPSH1-3 |

0-4.5m: Medium dense, SPT N=10-20, $\phi'=32-34^\circ$, $c'=0\text{kPa}$

4.5-7.5m: Dense, SPT N=20-40, $\phi'=34-36^\circ$, $c'=0\text{kPa}$

7.5-8m: Very dense, SPT N=40-50, $\phi'=36-38^\circ$, $c'=0\text{kPa}$

No refusal was reached within the maximum test depth of 8.1m at any of the test positions.
