## GEOTECHNICAL SOIL TEST REPORT

**Client:** Mr Beveridge c/o Dave Visser Consulting Engineers

**Project:** Rem of Ptn 57 Brakkloof 443, Plettenberg Bay

**Date of test:** 20.09.2024

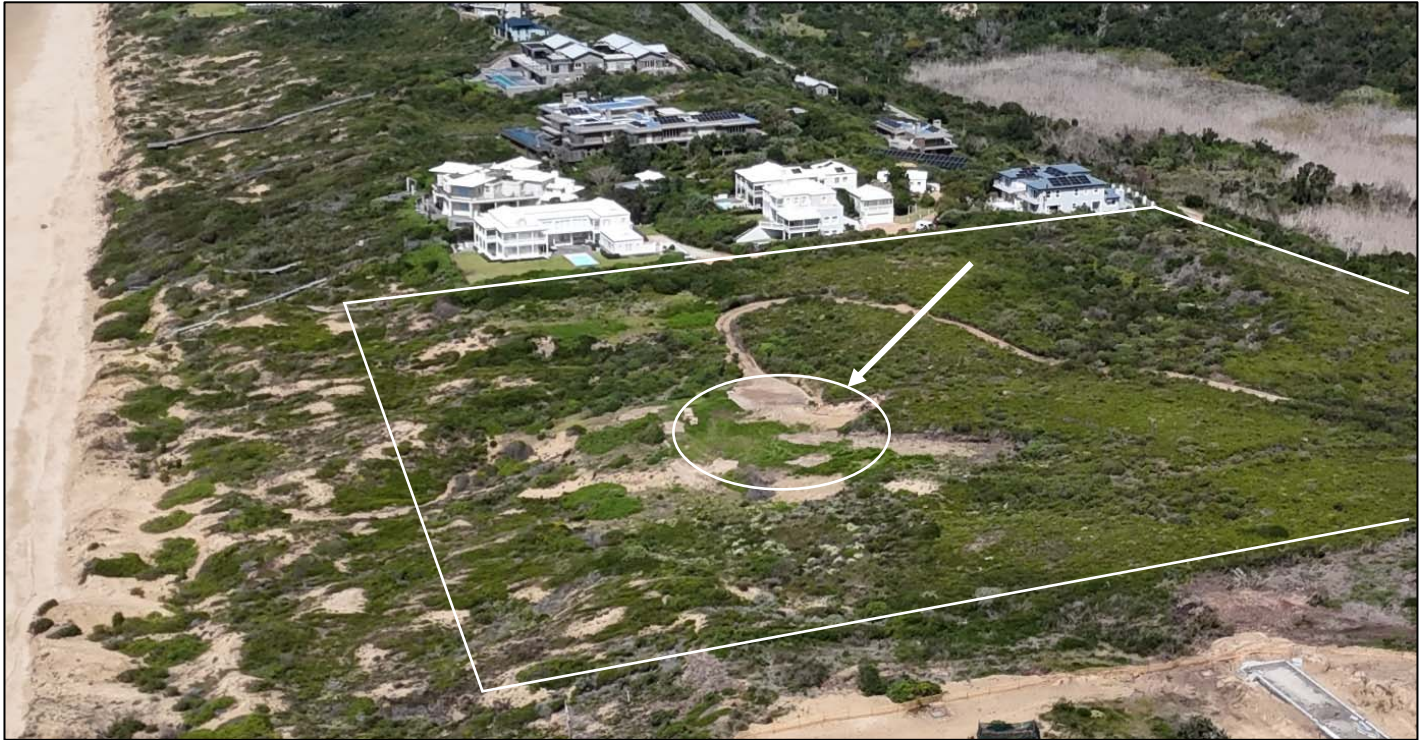
The natural topography of the site was generally characterised as a coastal dune ridge, sloping to the west and east. Robberg beach was located less than 100m to the east of the site. There were no significant natural drainage features or surface water bodies on the site such as streams, marshes or dams, but the ground surface was fairly irregular with several depressions and small hillocks, typical of a dune field. The proposed site for the new house was a fairly level existing platform where

the previous house was built (See Figure 1-2). The surface conditions were moist due to recent rain and loose/sandy but generally stable with no signs of any severe stability problems.

Figure 1: Oblique aerial view of the site and existing platform area, looking southwest

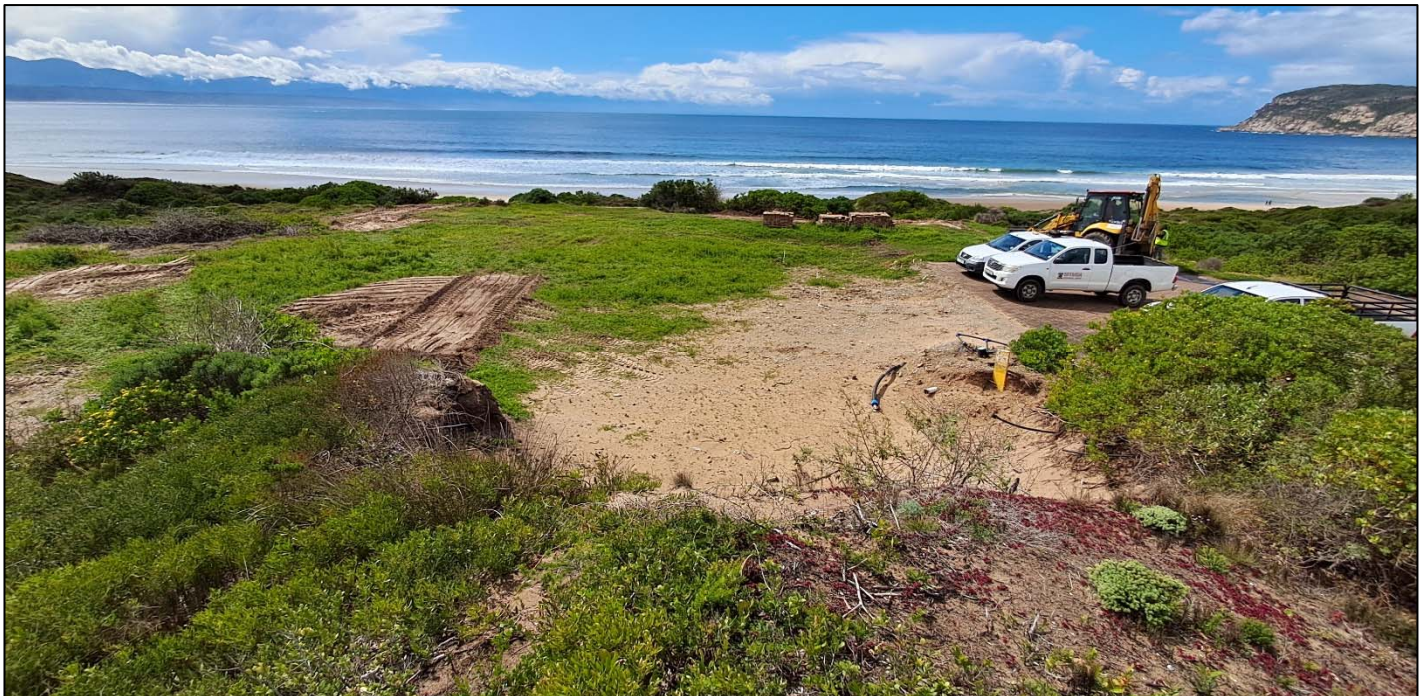
Figure 2: View of the site, looking east towards Robberg Beach

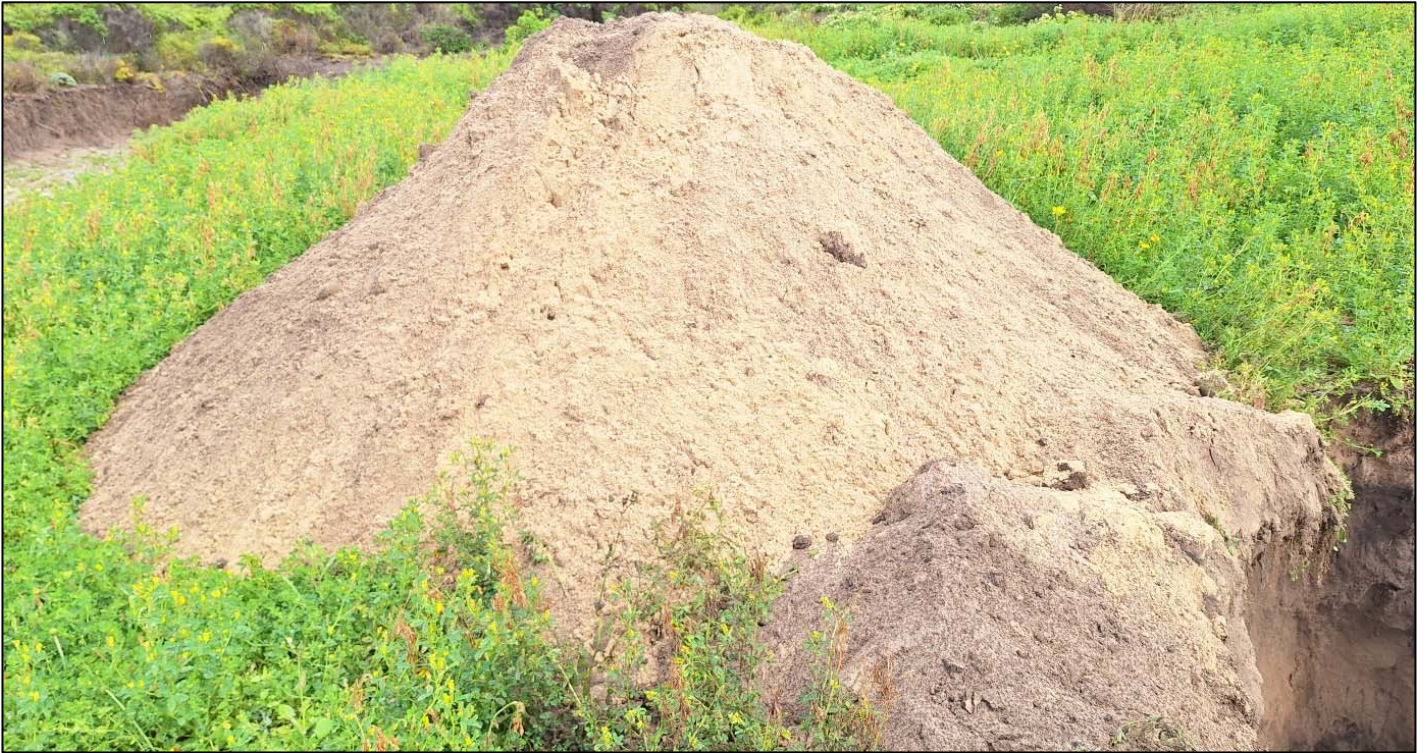
The profile excavated in test pits correlated with the local geology of the area. The natural soil profiles were dominated by fine aeolian (dune) sand (see Figure 3). Uncontrolled fill from the previous house and its demolition were encountered in some of the test pits, consisting of a mixture of rubble, sand and remnant foundation structures (See Figure 4). The underlying bedrock was not exposed on surface or in test pits and was not expected within a depth of at least 10m.

Figure 3: Typical fine grained aeolian sand encountered in test pits

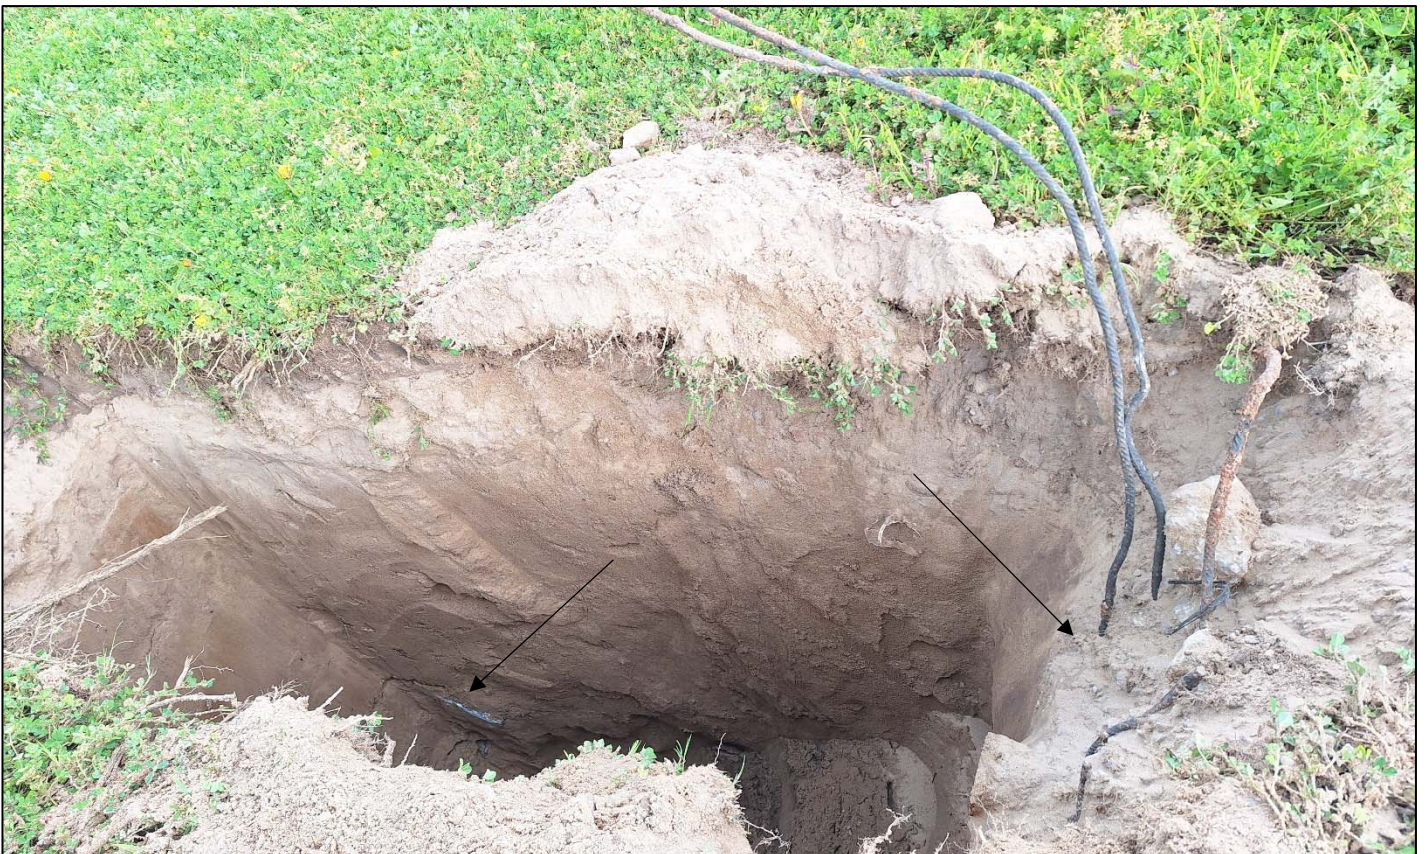
Figure 4: Rubble and remnant foundation structures encountered in some pits

**Earthworks:** Significant earthworks were expected to remove old remnant foundation structures and establish the various proposed platform levels. All excavations were provisionally classified as "soft" in accordance with SANS1200D and thus excavatable with a TLB or preferably tracked excavator, as some buried foundations may be difficult to excavate with a TLB.

All vegetation and existing uncontrolled fill should be completely stripped from the footprint of the proposed structures and stockpiled for later use or removed to spoil as directed by the engineer. The insut sandy soil could be re-used for bulk fill material on platforms, behind retaining walls and under floors and foundations, provided that any unsuitable rubble, steel rebar, etc is selected out and the required level of compaction is achieved (recommend 95-98% MDD (<25mm/blow of DCP) for load-bearing fill). All soils obtained from excavations on site should first be stockpiled for approval by the engineer before reuse as fill material. Allowance should also be made for importation of some higher quality material (such as G5) for upper layerworks under surface bed floors and under heavily loaded spread foundations, where necessary. Compaction should be properly tested. Deep excavations may be highly unstable at angles greater than  $45^\circ$  and shoring or battering of slopes is recommended in excavations >1m.

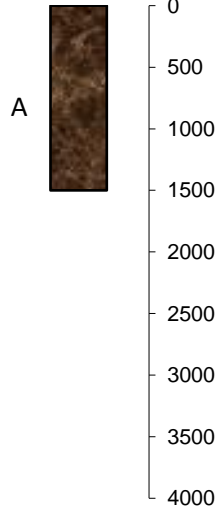
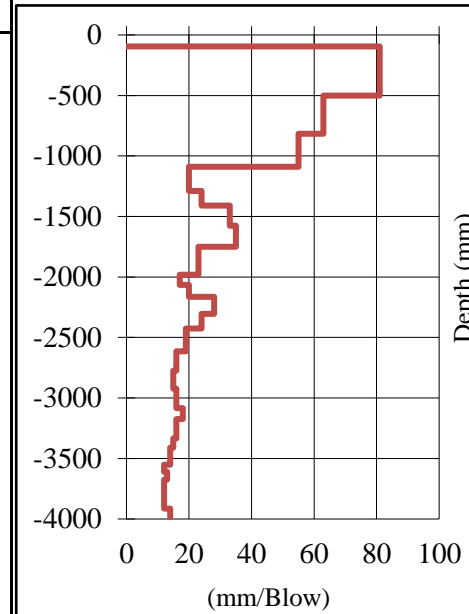
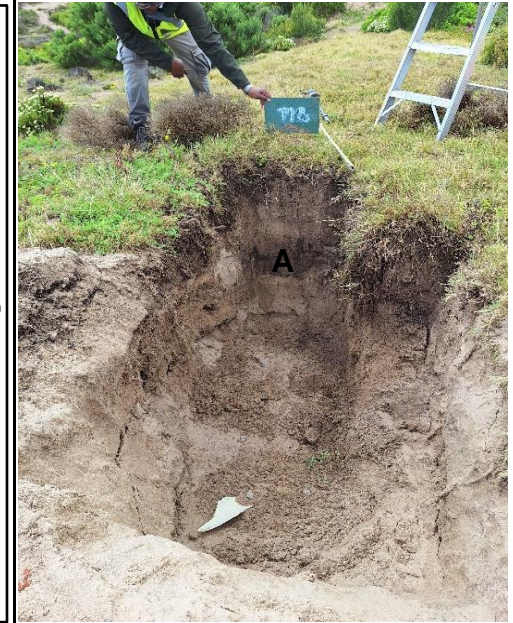
#### TP 5

(0 to 1500) Moist, dark brown & light yellow, very loose to medium dense, structureless, **slightly silty fine SAND**, imported (old concrete foundations).

**Sidewalls highly unstable**  
**TP refused on old foundations @NGL-1.5m**  
**No Water**

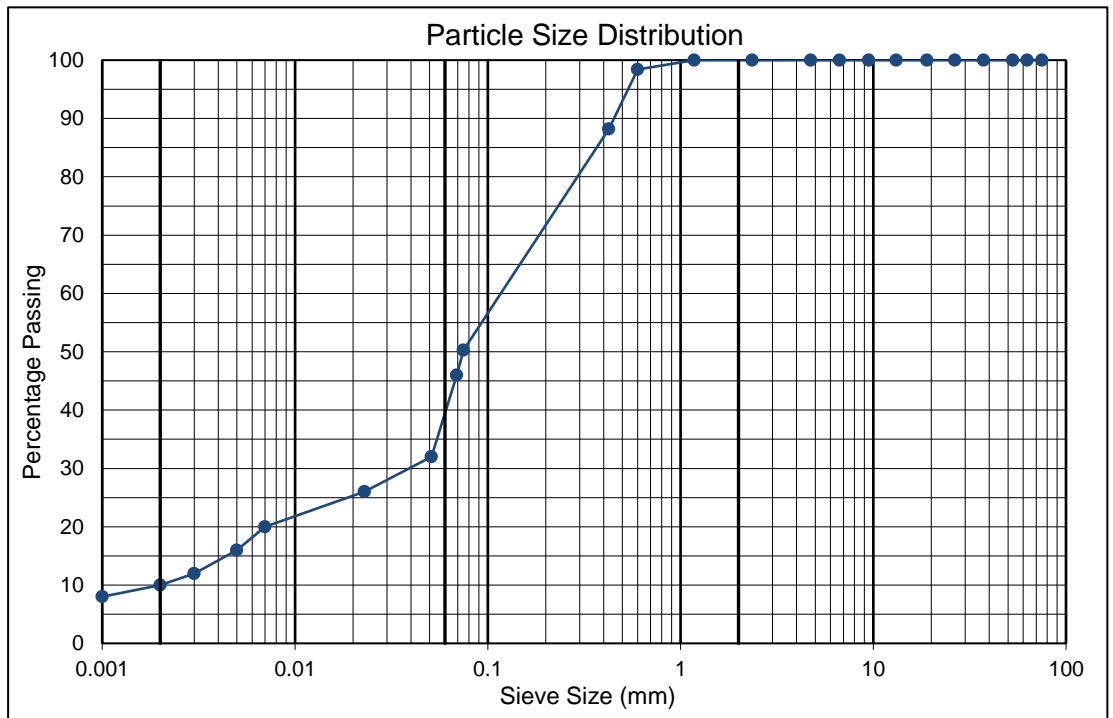
Sample Position (SV)	TP 2
Depth (mm):	1500 - 2500
Sample No.:	89477
Materials Description	Source
	Colour
	Soil Type
	Classification
	In-Situ
	Light Yellow
	Silty Sand
	Trail Pit

Liquid Limit (%)	NP
Plasticity Index (%)	NP
Linear Shrinkage (%)	NP
Moisture Content (%)	6.7

% Clay	9
% Silt	30
% Sand	61
% Gravel	0

Unified Soil Classification	SM
AASHTO Soil Classification	A-4

The lab results indicated that the insitu soil was dominated by non-plastic, silty fine sand with negligible clay content and zero heave potential. The soil type was classified according to the Unified Soil Classification as SM (sand with >12% fines) and was deemed suitable for use as a general filling material (probably G8 quality).

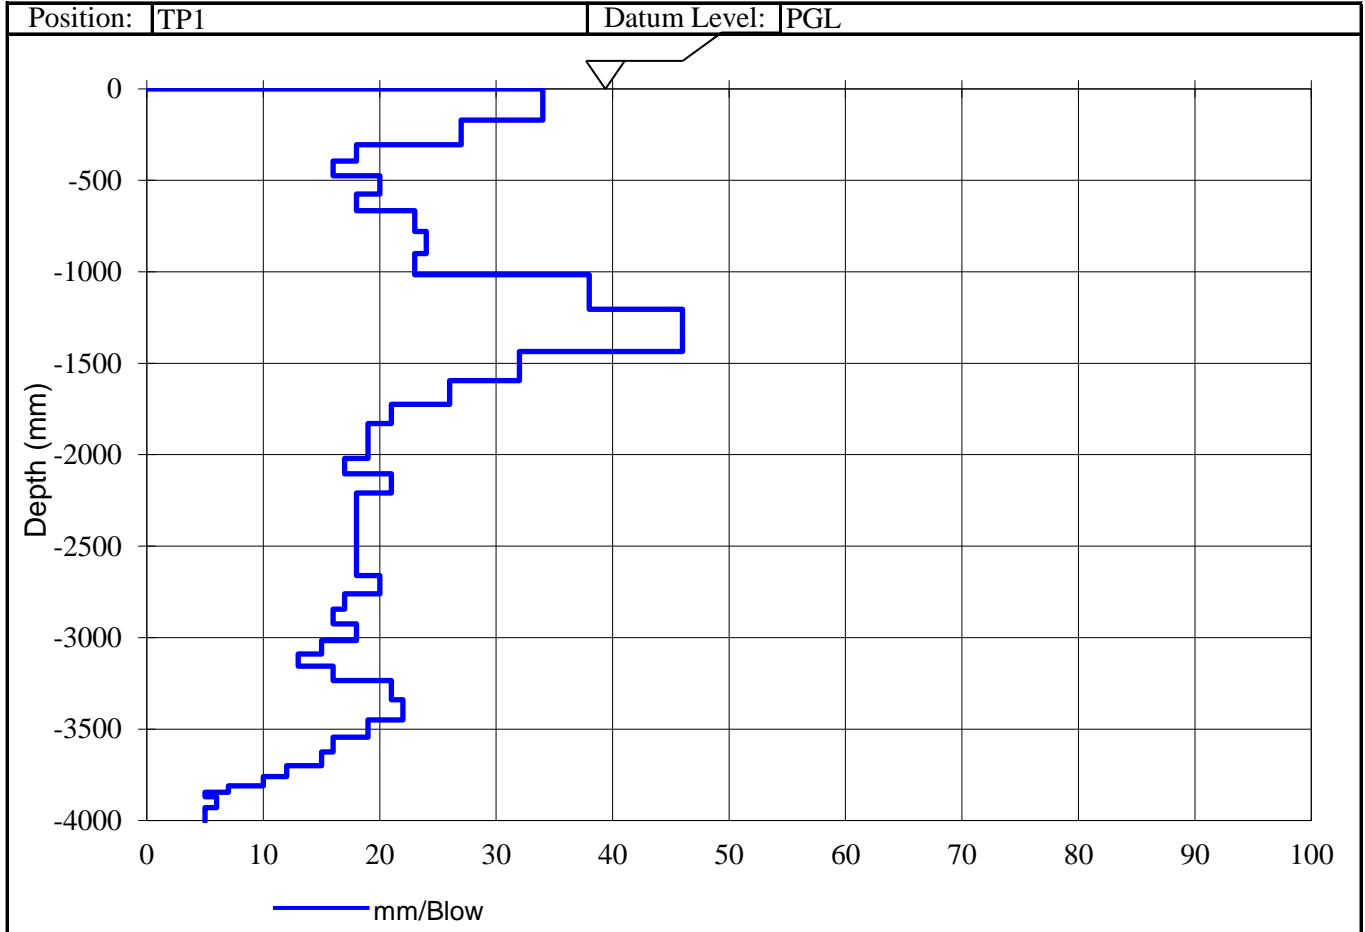
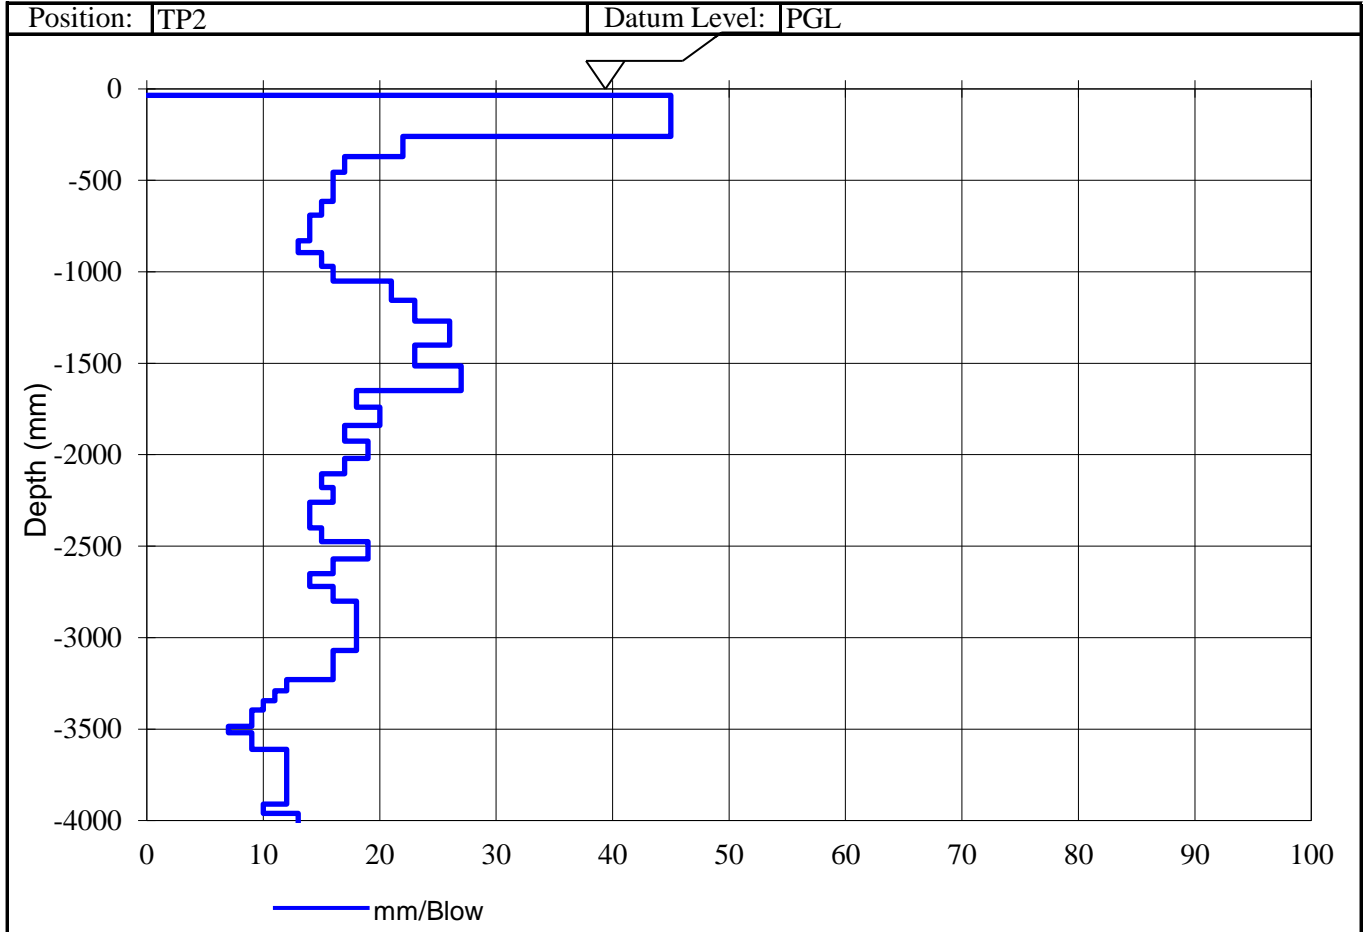
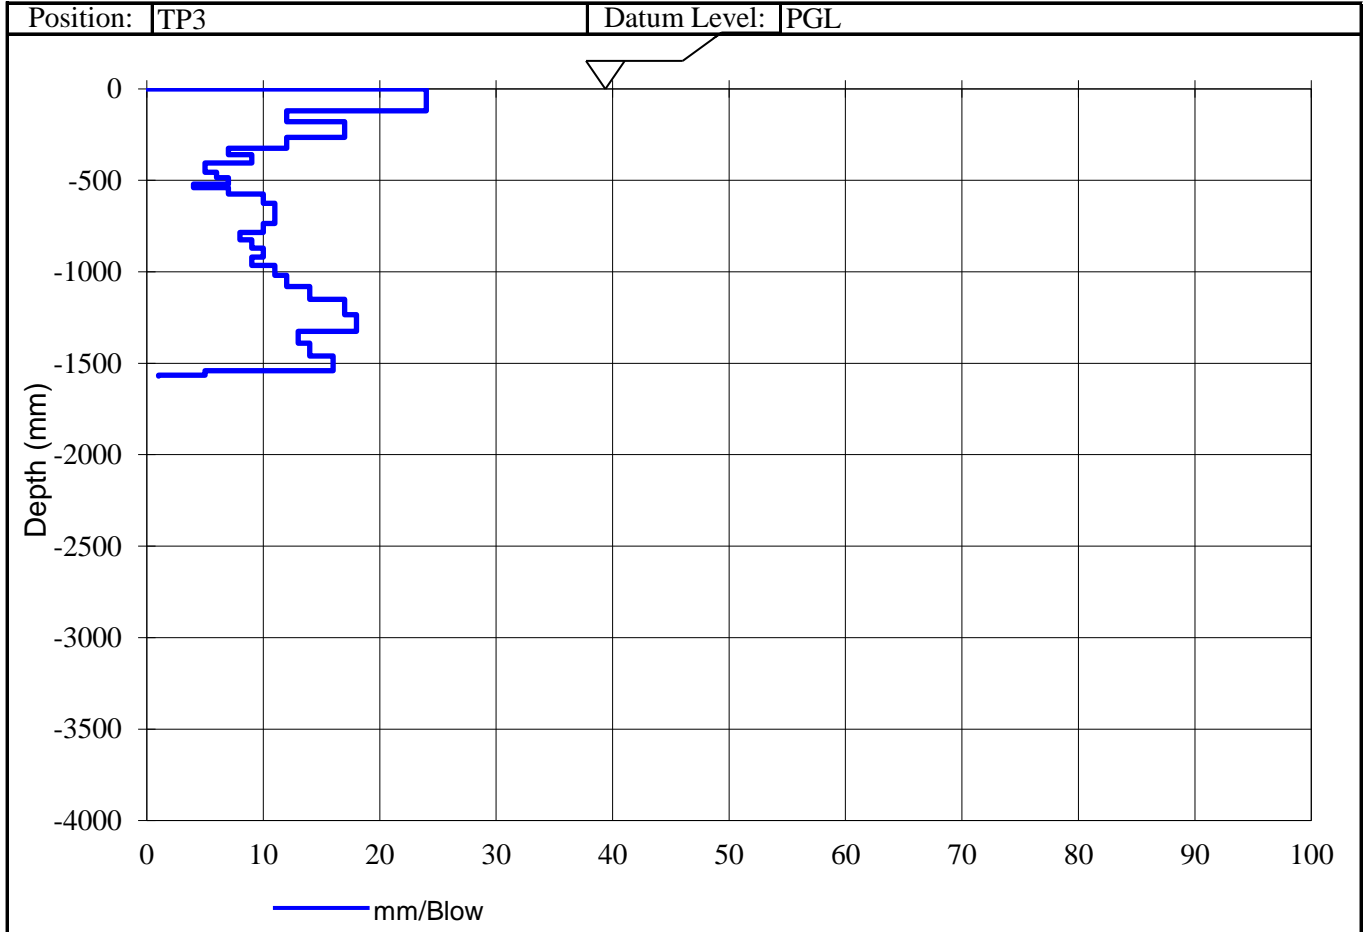
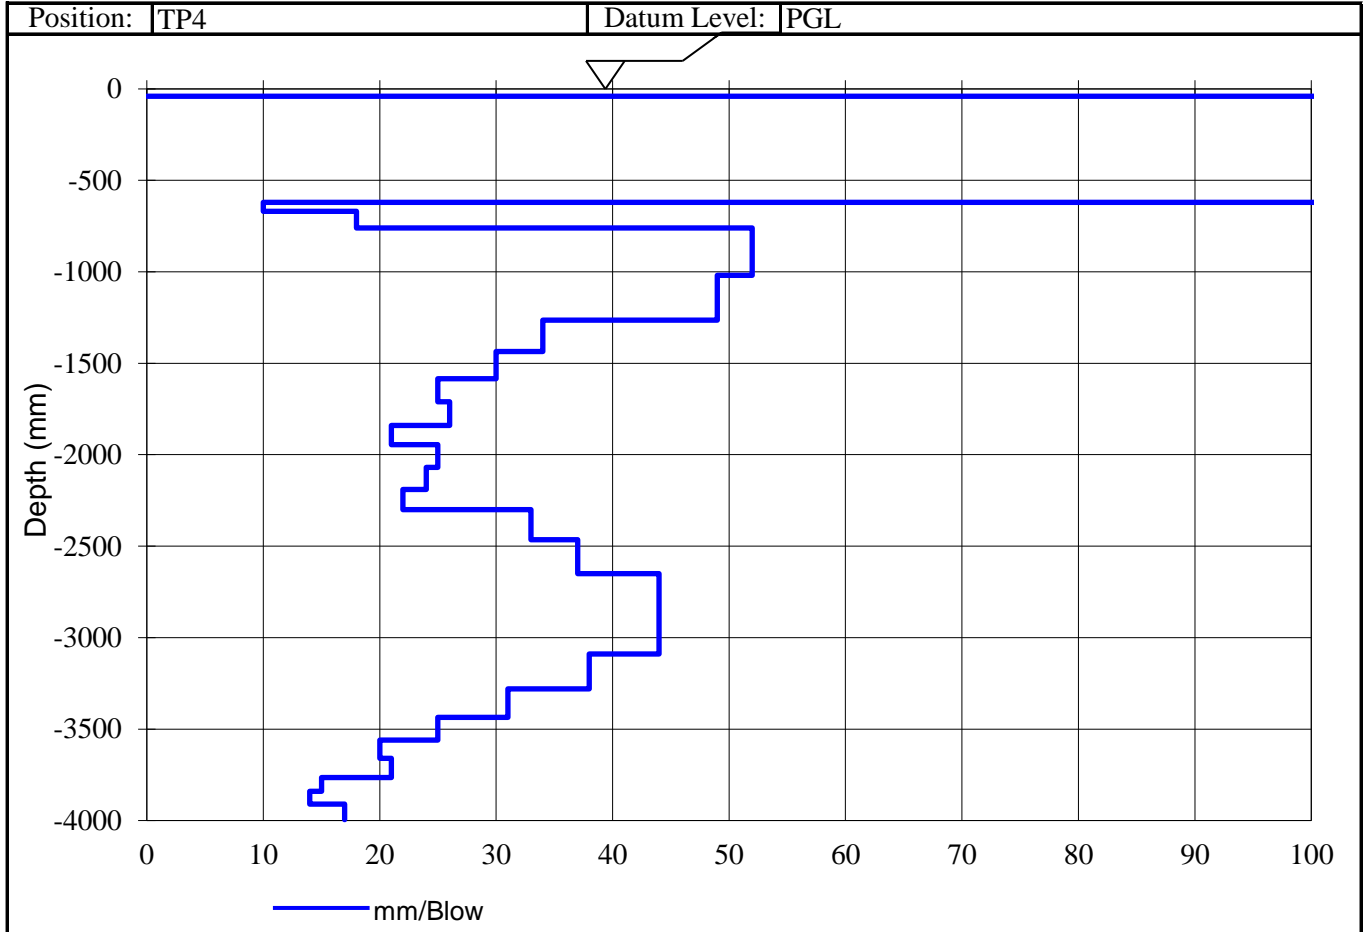
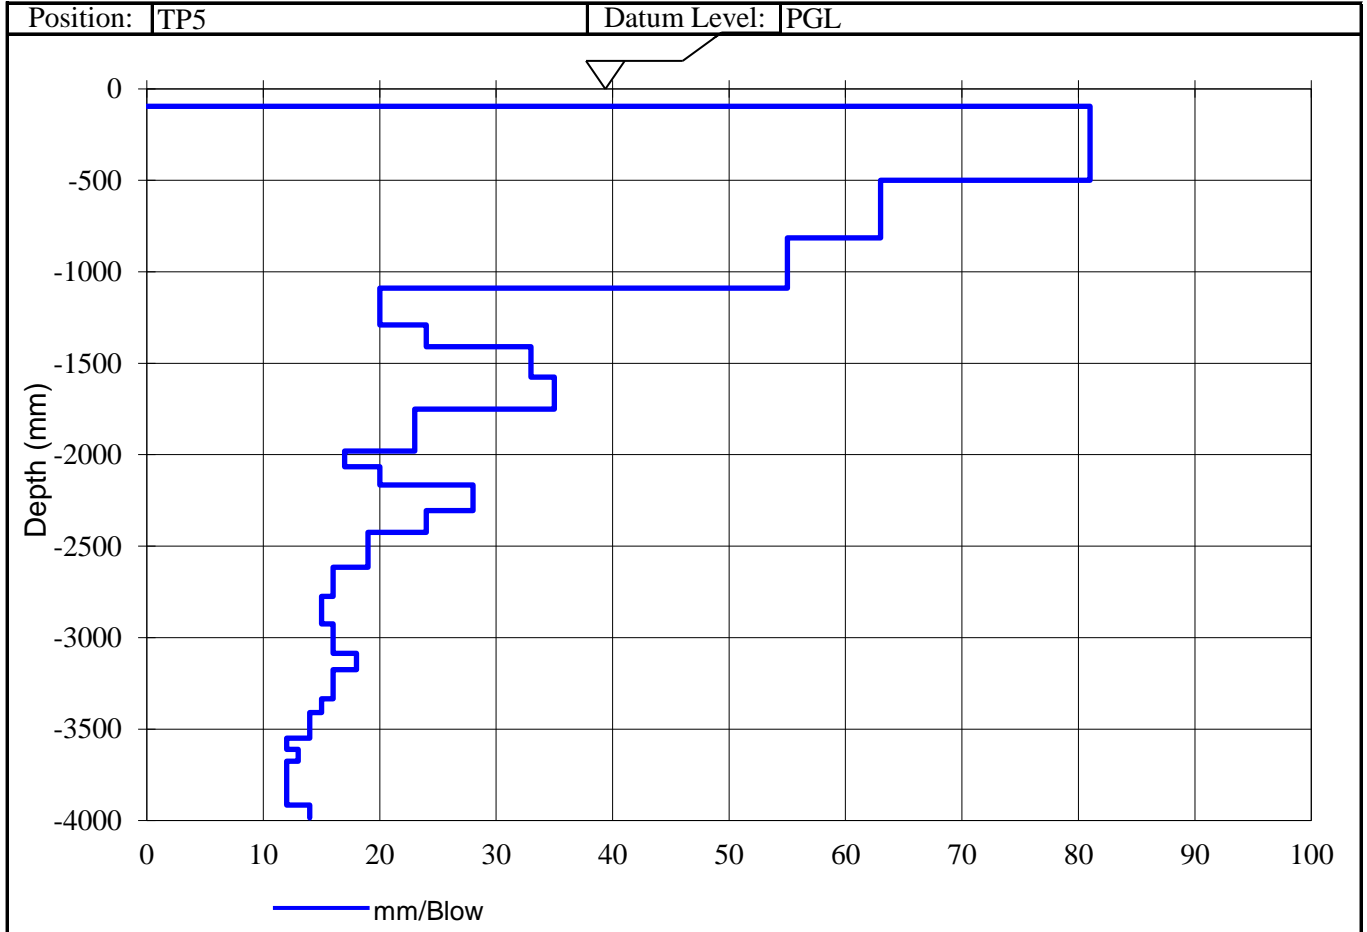
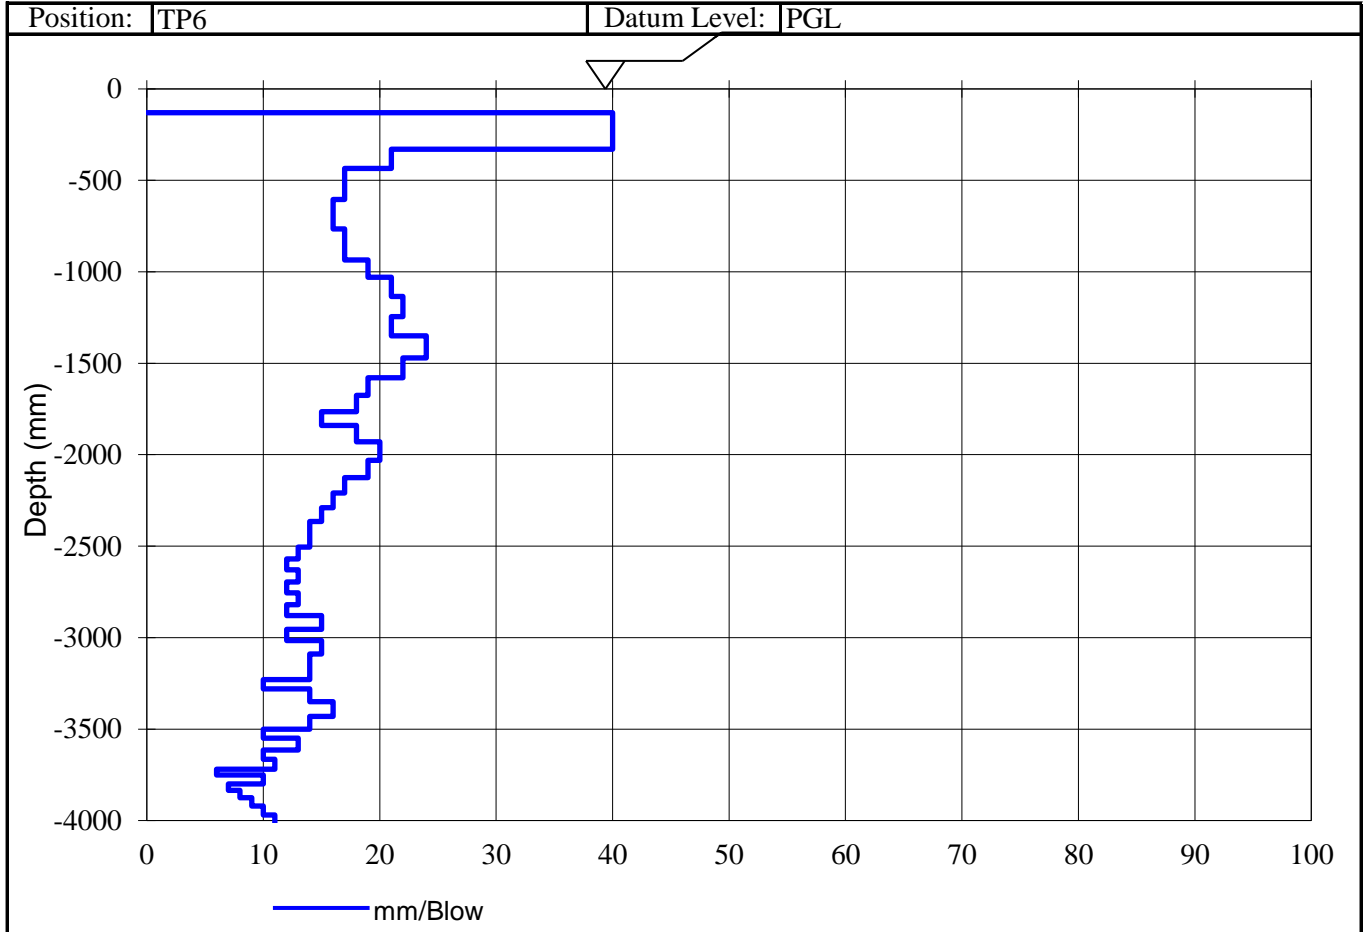
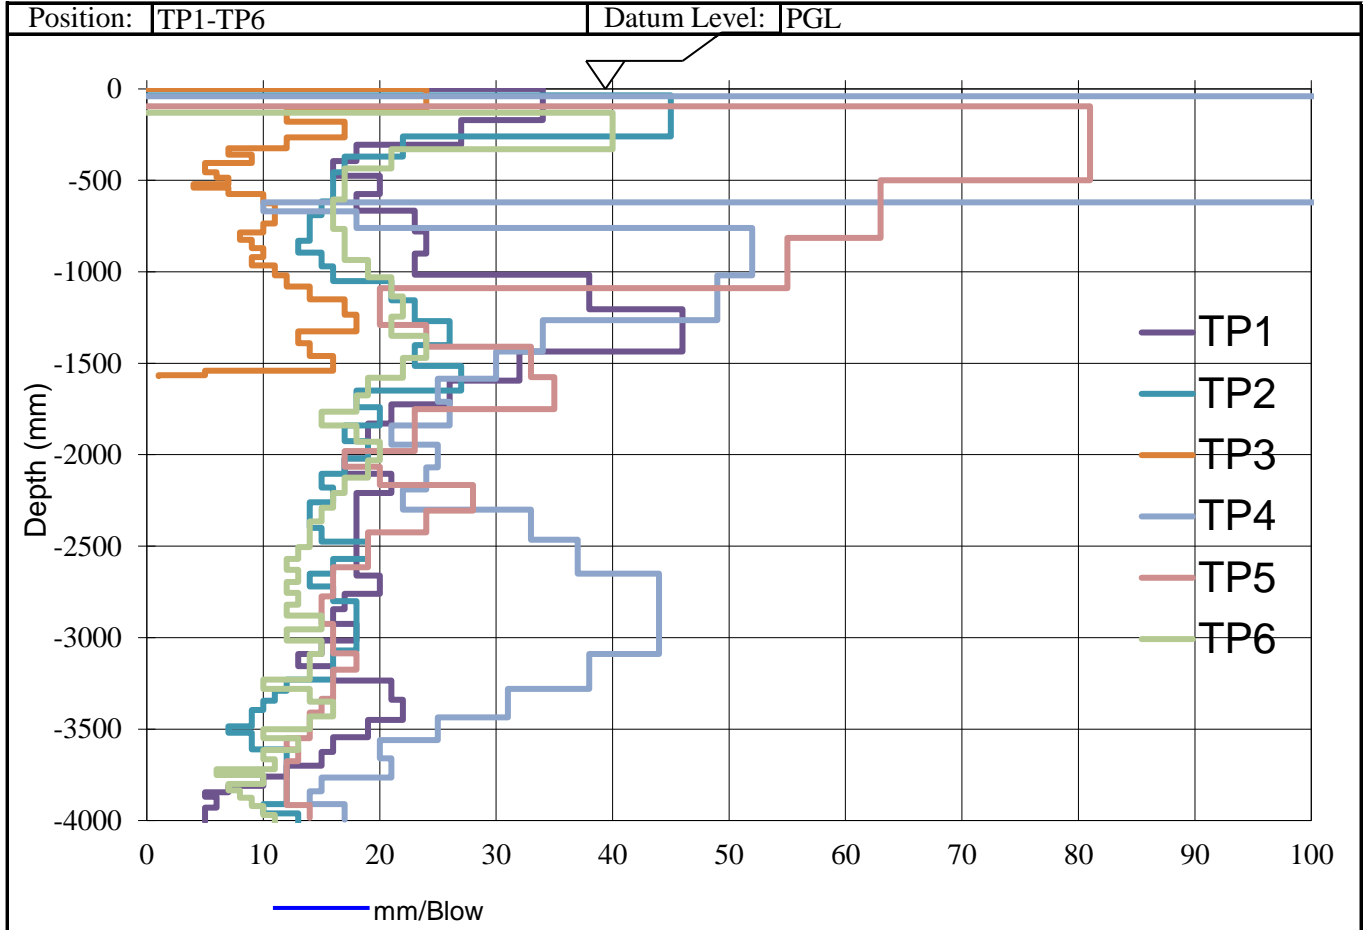
handheld penetration tests (DCP) conducted through the upper 4m of the profile indicated that the upper 1.5m was very loose, but consistently improving below 2m to medium dense state (see attached results). The following approximated shear strength parameters were derived from DCP tests:

- 0-1500mm: loose,  $\phi'=28^\circ$ ,  $c'=0\text{kPa}$ , high compressibility.
- 1500-2500mm: medium dense,  $\phi'=32^\circ$ ,  $c'=0\text{kPa}$ , moderate compressibility.
- 2500-4000mm: dense,  $\phi'=34^\circ$ ,  $c'=0\text{kPa}$ , low compressibility.

#### Dynamic Cone Penetrometer (DCP) - (TMH 6 Method ST6)

In general, the tests indicated a highly compressible soil within the influence zone of normal shallow foundations, thus requiring modified or improved foundation systems.

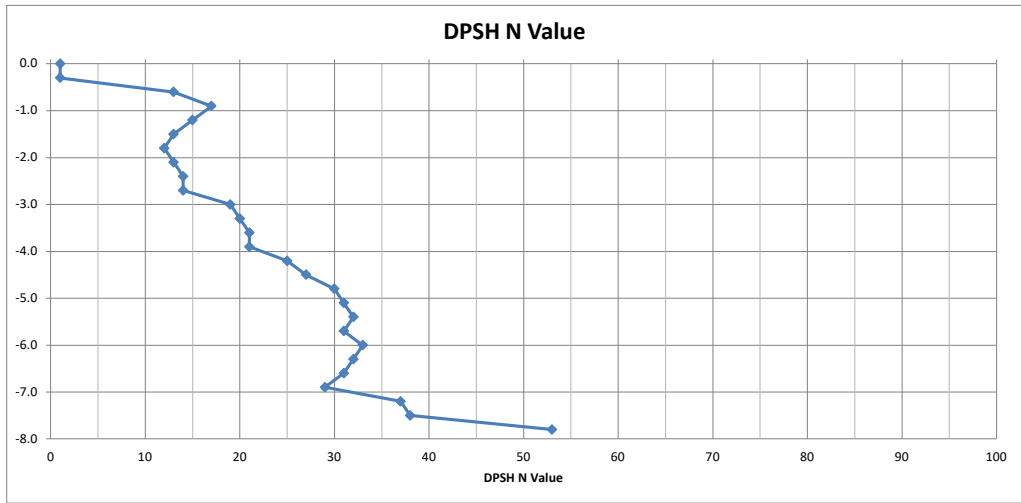
Depth m	DN* Blows/0.3m
0.0	0
-0.3	1
-0.6	1
-0.9	13
-1.2	17
-1.5	15
-1.8	13
-2.1	12
-2.4	13
-2.7	14
-3.0	14
-3.3	19
-3.6	20
-3.9	21
-4.2	21
-4.5	25
-4.8	27
-5.1	30
-5.4	31
-5.7	32
-6.0	31
-6.3	33
-6.6	32
-6.9	31
-7.2	29
-7.5	37
-7.8	38
-8.1	53

<b>Project</b>	Rem Portion 57 of Brakkloof 443
<b>Client</b>	Beveridge c/o Dave Visser Consulting Engineers
<b>Test date</b>	10.10.2024
<b>Position</b>	DPSH1 (TP1)

- **DPSH1:** Very loose upper 1m (<10 blows/300mm), improving to a medium dense state (10-20 blows/300mm) to a depth of 3.5m and then dense below this depth (>20 blows/300mm).
- **DPSH2:** The test indicated a very dense upper 2.5m possibly due to obstruction from buried old concrete foundations, underlain by a generally medium dense layer to 7.5m and becoming very dense beyond this depth.
- **DPSH3:** The test indicated a variable consistency (medium to dense) in the upper 4.5m, but consistently dense below this depth.

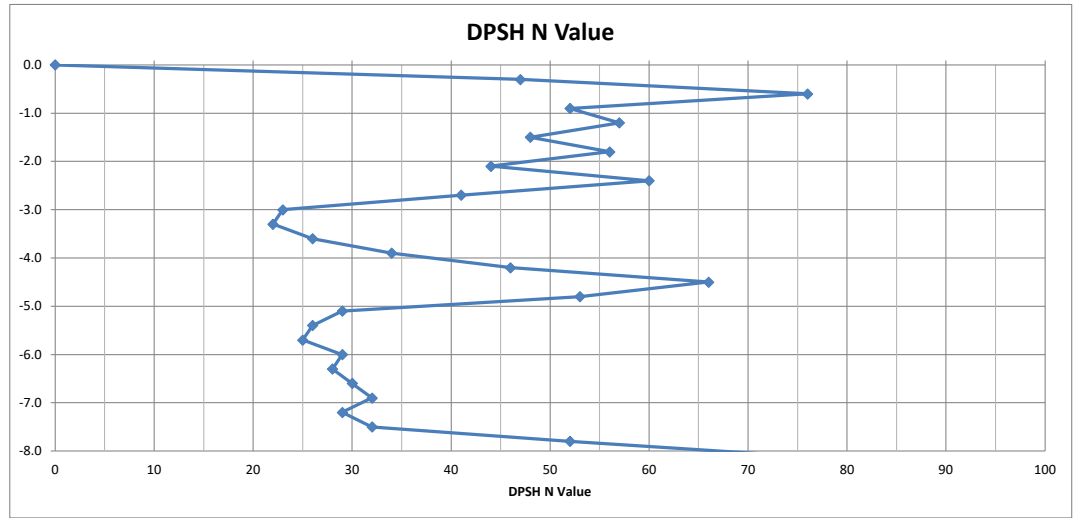
Depth	DN*
m	Blows/0.3m
0.0	0
-0.3	47
-0.6	76
-0.9	52
-1.2	57
-1.5	48
-1.8	56
-2.1	44
-2.4	60
-2.7	41
-3.0	23
-3.3	22
-3.6	26
-3.9	34
-4.2	46
-4.5	66
-4.8	53
-5.1	29
-5.4	26
-5.7	25
-6.0	29
-6.3	28
-6.6	30
-6.9	32
-7.2	29
-7.5	32
-7.8	52
-8.1	75

<b>Project</b>	Rem Portion 57 of Brakkloof 443
<b>Client</b>	Beveridge c/o Dave Visser Consulting Engineers
<b>Test date</b>	10.10.2024
<b>Position</b>	DPSH2 (TP3)

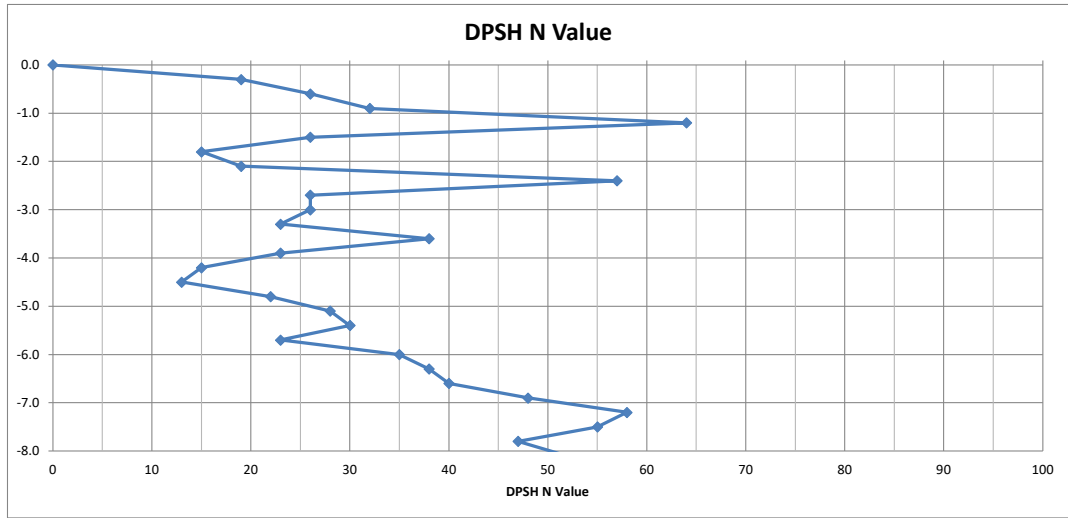
Depth m	DN* Blows/0.3m
0.0	0
-0.3	19
-0.6	26
-0.9	32
-1.2	64
-1.5	26
-1.8	15
-2.1	19
-2.4	57
-2.7	26
-3.0	26
-3.3	23
-3.6	38
-3.9	23
-4.2	15
-4.5	13
-4.8	22
-5.1	28
-5.4	30
-5.7	23
-6.0	35
-6.3	38
-6.6	40
-6.9	48
-7.2	58
-7.5	55
-7.8	47
-8.1	52

<b>Project</b>	Rem Portion 57 of Brakkloof 443
<b>Client</b>	Beveridge c/o Dave Visser Consulting Engineers
<b>Test date</b>	10.10.2024
<b>Position</b>	DPSH3 (TP5)

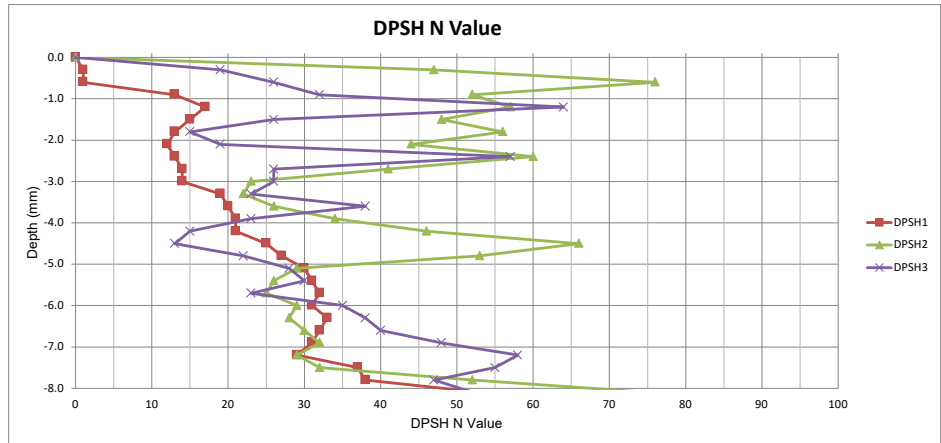
Depth	DPSH 1 (TP1)	DPSH 2 (TP3)	DPSH 3 (TP5)
m	DN*	DN*	DN*
0.0	0	0	0
-0.3	1	47	19
-0.6	1	76	26
-0.9	13	52	32
-1.2	17	57	64
-1.5	15	48	26
-1.8	13	56	15
-2.1	12	44	19
-2.4	13	60	57
-2.7	14	41	26
-3.0	14	23	26
-3.3	19	22	23
-3.6	20	26	38
-3.9	21	34	23
-4.2	21	46	15
-4.5	25	66	13
-4.8	27	53	22
-5.1	30	29	28
-5.4	31	26	30
-5.7	32	25	23
-6.0	31	29	35
-6.3	33	28	38
-6.6	32	30	40
-6.9	31	32	48
-7.2	29	29	58
-7.5	37	32	55
-7.8	38	52	47
-8.1	53	75	52
Refusal

<b>Project</b>	Rem Portion 57 of Brakklouf 443
<b>Client</b>	Beveridge c/o Dave Visser Consulting Engineers
<b>Test date</b>	10.10.2024
<b>Position</b>	DPSH1-3

The general interpretation of the tests was as follows:

0-4.5m: Medium dense, SPT N=10-20,  $\phi'=32-34^\circ$ ,  $c'=0\text{kPa}$

4.5-7.5m: Dense, SPT N=20-40,  $\phi'=34-36^\circ$ ,  $c'=0\text{kPa}$

7.5-8m: Very dense, SPT N=40-50,  $\phi'=36-38^\circ$ ,  $c'=0\text{kPa}$

No refusal was reached within the maximum test depth of 8.1m at any of the test positions.
