GEOTECHNICAL REPORT

PROPOSED NEW RESIDENTIAL AND COMMERCIAL DEVELOPMENT OF PORTIONS 59, 62 & 63 OF BRAKKLOOF 443, PLETTENBERG BAY

6 MAY 2011 (Rev 0)

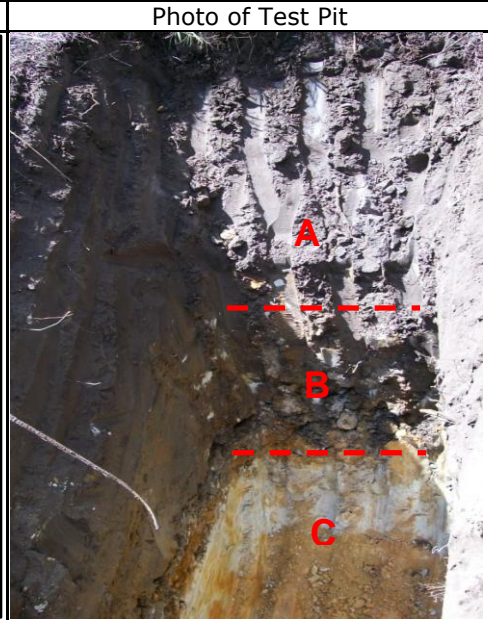
TP 17	Datum: NGL	Co-ords: 23 Y-033587 X3774457
	Key to symbols: ○ Sample taken ▽ Groundwater	
(0 to 900)	Slightly moist to moist, dark brown, loose to medium dense, intact, SILTY SAND , transported (Organic 0-100).	
(900 to 1800)	Moist, dark brown to dark red orange, stiff, fissured & slickensided, SILTY SANDY CLAY , transported (Cobbles & boulders @ base of layer).	
(1800 to 2700)	Moist, light grey to light red orange, very stiff to very dense, intact, CLAYEY SILT , residual (completely weathered siltstone)

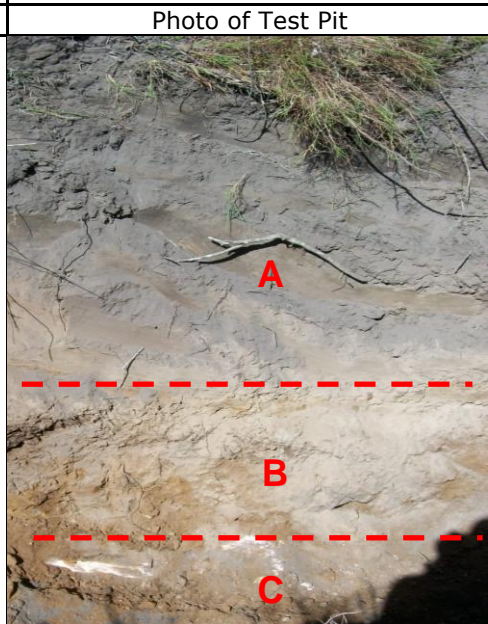
TP 18	Datum: NGL	Co-ords: 23 Y-033641 X3774388
	Key to symbols: ○ Sample taken ▽ Groundwater	
(0 to 1000)	Slightly moist to moist, dark brown, loose to medium dense, intact, SILTY SAND , transported (Topsoil, organic 0-100).	
(1000 to 1400)	Moist, dark brown dense, intact, SILTY SANDY GRAVEL , pedogenic (ferricrete layer).	
(1400 to 1500)	Light brown, moderately fractured, slightly weathered, medium hard, SANDSTONE (Robberg Fm).	
Refusal @ 1500mm on sandstone

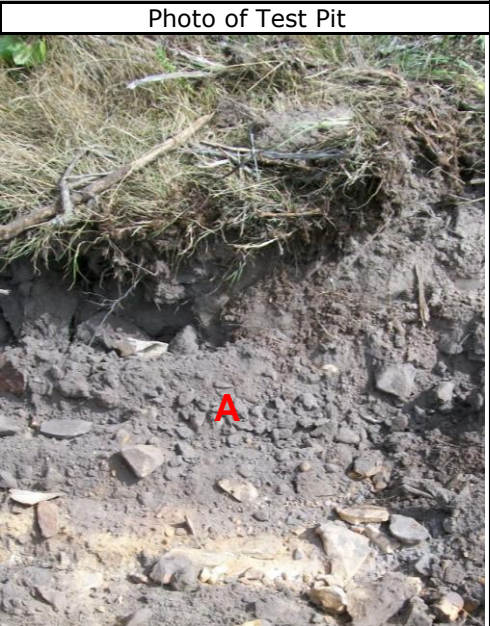
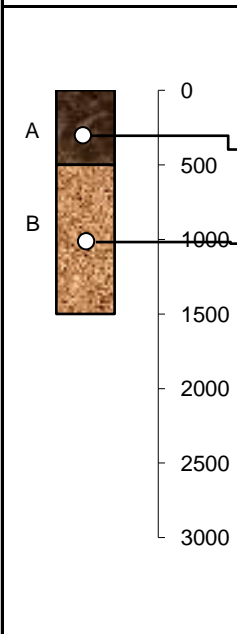
<p>TP 22</p> <p>(0 to 500)</p>	<p>Datum: NGL Co-ords: 23 Y-033464 X3774264</p> <p>Key to symbols: ○ Sample taken ▽ Groundwater</p>	<p>DCP</p>

<p>Slightly moist to moist, dark brown, medium dense, intact, SILTY SAND + LARGE BOULDERS (1mØ), transported.</p> <p>Refusal @ 400mm on sandstone rock.</p>

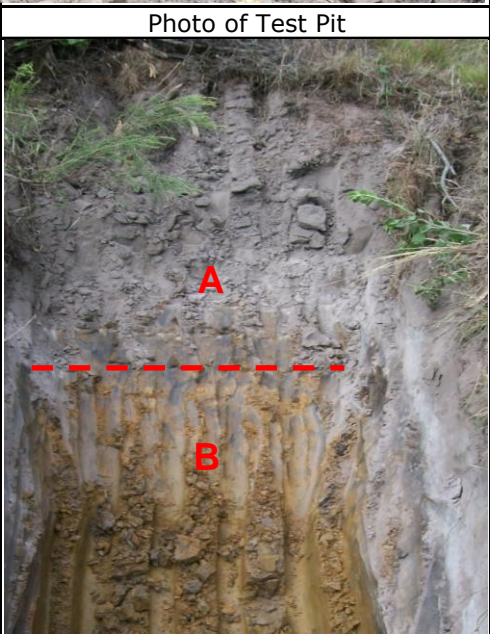
<p>(500 to 1500)</p> <p>Slightly moist, dark brown, medium dense to dense, intact, SILTY SAND, transported, (Topsoil organic 0-50). MOD/CBR/Indicator</p> <p>Slightly moist, dark red orange, very stiff, fissured, SANDY SILTY CLAY, residual. Foundation Indicator</p> <p>Excavator struggling to dig further</p>
