AQUATIC SITE SENSITIVITY AND BASELINE REPORT

FOR THE PROPOSED

DEVELOPMENT ON PORTIONS 59 AND 62 OF FARM BRAKKLOOF NO. 443, BITOU MUNICIPALITY

DATE: 21 January 2026

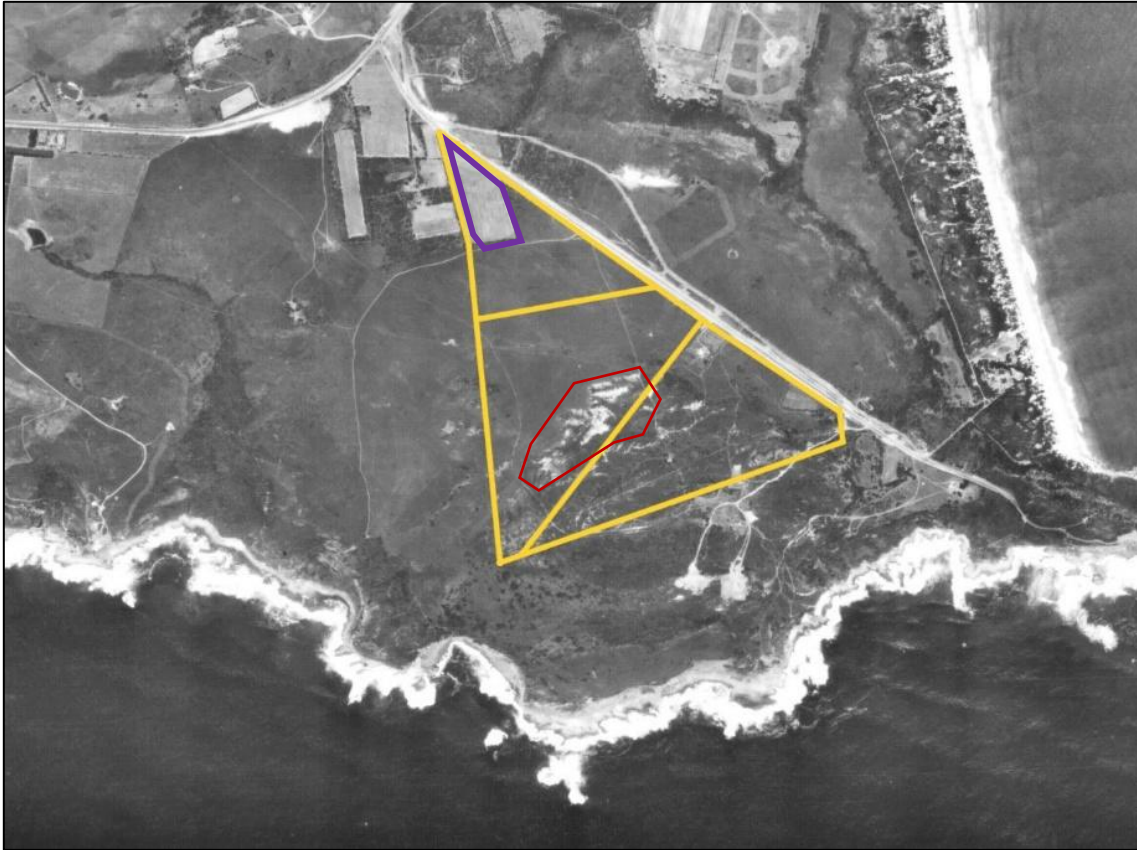
Figure 8: Historic aerial imagery from 1974 (purple polygon depicts ploughed lands and red polygon depicts approx. mined area but there is also other disturbances visible)

The current ecological and hydrological condition of the study area reflects a history of agricultural use, mineral extraction and fluctuating levels of invasive alien plant infestation. Review of historical aerial imagery (Figures 8 & 9), together with site observations, indicates a landscape characterised by variable disturbance intensity, with some portions of the site having been extensively transformed while others remain comparatively intact.

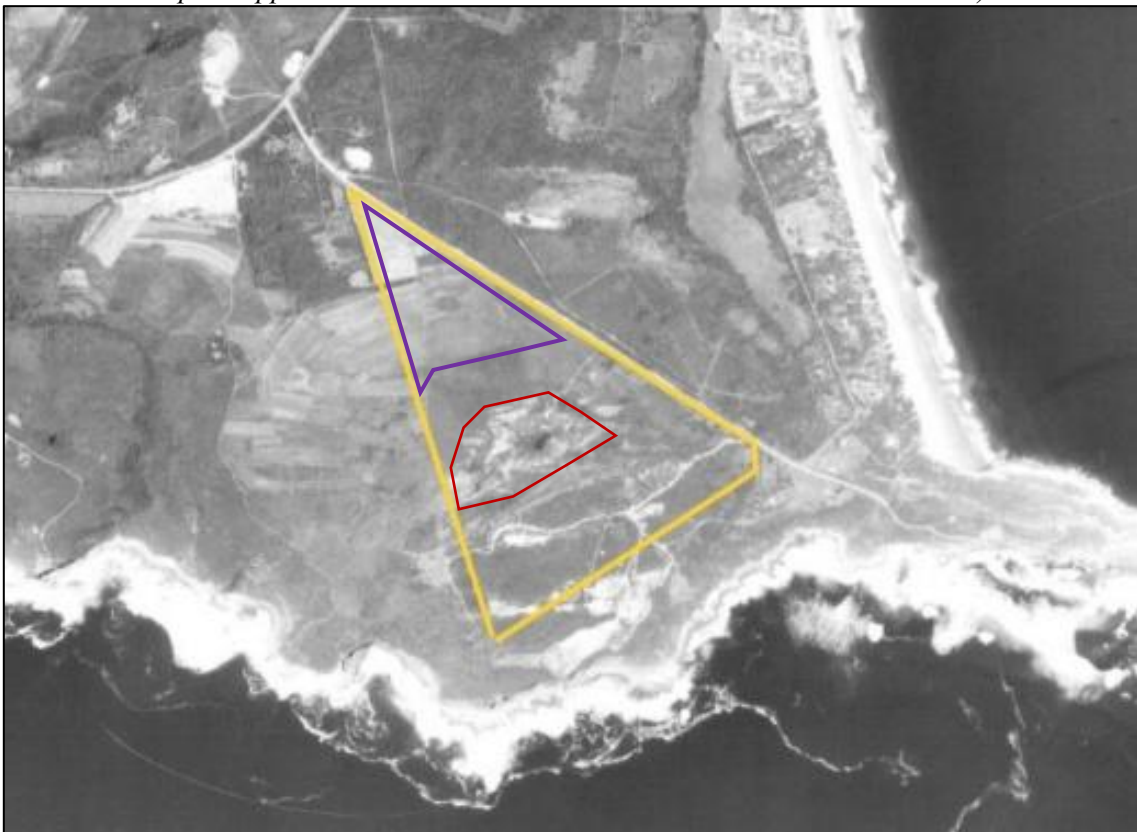
Figure 9: Historic aerial imagery from 1990 (purple polygon depicts ploughed lands and red polygon depicts approx. mined area but there are also other types of disturbance visible)

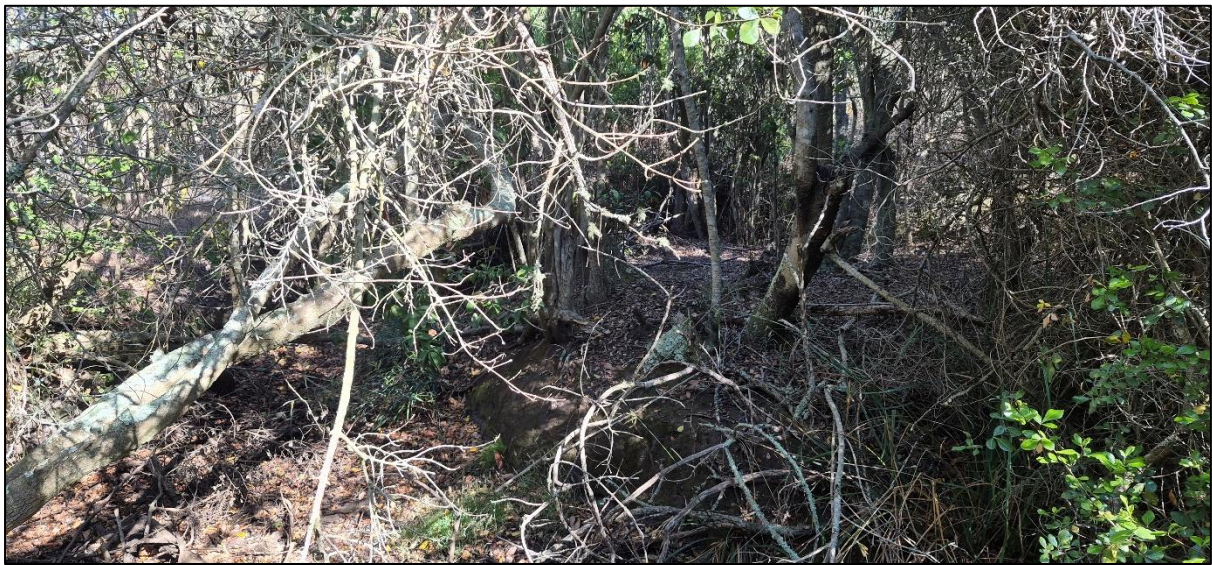
The dry channel is approximately 2 meters in width with vertical 1m high banks. Its substrate consists primarily of fine alluvial silty sands over a low-permeability clayey-silt residual horizon, which facilitates the rapid seaward transport of surface runoff.

Despite the lack of permanent water, HGM 1 is still a significant aquatic feature on site from a functional perspective as it provides a longitudinal ecological corridor to and from the coast.

Plate 1: Photograph of the dry stream channel of HGM1 on portion 62

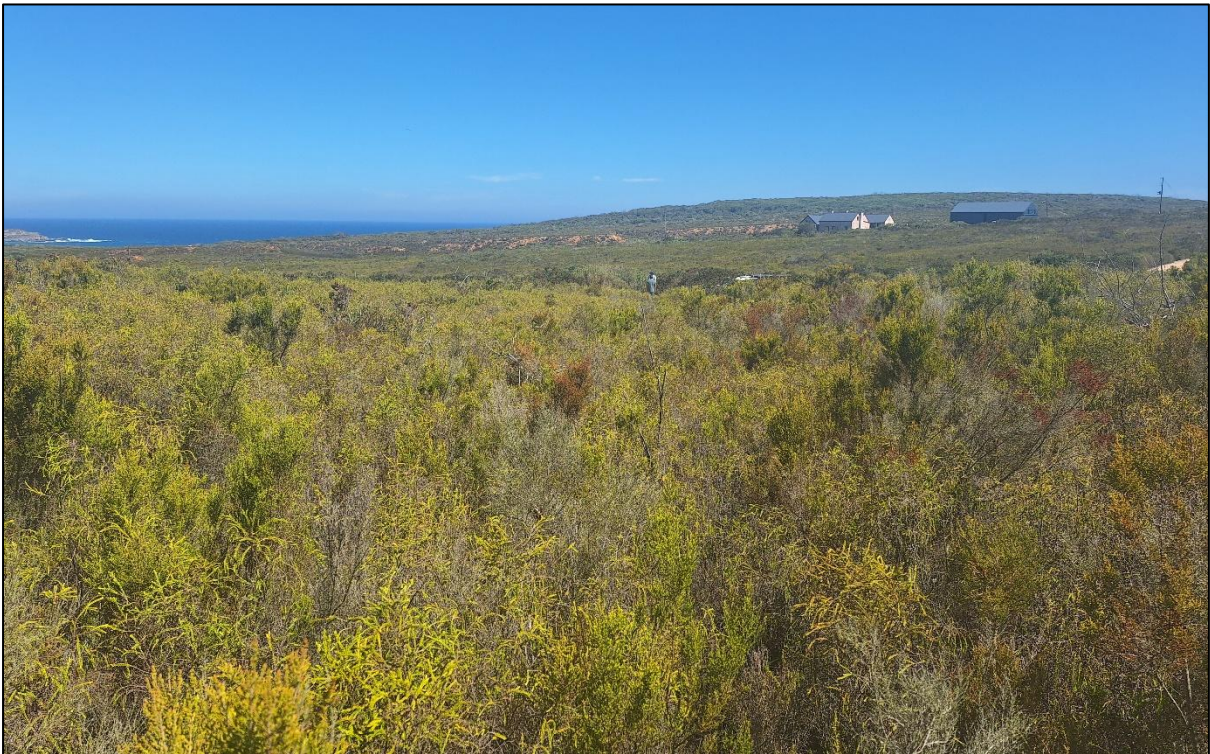
Plate 2: Photograph taken upslope of the road, showing no channel or riparian vegetation, looking towards HGM2 which forms beyond Portion 59

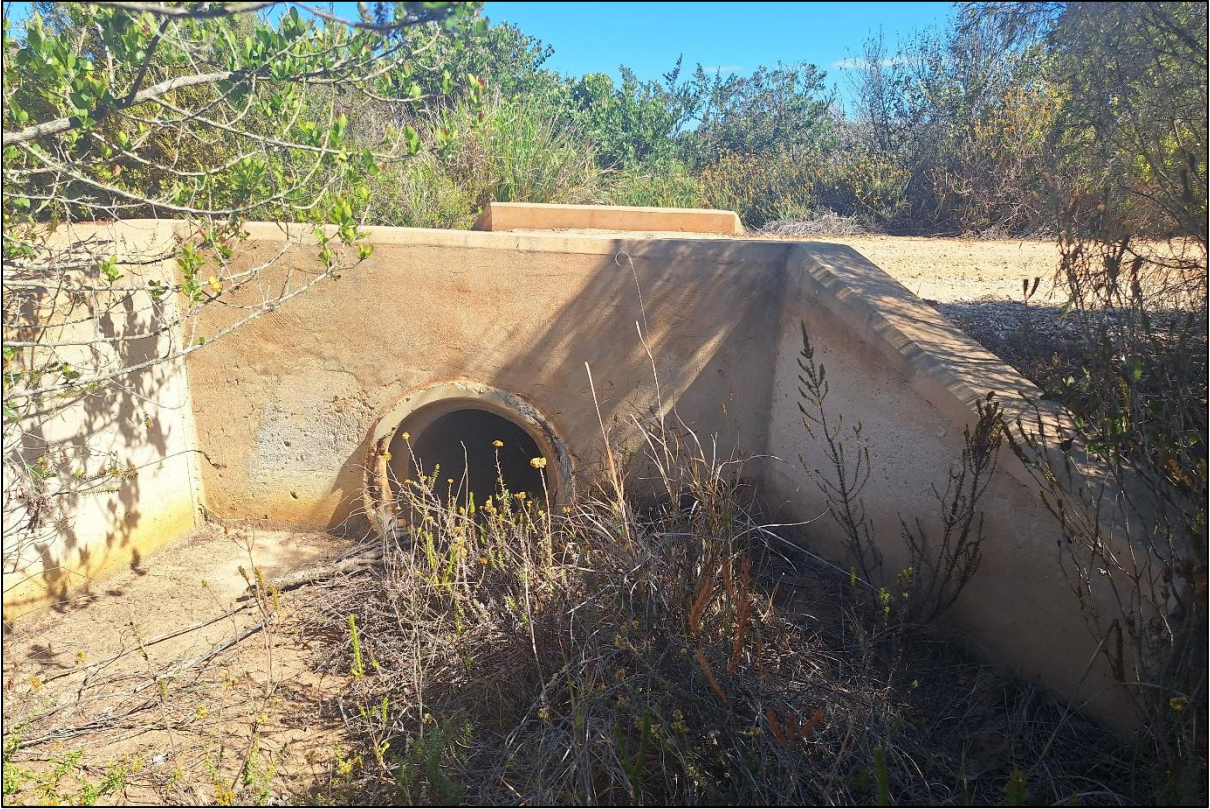
Plate 3: Photograph of the road culvert which is not in fact within riparian habitat but directs surface runoff, collected by the roadside ditch upslope, towards the downslope watercourse

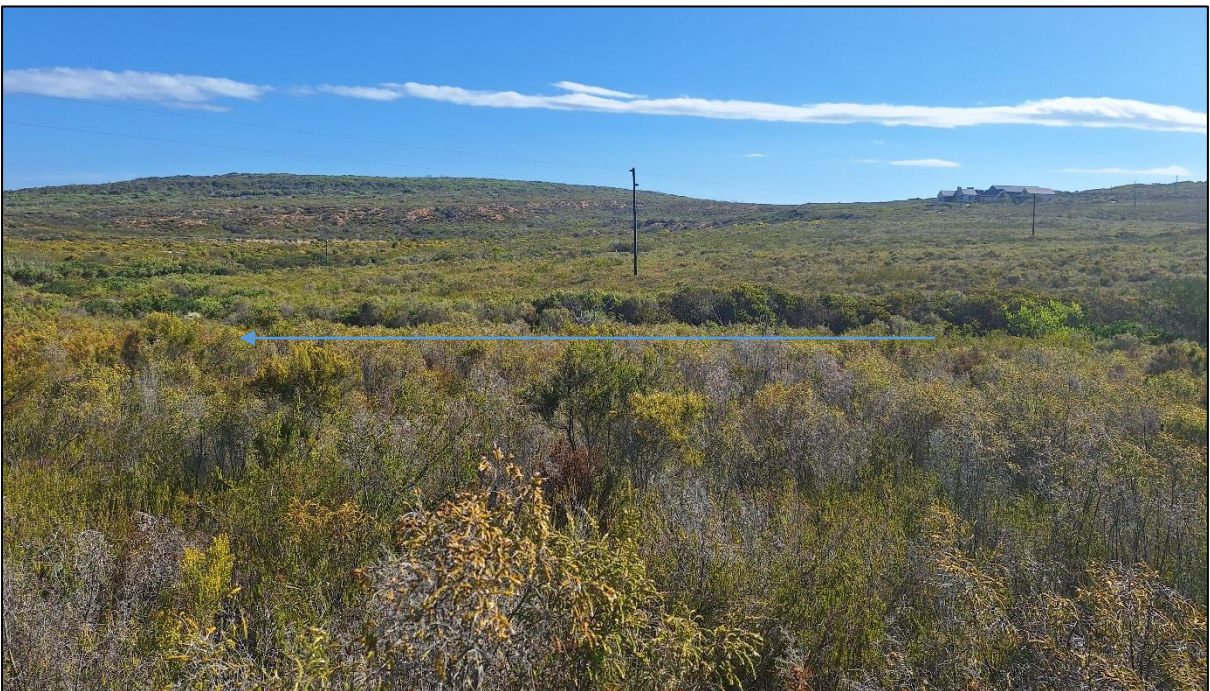
HGM 2 has relatively intact riparian vegetation cover compared to the more disturbed upper slopes. Because the topography of the first-order valley provides a degree of shelter from wind and slightly higher localized moisture retention in the soil, the vegetation is characterized by a denser thicket-fynbos ecotone. Similar to the rest of the site, this corridor was historically affected by invasive alien plants but has benefited from recent clearing efforts.

The conservation importance of HGM 2 is primarily derived from its role as a supplementary ecological corridor. It is not of high EIS and is a minor feature with infrequent hydrological activity, but it contributes to the overall landscape connectivity of the site. It serves as a natural input to HGM 1, ensuring the continuity of the drainage network.

Plate 4: Photograph of the HGM2 drainage line on portion 63 (indicated by the taller thicket plant species) which flows to the HGMI

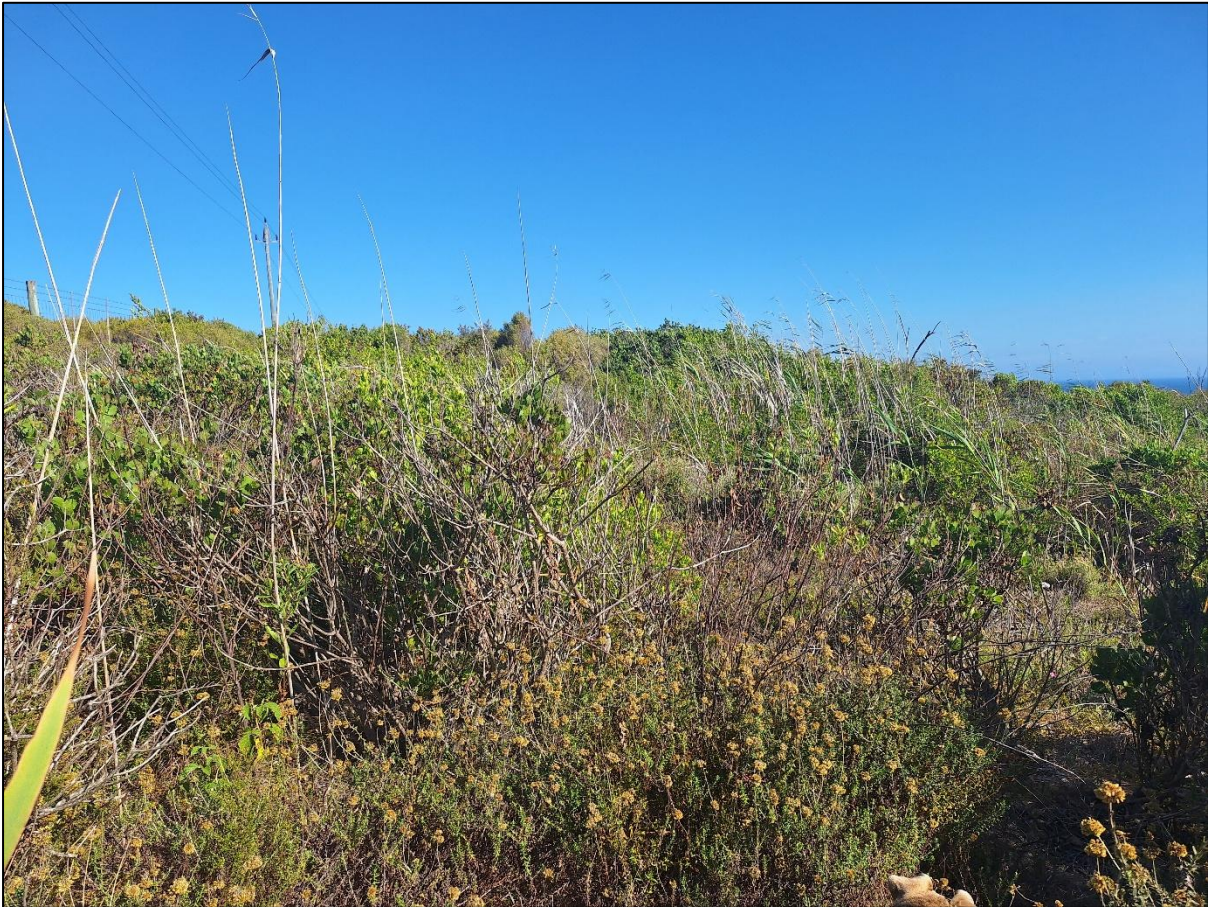
The hydrological regime is characterised by temporary soil wetness rather than sustained surface ponding. The contributing catchment (water input) is minor, and the feature receives very little actual stormwater runoff. Its "wetland" status is marginal, as the saturation is transient and occurs only after significant rainfall events. There is no evidence of a perched water table or groundwater emergence; instead, the feature simply delays the infiltration and evaporation of a negligible volume of surface water.

From a biodiversity perspective, HGM 3 is of negligible value. The short hydroperiod and the artificial nature mean it does not support aquatic dependent species. The vegetation is primarily opportunistic and does not consist of true obligate hydrophytes, and they are characteristic more of a disturbed area species. Additionally, while this feature technically displays signs of temporary saturation, its conservation importance is Very Low. It is a man-made feature of road construction that performs no significant ecological service. But it is recommended to retain it because it serves as a minor, localized point of surface water impedance to reduce the risk of erosion from the drain.

Plate 5: Phragmites australis below road stormwater outlet indicating HGM3 artificial wetland

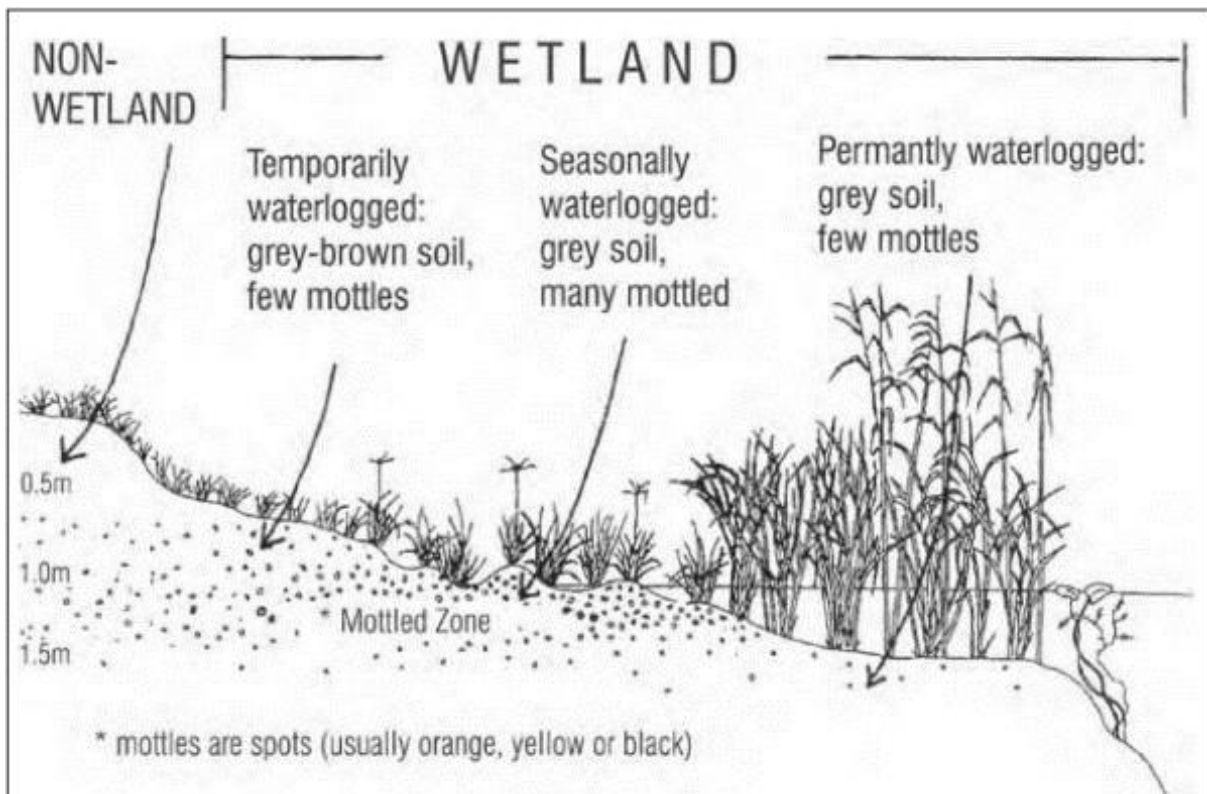
Figure: Cross section through a wetland, indicating how the soil wetness and vegetation indicators change as one moves along a gradient of decreasing wetness, from the middle to the edge of the wetland. Source: Donovan Kotze, University of KwaZulu-Natal.

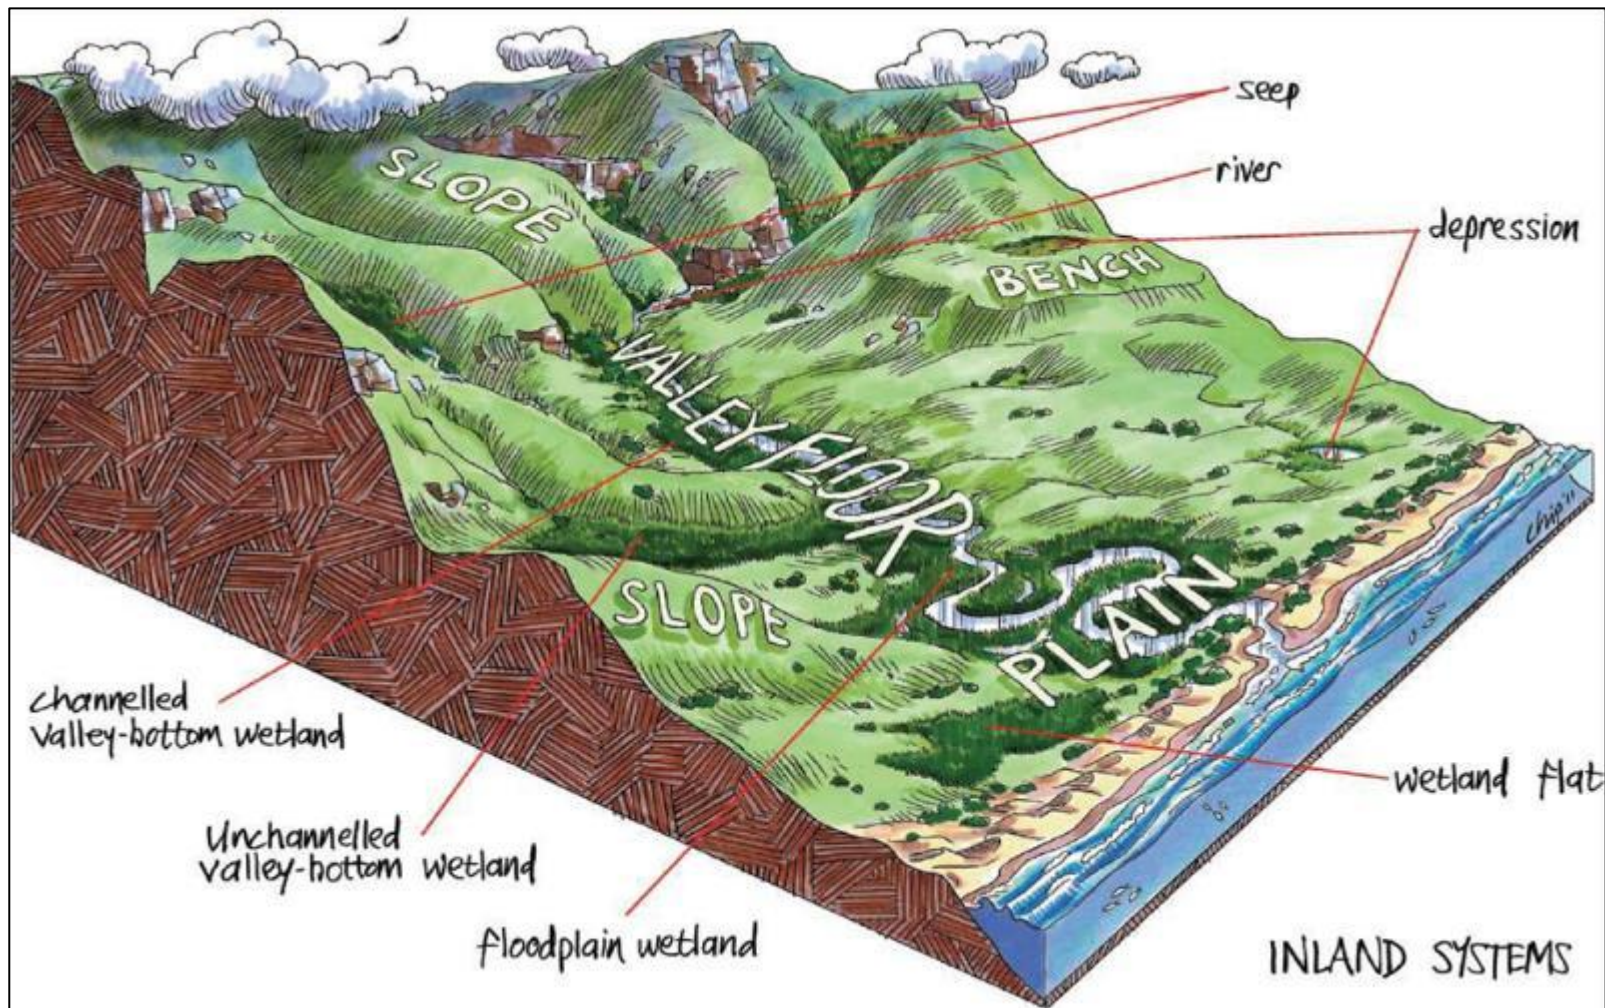
Figure: Illustration of wetland types and their typical landscape setting (From Ollis et al. 2013)

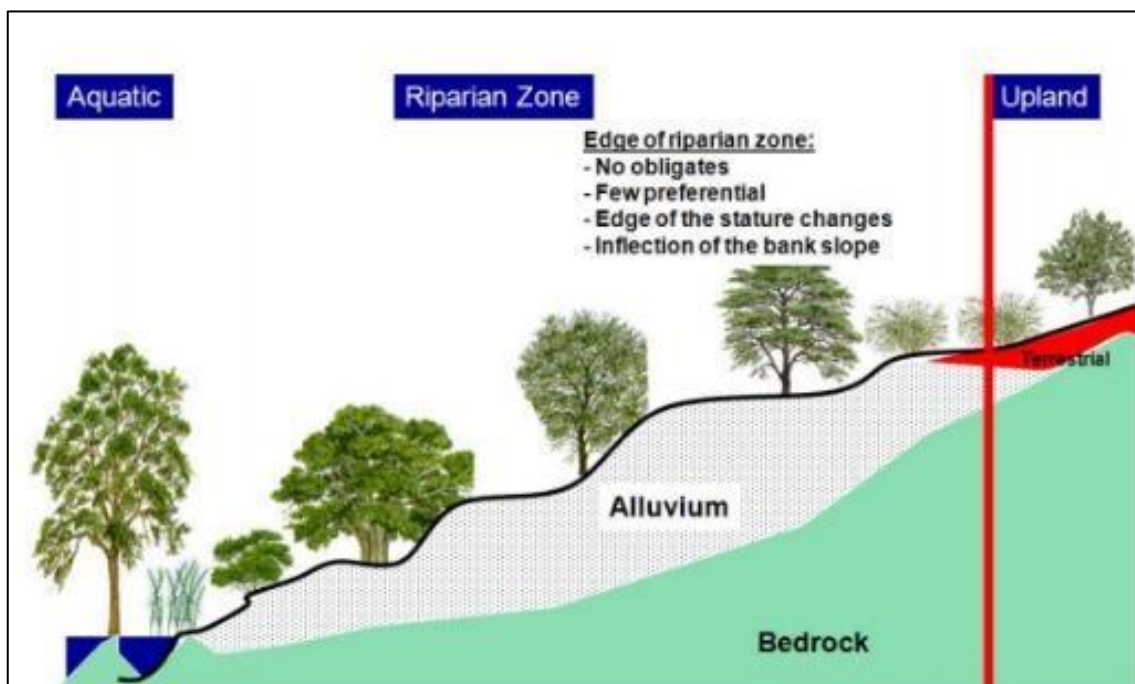
A schematic diagram illustrating the edge of the riparian zone on one bank of a large river. Note the coincidence of the inflection (in slope) on the bank with the change in vegetation structure and composition. The edge of the riparian zone coincides with an inflection point on the bank; where there are not obligates upslope; few preferential. The boundary also coincides with the outer edge of the stature differences (DWAF 2008).
