# Proposed Development of Tourist Facilities on Portion 104 of Farm 216, Uitzicht, Knysna, Western Cape.

Aquatic Biodiversity Site Sensitivity Verification and Impact Assessment.

**Prepared For:** Eco Route Environmental Consultancy

**Author:** Mr. F de Ridder (MSc)  
Confluent Environmental Pty (Ltd)  
7 St. Johns Street,  
Dormehlsdrift,  
George, 6529

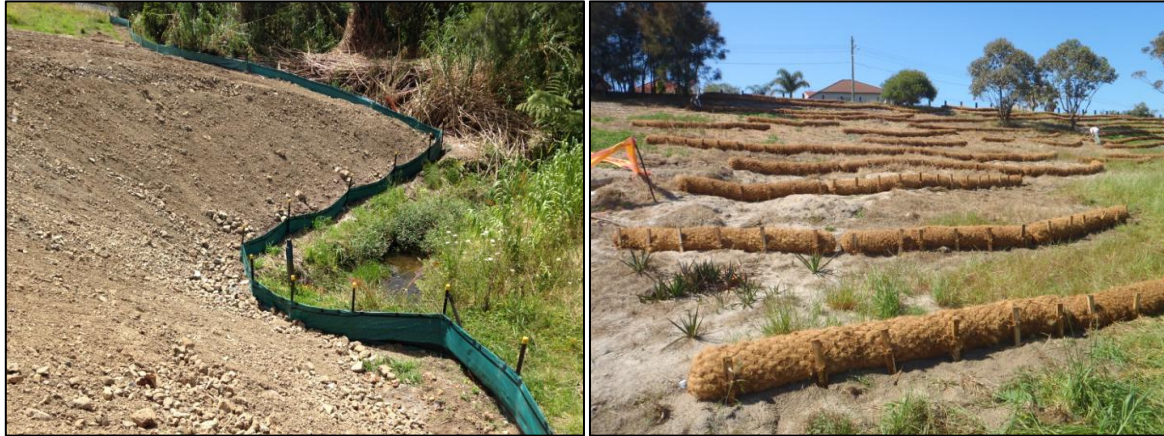
Figure 20: Examples of silt fences (left) and coir logs (right) used to trap sediment mobilised from steep slopes.

- Do not clear vegetation outside the proposed development footprint.
- Only use one access road for each camp unit.
- Use the existing road as far as possible.
- Install silt fences or sediment barriers around the perimeter of the construction site to trap sediment-laden runoff and prevent it from entering the estuary.
- Implement phased construction to minimise the area of exposed soil at any given time and reduce the potential for erosion.
- Apply mulch or erosion control mats on exposed slopes and disturbed areas to stabilise soils and reduce erosion rates.
- The 36 m buffer must be maintained and demarcated as a no-go area.
- The laydown areas must be constructed on flat surfaces with a minimum distance of 20 m from the buffer.
