GEOTECHNICAL REPORT

Project: Erf 155 Keurboomstrand, Plettenberg Bay

Date: 11.12.2020

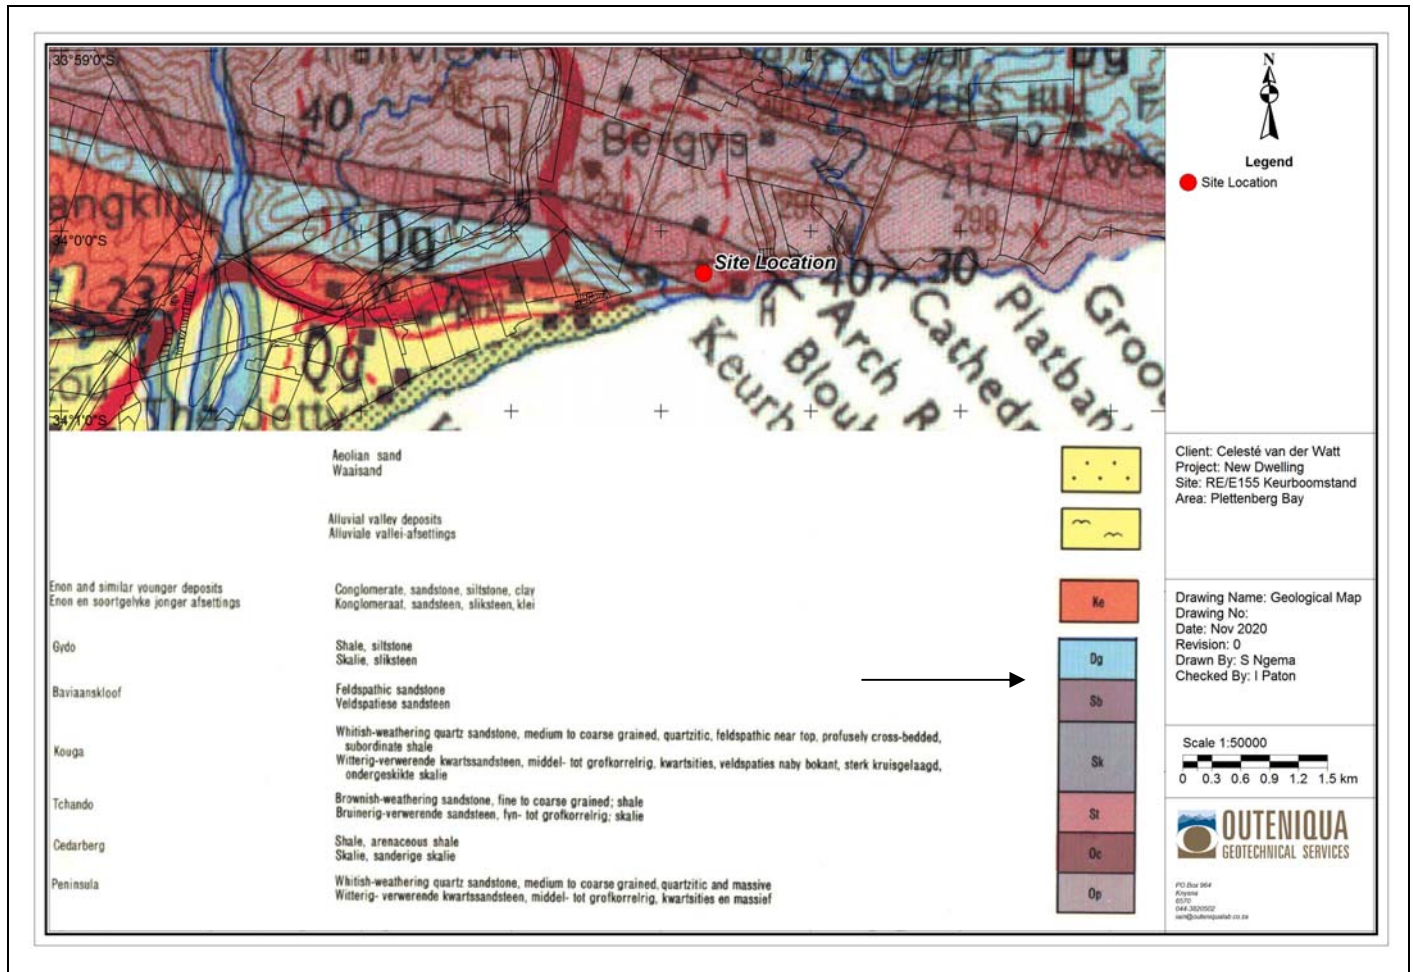
Figure 4: Geological map of site

The site is underlain by feldspathic sandstone and shale of the Silurian Baviaanskloof Formation of the Table Mountain Group, which is clearly visible on the steep slopes near the southern boundary (see Figure 4&5). The bedrock is locally overlain by alluvial and/or colluvial silty sand, gravel and cobbles.

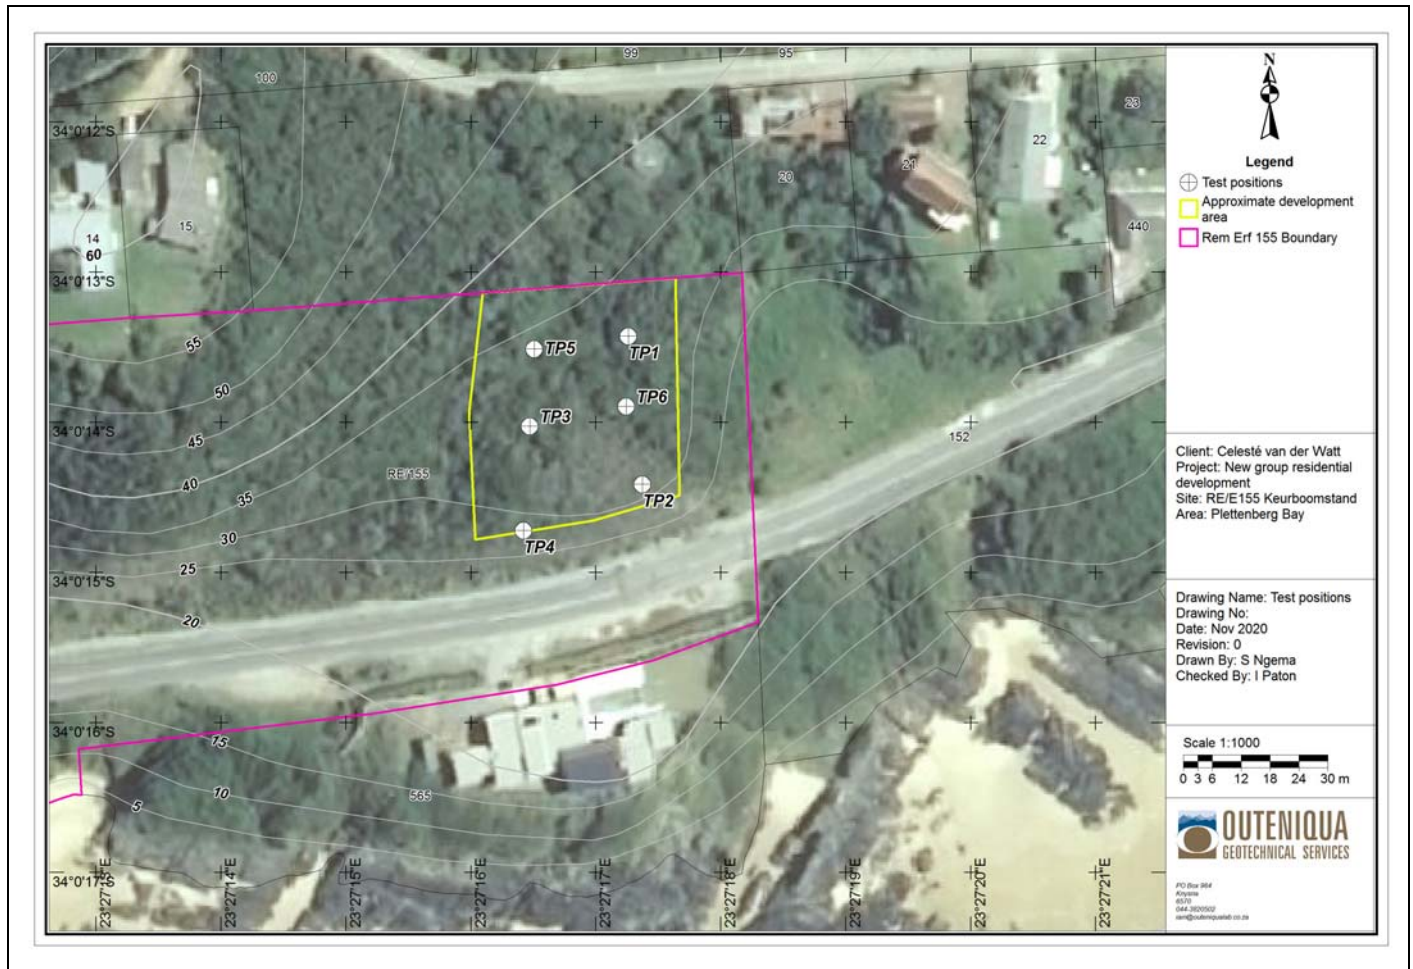
Figure 6: Plan of test positions

Test pits conducted on the site (see Figure 6&7) recorded a general soil profile consisting of silty sandy gravel and cobbles of colluvial origin, overlying bedrock shale and feldspathic sandstone of

the Baviaanskloof Formation. Two test pits refused on this rock at a depth of 0.5m below NGL, and one test pits refused on very dense colluvial cobbles at a depth of 0.8m BNGL. Insitu penetration tests (DCP) refused on this rock or very dense cobbles at a maximum depth of 0.45m BNGL. No clay or any other highly problematic soils were encountered in the test pits and the general subsurface conditions were found to be highly favourable for structural loading. No lab tests were necessary due to the presence of shallow hard rock which provides a highly suitable founding medium.
