Aquatic Specialist Assessment for a Section 24G and Water Use License Application at 17 / 232 Redford Farm, Knysna.

Prepared by Dr. Jackie Dabrowski of Confluent Environmental (Pty) Ltd

September 2021

Updated June 2022

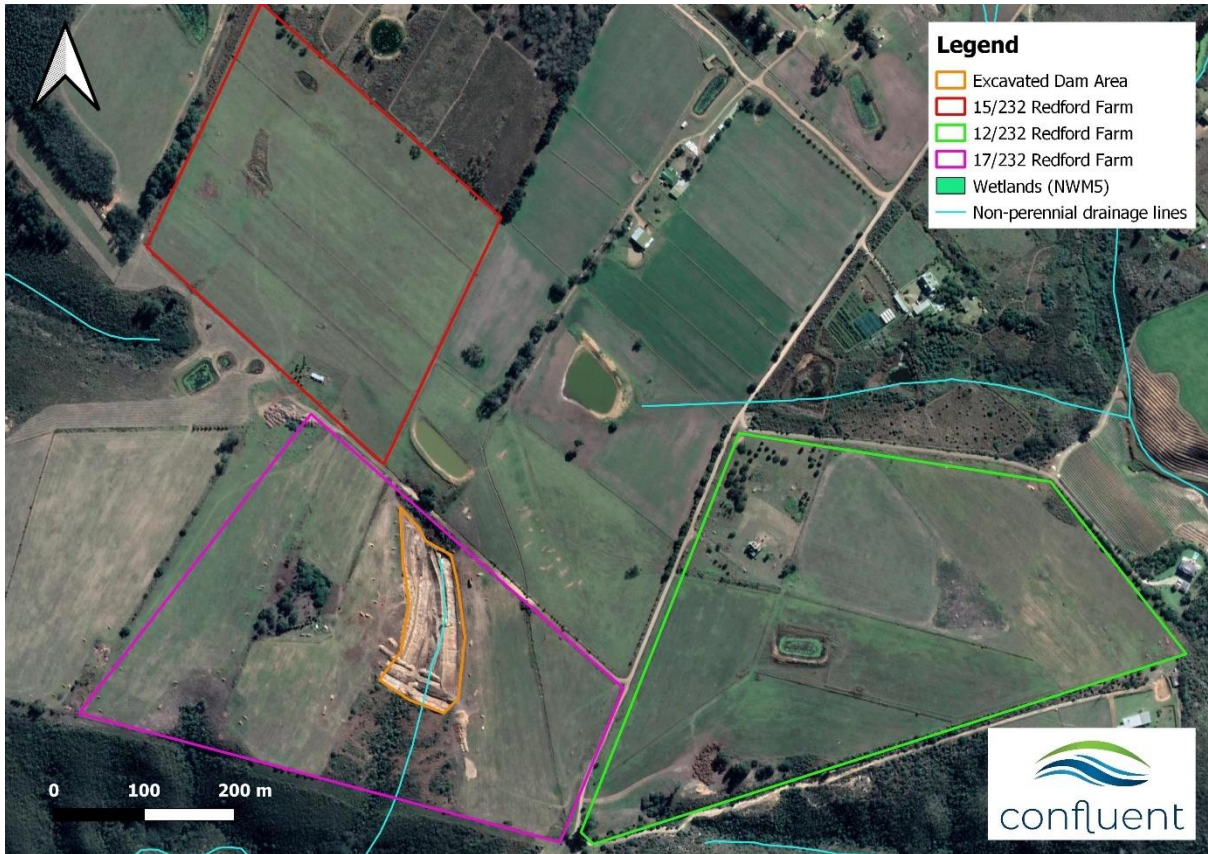
Figure 1. Map of the excavated dam area showing the three farm portions owned by the applicant (Google Earth imagery, March 2021).

At the beginning of 2021 the owners of portion 17 / 232 Redford Farm commenced with construction of an instream dam (Figure 1). The dam is located at the upper extent of a non-perennial watercourse. The intended dam capacity was 300 000 m³ with a dam wall height of 17 m. This required volume was calculated based on purchasing 5 farm portions and planting them with Macadamia nuts which require drip irrigation. Subsequently, the applicant secured 3 of the 5 properties (Figure 1), with purchase of the remaining 2 properties uncertain. It has since been shown in the engineering report (J. Brink, November 2021) that even if the full extent of the excavated site is utilised, a maximum storage capacity of 73 000 m³ is attainable with a dam wall height of 17 m.

The appointed earthworks contractor commenced with scraping out the basin area which comprised of steep vegetated valley sides and a watercourse at the bottom of the valley. Alien vegetation was present on the slopes as can be seen in photos of the site provided by the landowner (Figure 6). Topsoil, subsoil, and underlying rock in some places was excavated and stockpiled (Figure 2). The total area excavated and disturbed covers approximately 1.2 ha. Construction of the dam was stopped by receipt of the pre-directive from DEA&DP prior to the dam wall being built. Therefore, no water storage is currently taking place. The water source for the dam was intended to include surface water runoff from the catchment, borehole water, and 3 furrow allocations (1 per portion) through the Rondebosch River Water User Association (RRWUA).

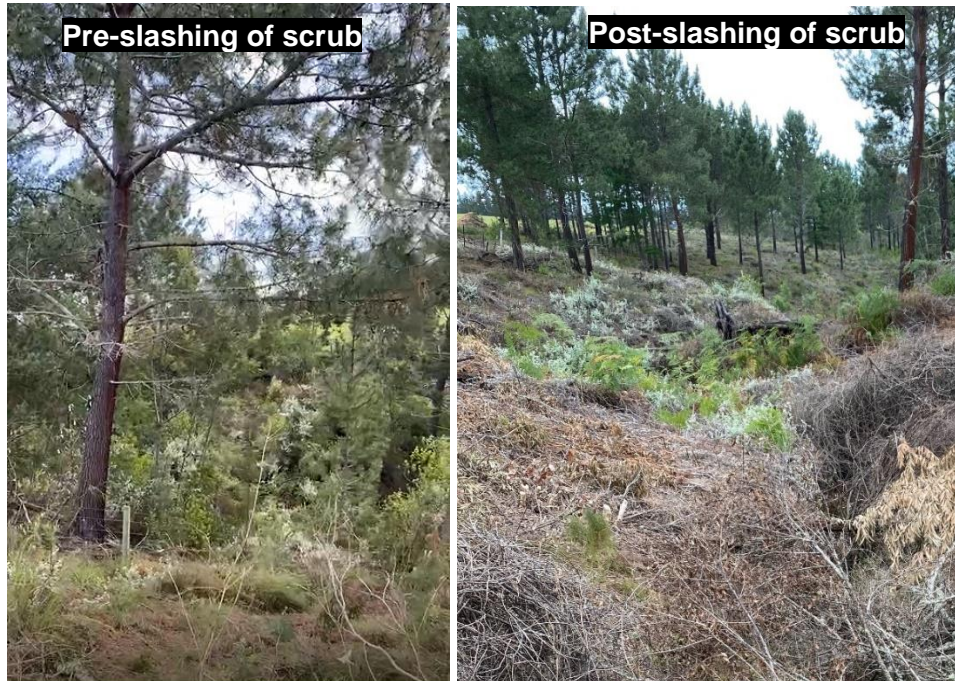
Figure 6. Photos of vegetation in the dam area pre- and post-slashing of alien invaded scrub and pre-earthworks supplied by the landowner (D. Bernard, 25/11/2020).

The mapped vegetation type is Tsitsikamma Sandstone Fynbos. The area where vegetation was cleared for excavation of the dam was invaded by alien vegetation including mature black wattle (*Acacia mearnsii*) and *Pinus* sp. trees which are evident in photos of the site prior to

excavation (Figure 6). During the site visit conducted on 17 June 2021, vegetation above and below the excavated area was in relatively good condition consisting largely of indigenous plants typically associated with the area. The state of this vegetation has been assisted by alien clearing conducted by the landowner. It is likely that some indigenous plants typically associated with riparian and possibly wetland areas were in the footprint of the dam and were subsequently cleared during excavation. However, it is not possible to accurately determine the relative proportion of indigenous to alien vegetation.

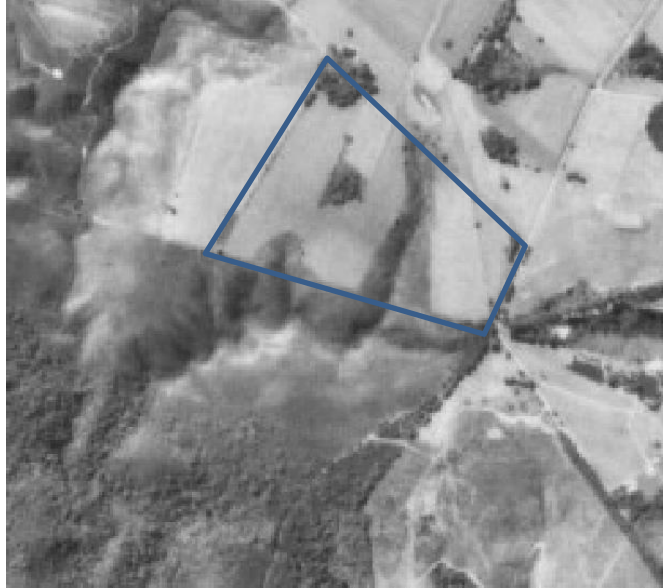
Figure 8. Historical photo of the drainage line that was cleared from 1990 showing the approximate farm boundary for 17/232.

Vegetation along the watercourse that was excavated appears to be fairly uniform and similar to that downstream in the Whiskey Creek Nature Reserve according to the historical photo from 1990. This suggests that the watercourse was not heavily invaded by alien vegetation at this time, although it is impossible to be certain of this.

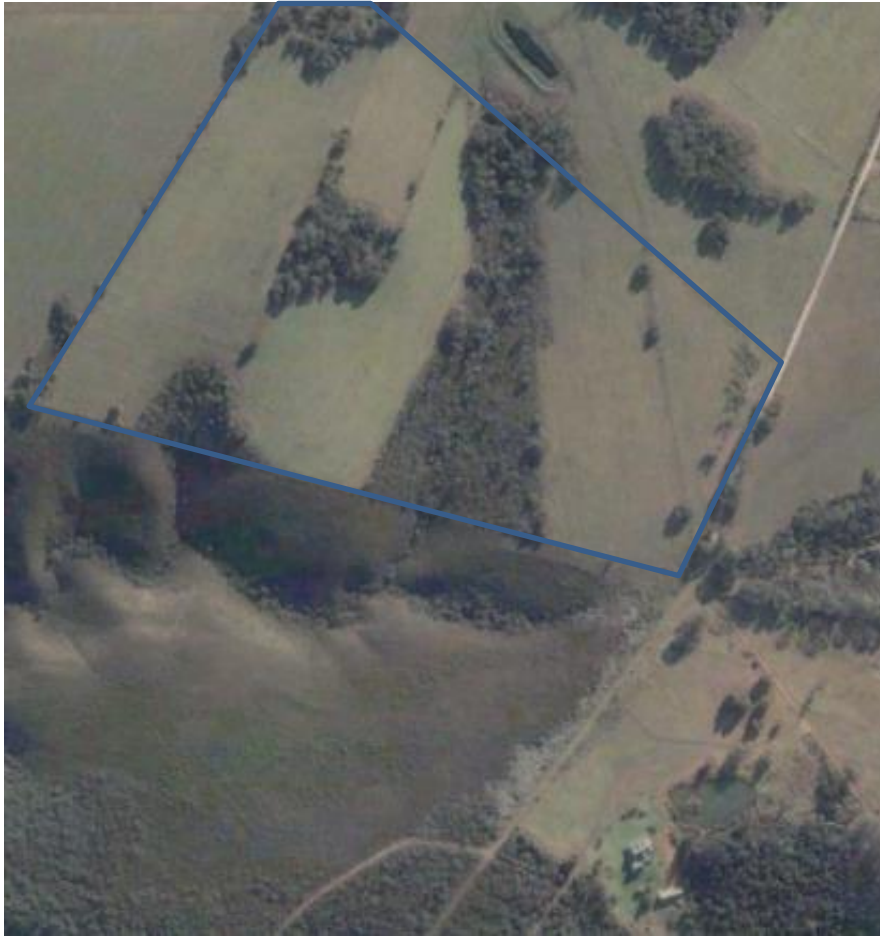
Figure 9. Historical photo of the drainage line that was cleared from 2004 showing the approximate farm boundary for 17/232.

Almost two decades later the extent of vegetation along the drainage line was similar to that in 1990. While the composition of vegetation could not be confirmed, it does appear that more woody, denser vegetation has colonised the drainage line in the 2004 photo. Again, it is not possible to confirm this, and may be due to better resolution in the more recent photo.

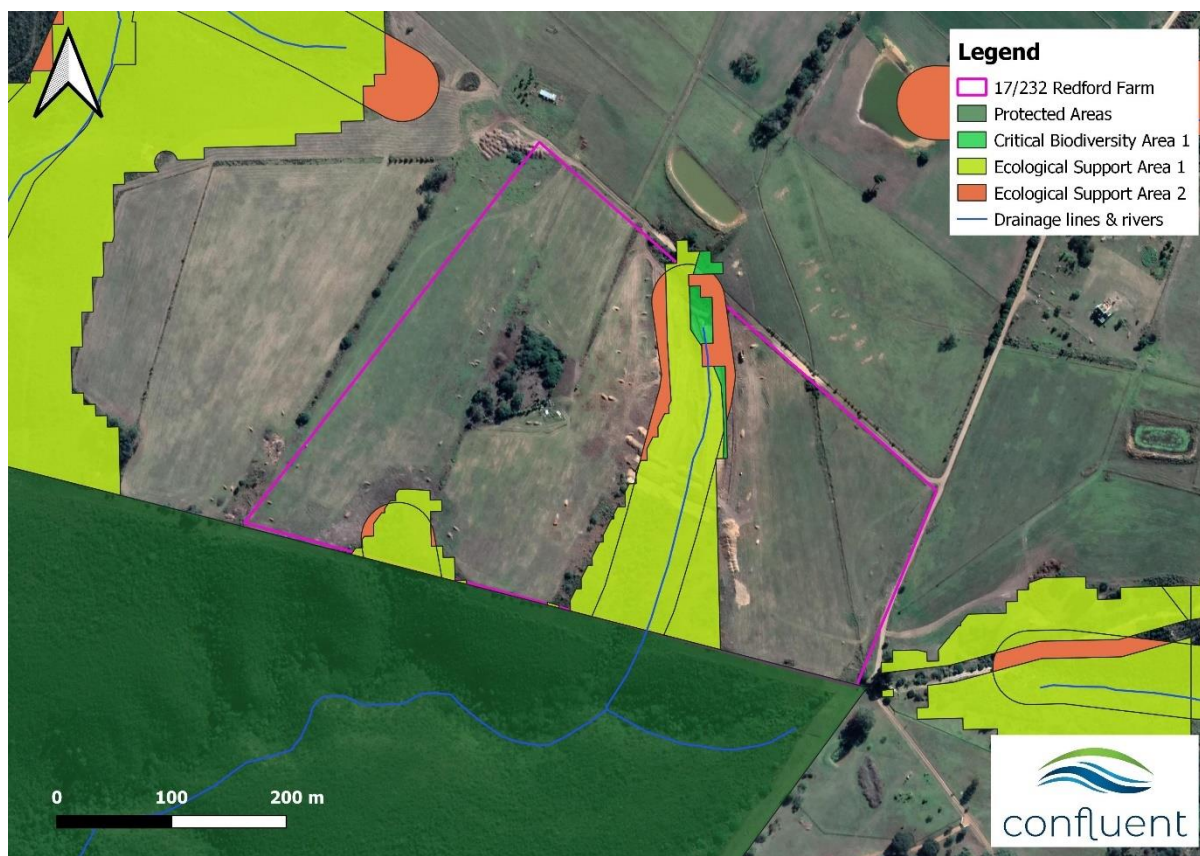
Figure 10. Areas classified in the Western Cape Biodiversity Spatial Plan.

The location of the watercourse immediately upstream of the Whiskey Creek Nature Reserve (the Protected Area) is consistent with the definition. Excavation of the valley for construction of the dam is not consistent with the management objective because entire habitat loss has occurred resulting in complete loss of ecological functioning at this location.

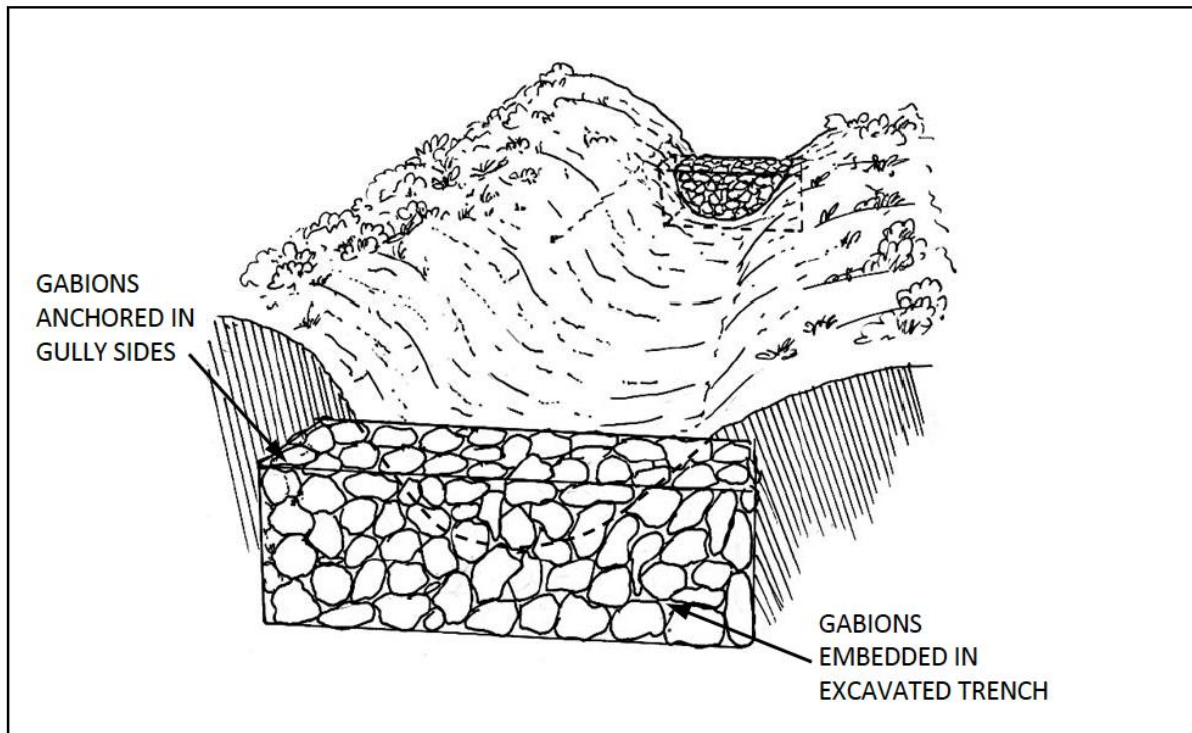
Figure 16. Cross section of recommended gabion check dam excavated into the stream bed to control erosion and slow flow (from Ministry of Environment, Water and Natural Resources, Kenya).

Revegetation of the slopes and stream bed will be required to provide stability to the soil and prevent erosion. This is the primary aim in the short-term, while improving biodiversity of the site would be a longer-term aim. Monitoring of the site is recommended (Table 16) to ensure that rehabilitation efforts are successful and that problematic areas are attended to effectively and proactively. Without successful revegetation, the slopes will undoubtedly erode in areas, causing ongoing degradation of the watercourse. It is therefore crucial that if the decision is made for the excavated area to be rehabilitated that a detailed rehabilitation plan be followed using the mitigation measures in Table 16.

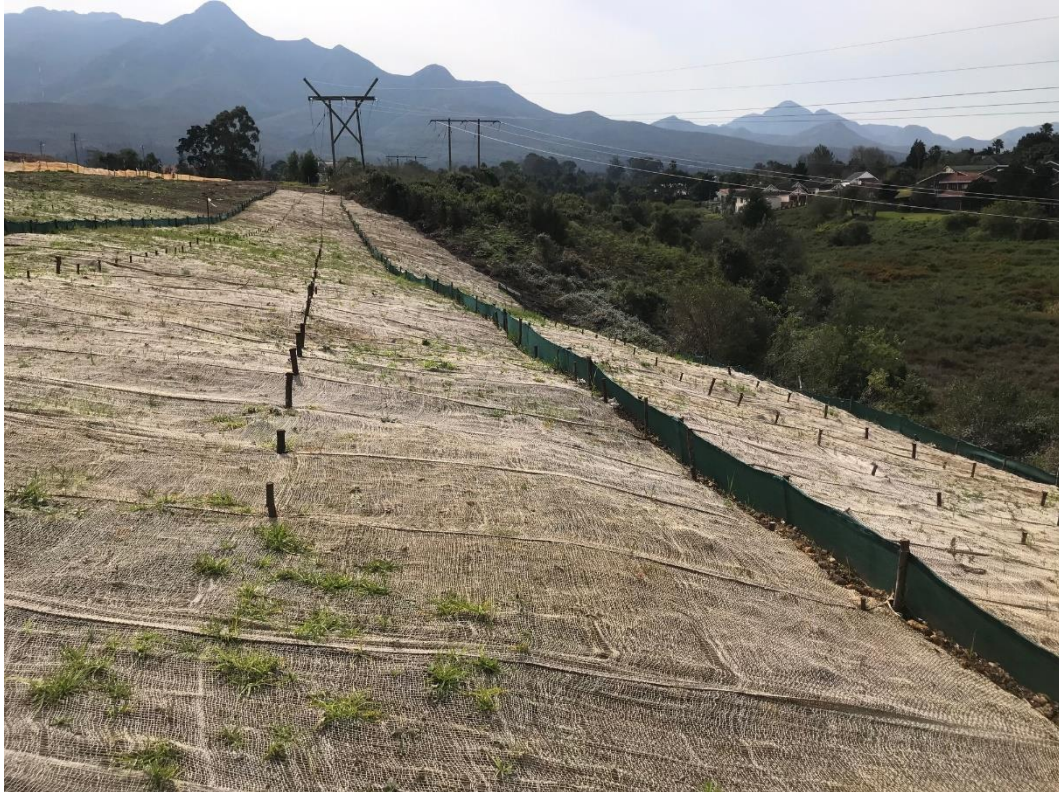
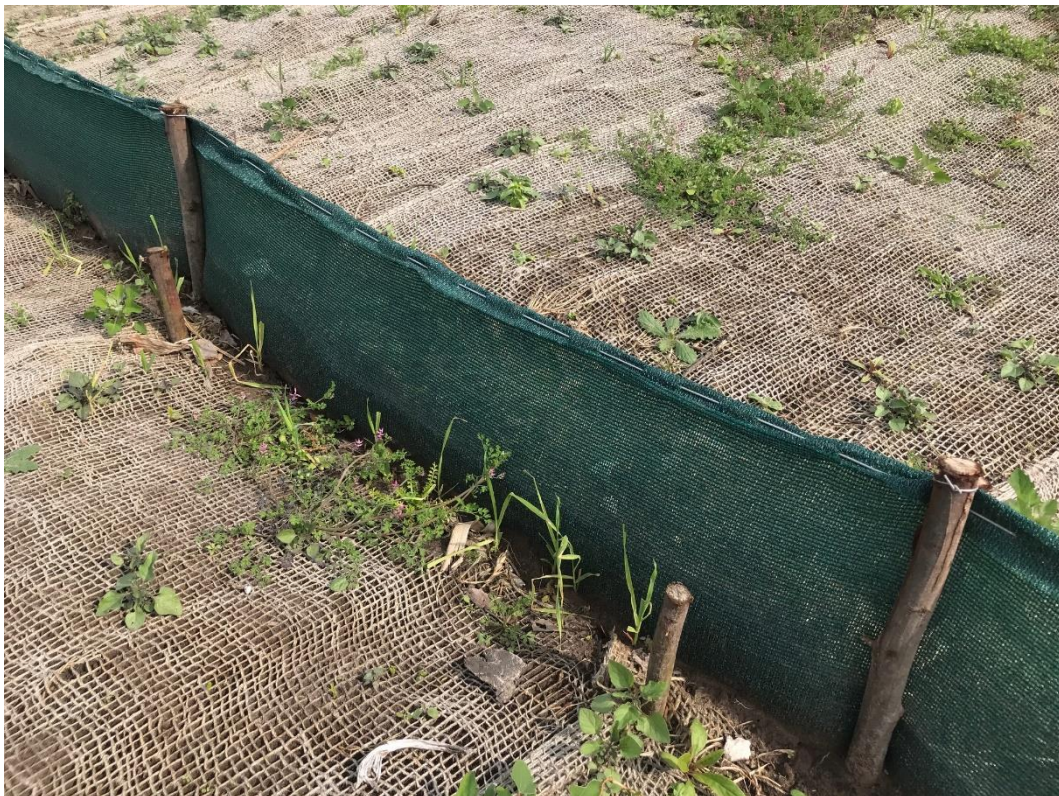
Figure 17. Images of installed soil saver matting and silt fences several weeks after installation.

- Cover the seeded and mulched slopes with a rolled erosion control product (such as jute, coir or straw matting). Preferably a natural (vs. man-made), bio-degradable product should be used. The use of a jute geotextile called *Soilsaver* is recommended. It is available from Kaytech in Port Elizabeth and in Cape Town.

The role of the erosion control matting is not to provide long-term protection for slopes from erosion, but to protect the soil surface until vegetation can establish and become the permanent stabilising feature. The slope should be seeded and mulched, and then covered with erosion control matting which will remain in place until the vegetation has established.

Matting should be overlapped by about 10cm and secured using wooden stakes along the edges. Terminal ends of the matting can also be staked or buried in an anchor trench.

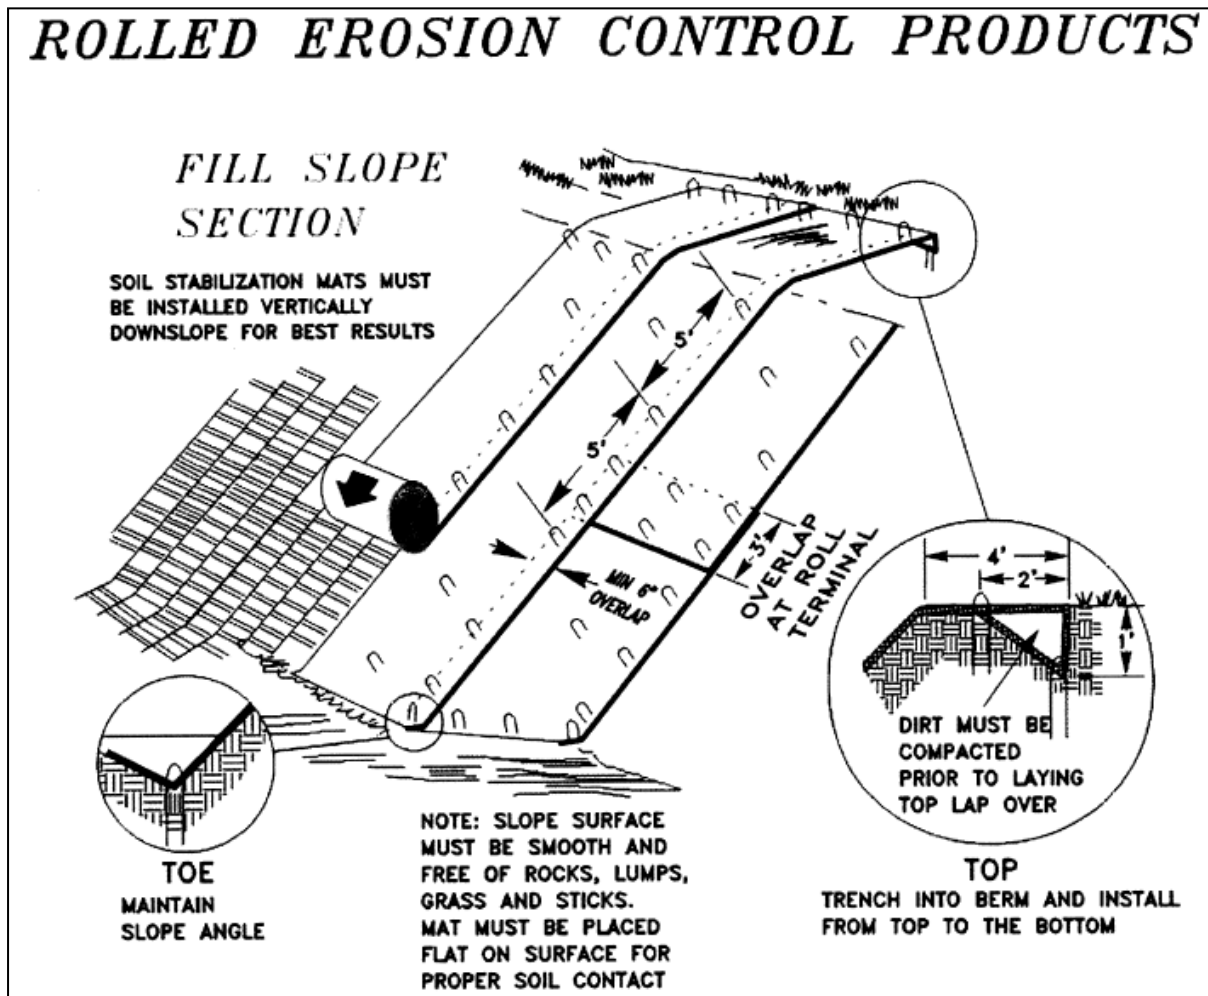
Figure 18. Example of methods recommended to install erosion control matting on sloping areas that require revegetation (Source: Department of Environmental Protection, West Virginia)

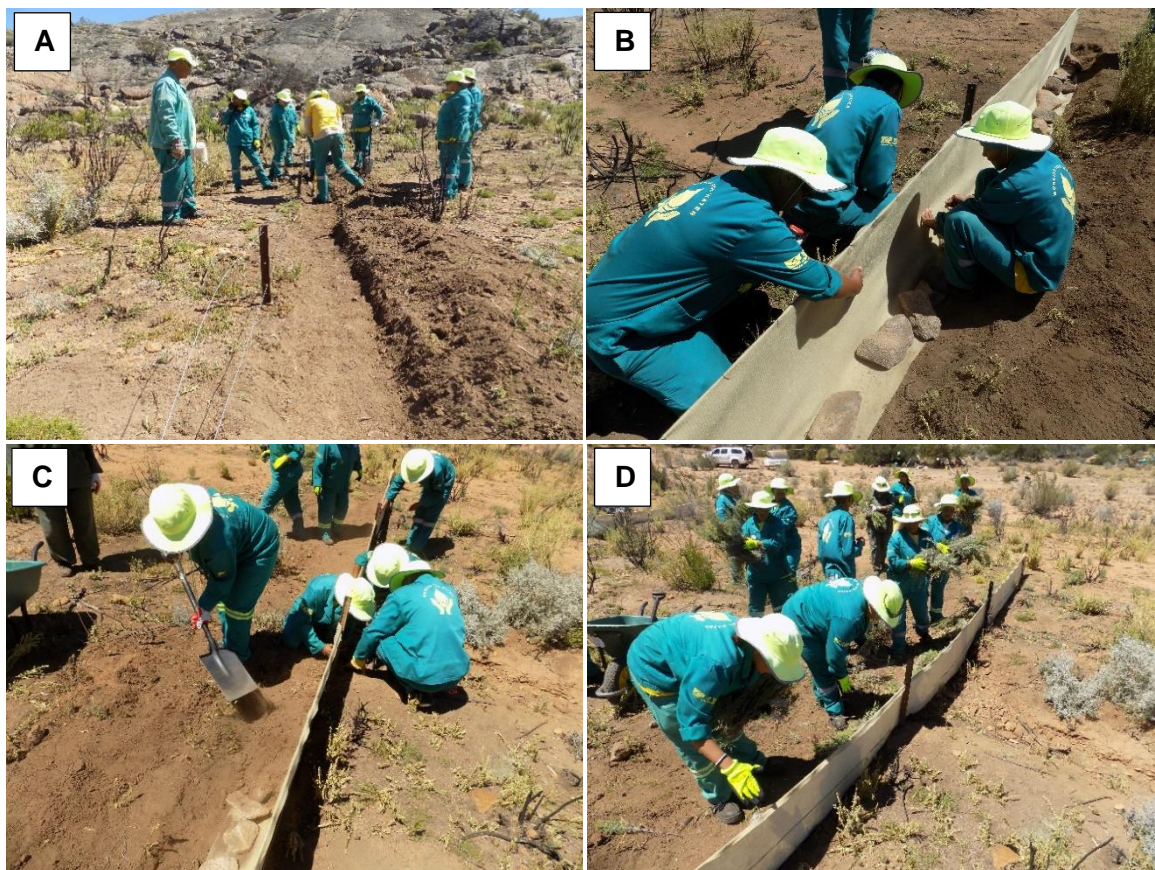
Figure 19. Installation of the soil erosion control fence. A: Installing the standards and wires and preparing the trench. B: Fitting the geotextile, tying it on with wire. C: Filling in the trench over the geotextile. D: Applying a mulch against the completed fence (Photos courtesy Ken Coetzee).

- Terminal ends of the silt fence should run slightly uphill to prevent runoff from going around the ends of the fences.
- Silt fences will be removed once vegetation has established on exposed areas.

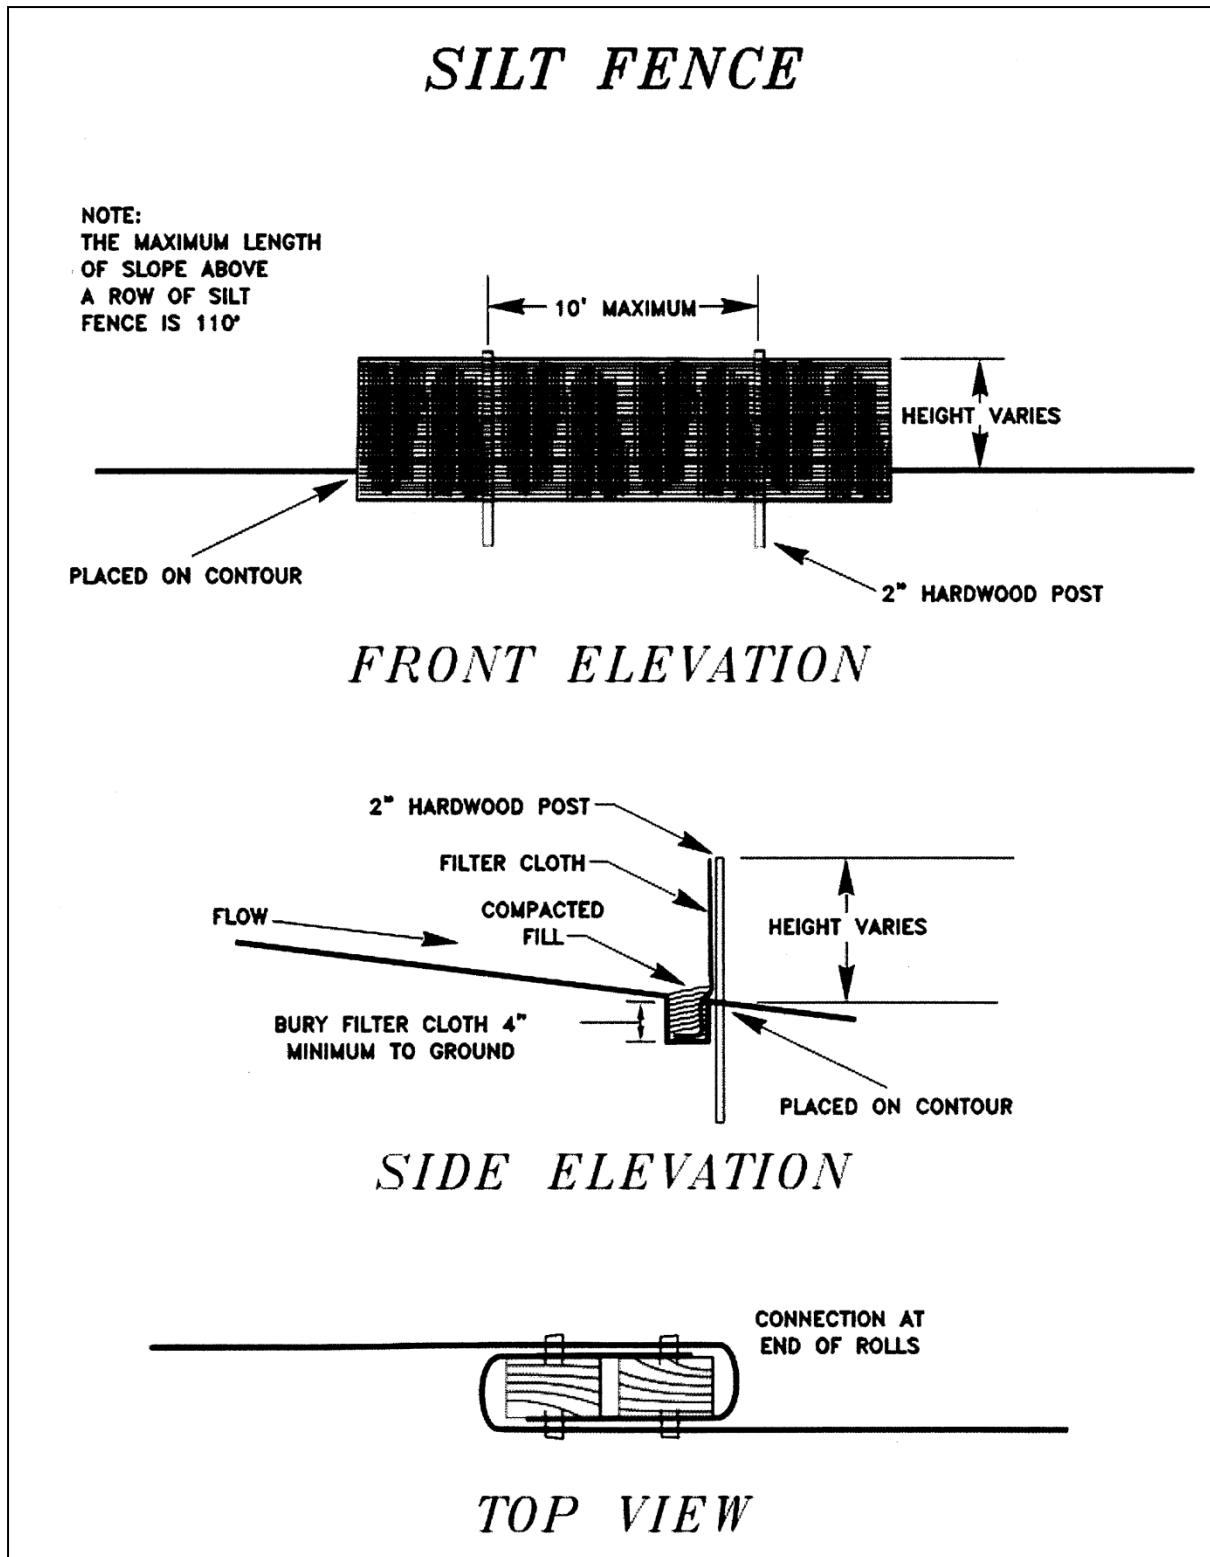
Figure 20. Example of methods recommended to install silt fencing (Measurements in inches; Source: Department of Environmental Protection, West Virginia)

- Geotextile should be in a continuous roll to avoid joins which weaken the structure. Where joins are unavoidable both fabric ends should be wound around stakes to prevent it from unravelling (See Figure 20);
